**ANNUAL CCR UNIT INSPECTION REPORT  
2022**

**NEW CASTLE STATION ASH LANDFILL  
WEST PITTSBURG, LAWRENCE COUNTY, PENNSYLVANIA**

**CEC Project 327-485.0001**

**INSPECTION DATE: 11/7/2022  
REPORT DATE: 1/13/2023**

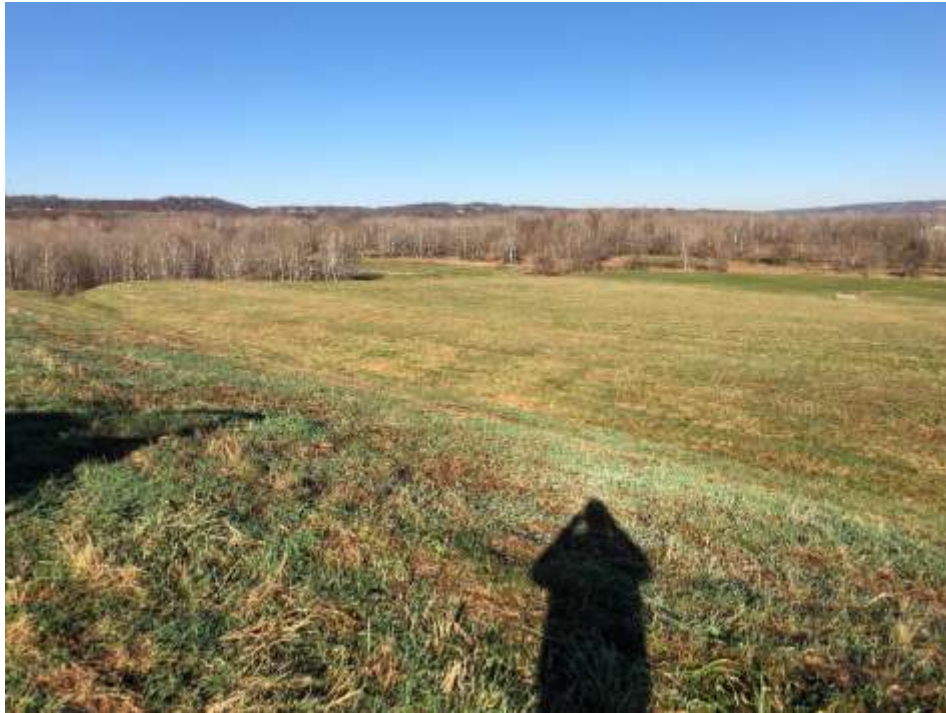
**Photograph 1:** Stage 5 final cover is well vegetated and mowed annually. No evidence of animal burrows, erosion, or stability issues.

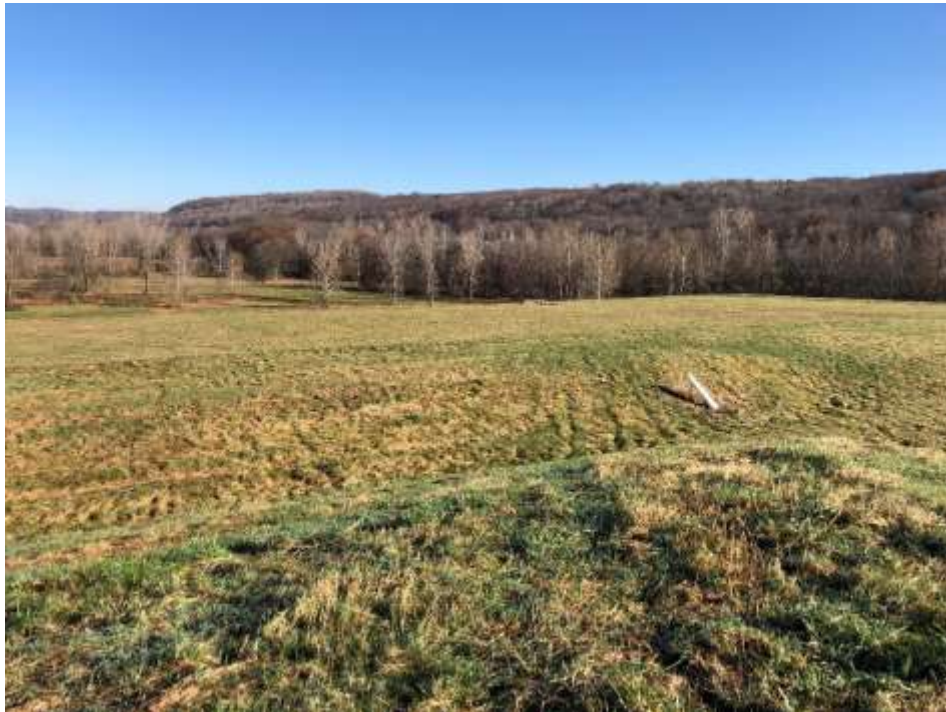
**Photograph 2:** Stage 5 final cover is well vegetated and mowed annually. No evidence of animal burrows, erosion, or stability issues.

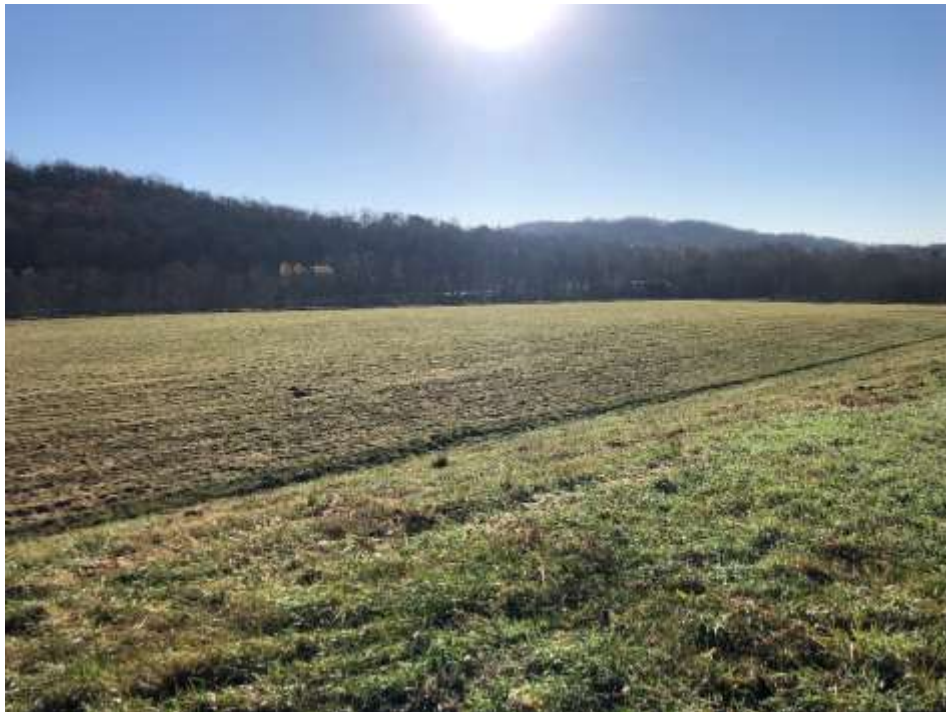
**Photograph 4:** Stage 6 final cover is well vegetated and mowed annually. No evidence of animal burrows, erosion, or stability issues.

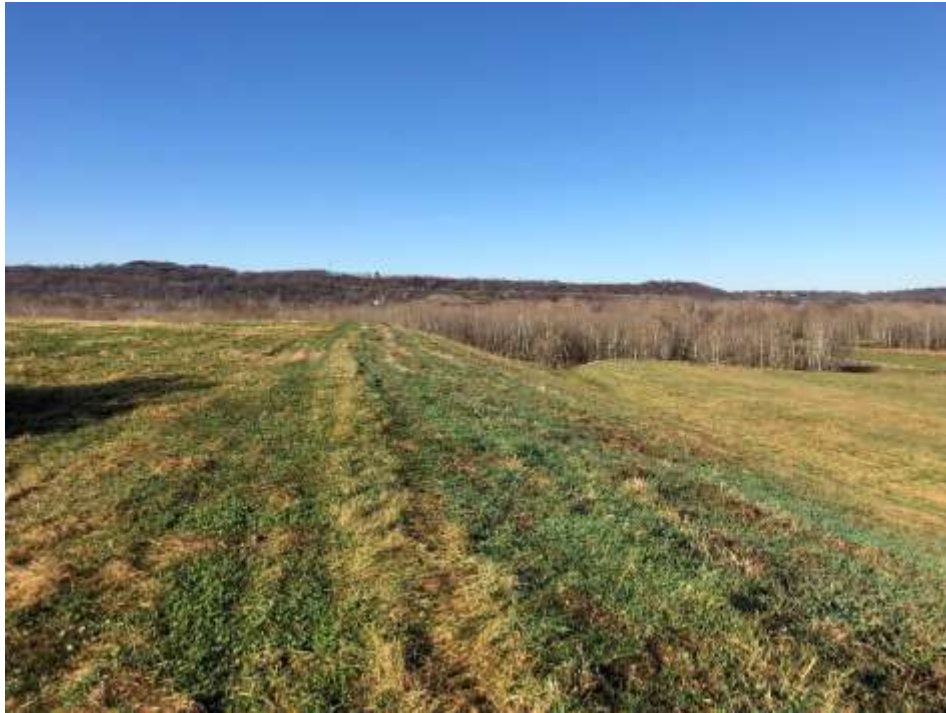
**Photograph 5:** Stage 4 north slope is well vegetated and mowed annually. No evidence of animal burrows, erosion, or stability issues.

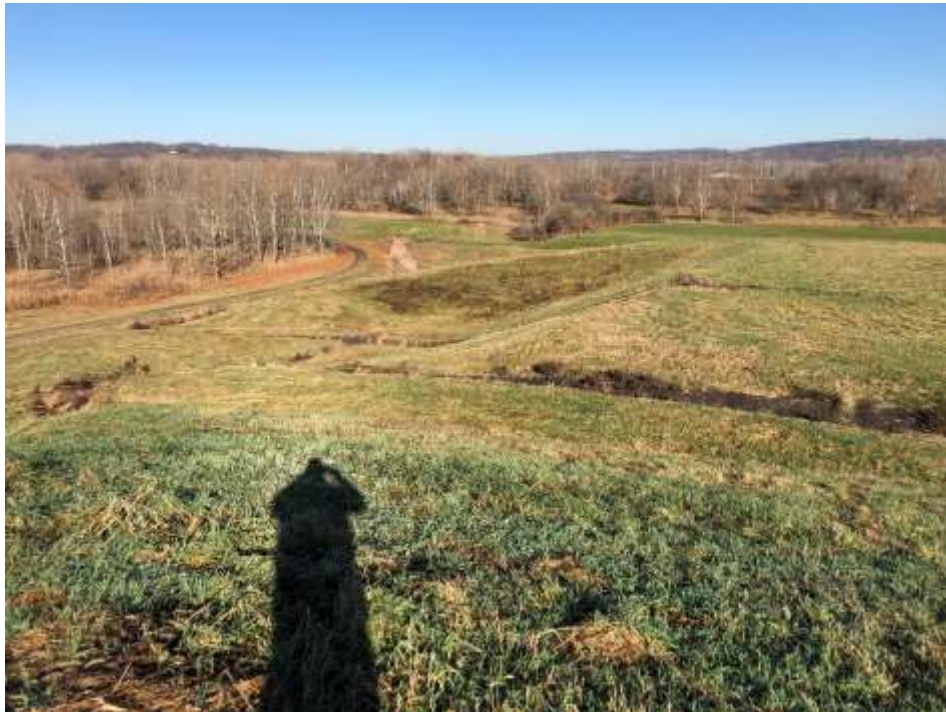
**Photograph 6:** Downchutes from west side of Stage 4 and Stage 5. No evidence of animal burrows, erosion, or stability issues on the vegetated slopes.

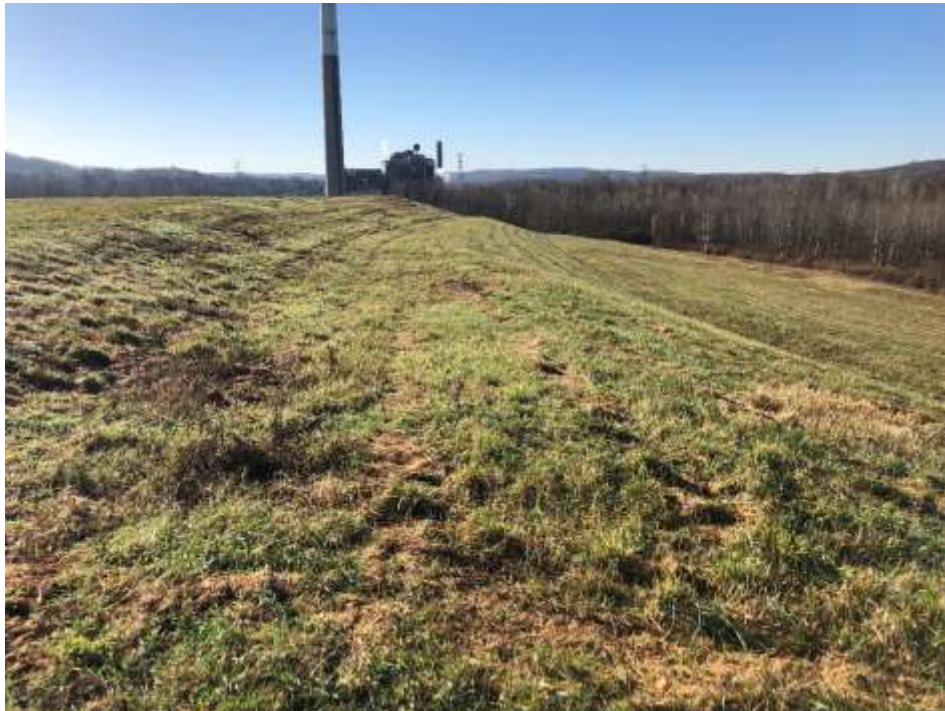
**Photograph 8:** Stage 4 west slope is well vegetated and mowed annually. No evidence of animal burrows, erosion, or stability issues.

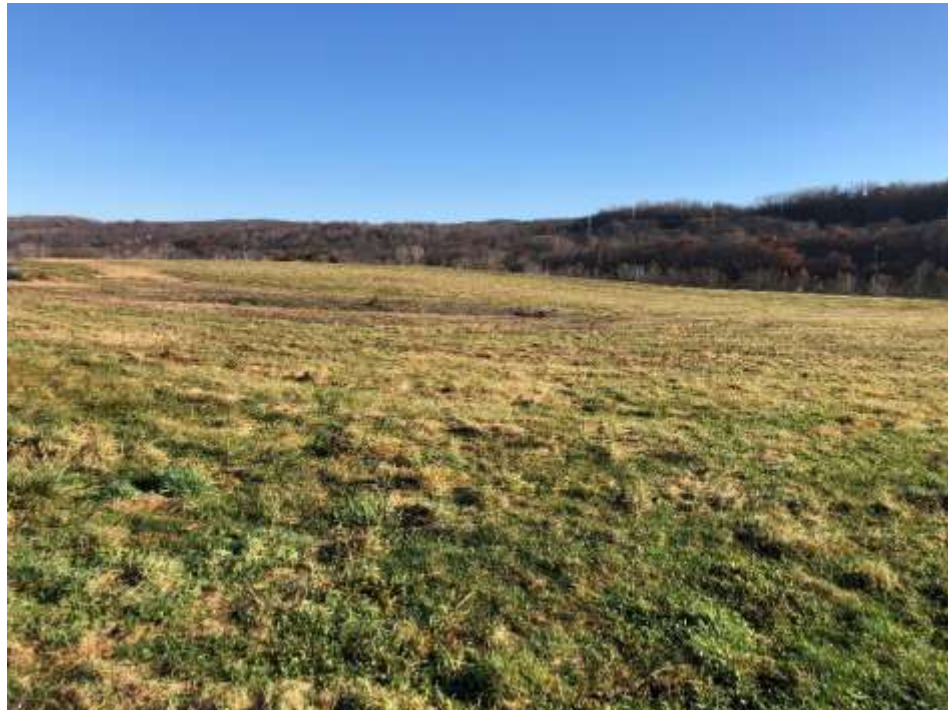
**Photograph 10:** Intermediate cover in active area is well vegetated and mowed annually.

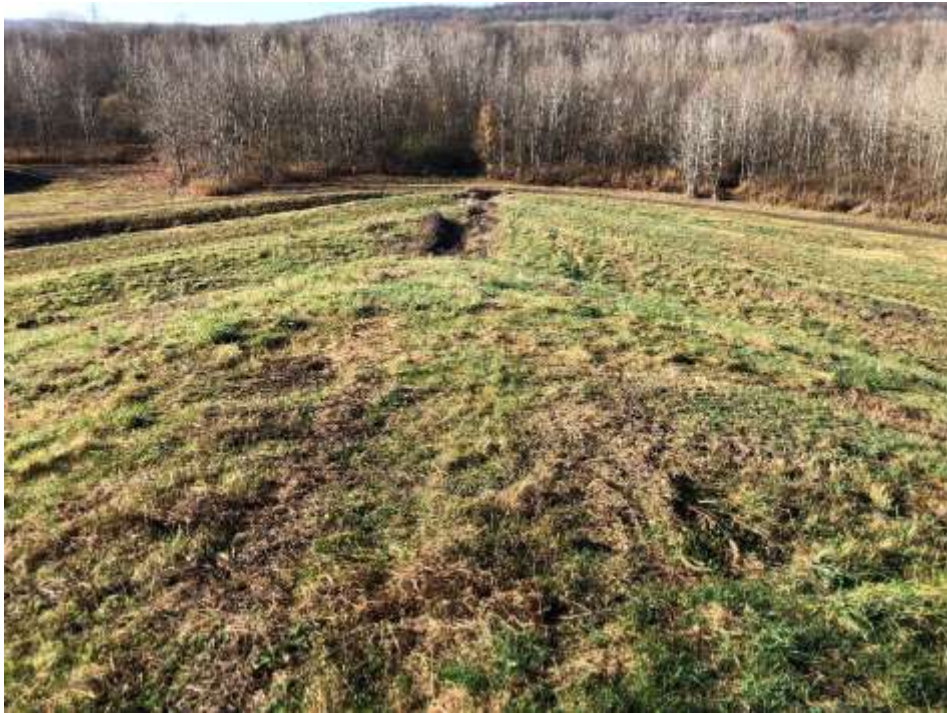
**Photograph 11:** Stage 4 southwest corner slope is well vegetated and mowed annually. No evidence of animal burrows, erosion, or stability issues.

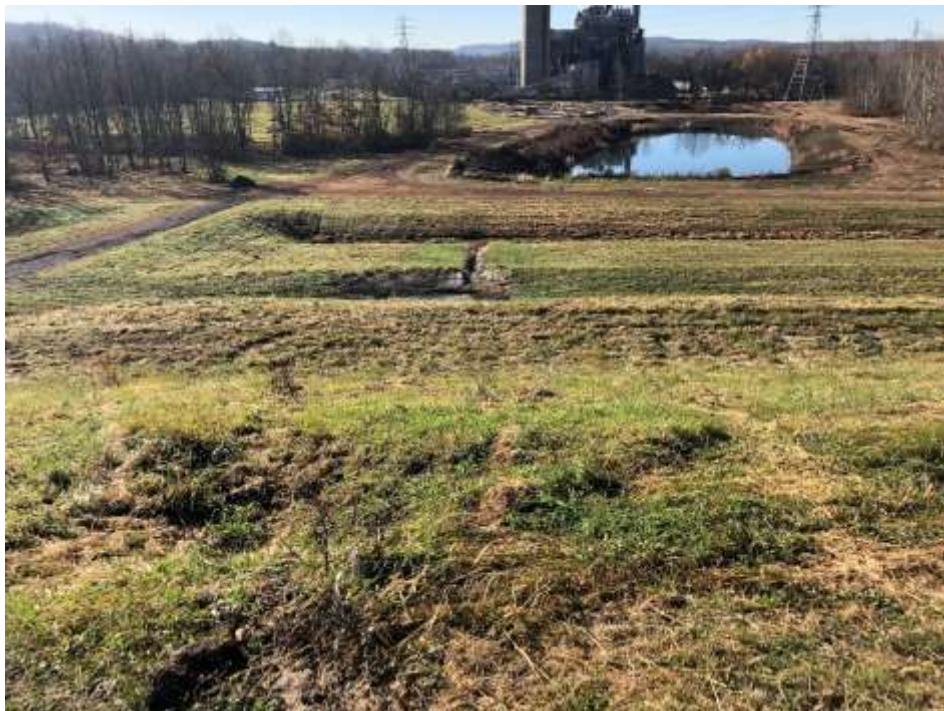
**Photograph 12:** Stage 4 south slope is well vegetated and mowed annually. No evidence of animal burrows, erosion, or stability issues.

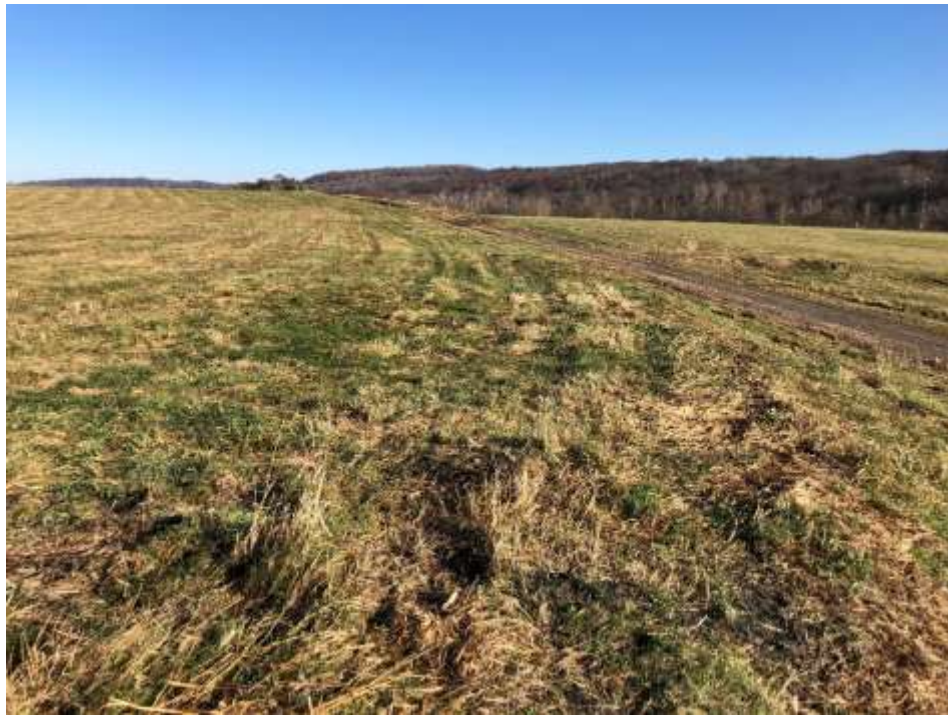
**Photograph 13:** Intermediate cover in active area is well vegetated and mowed annually.

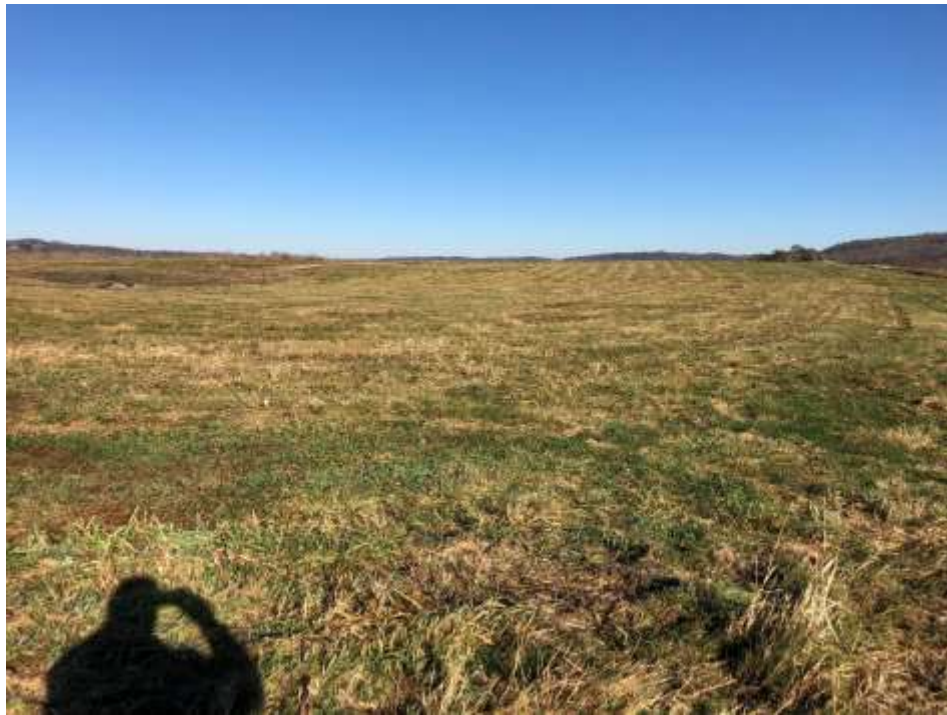
**Photograph 14:** Intermediate cover in active area is well vegetated and mowed annually.

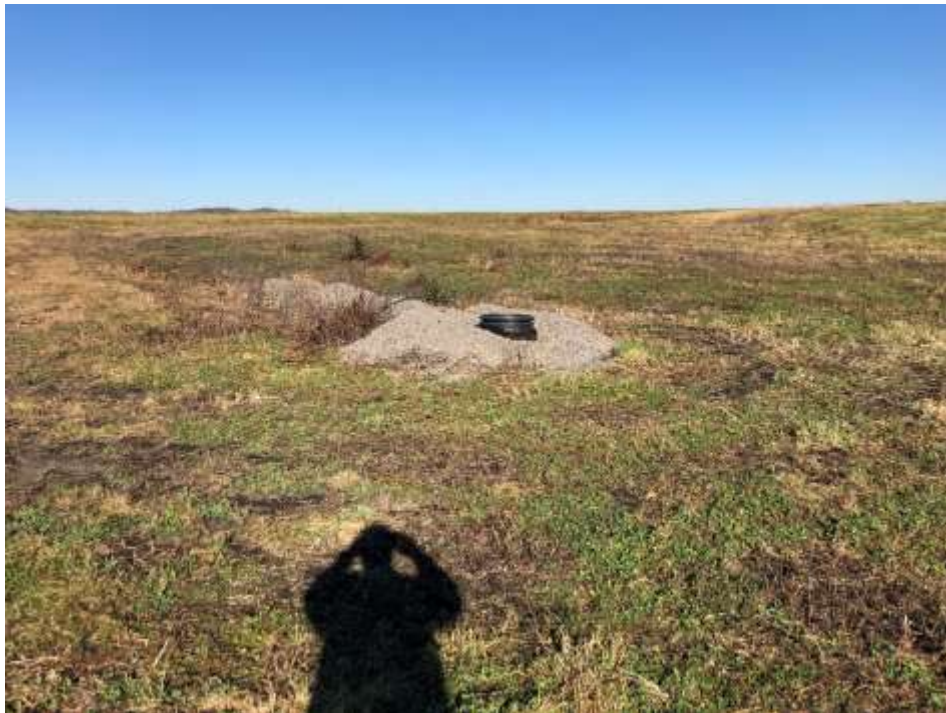
**Photograph 15:** Contact water collection riser in active area.

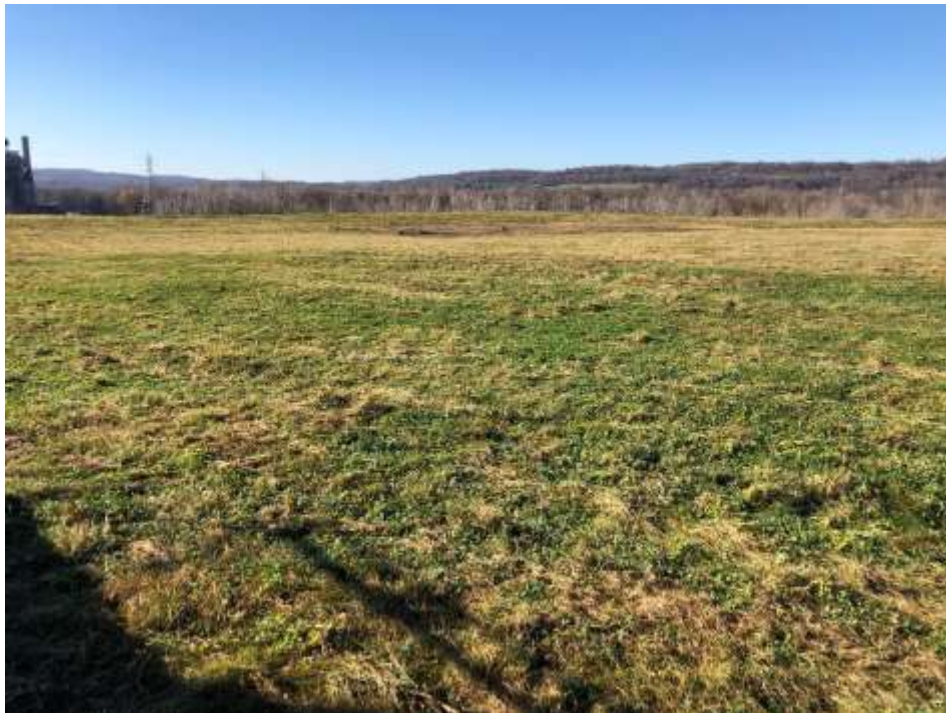
**Photograph 16:** Intermediate cover in active area is well vegetated and mowed annually.

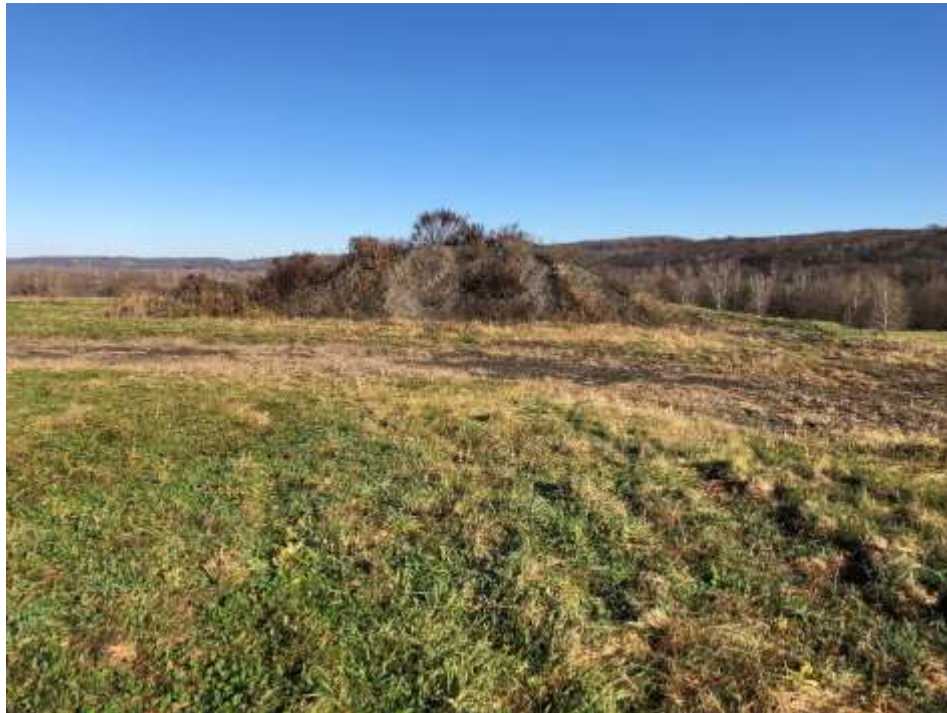
**Photograph 17:** Intermediate cover in active area is well vegetated and mowed annually. Bottom ash storage pile.

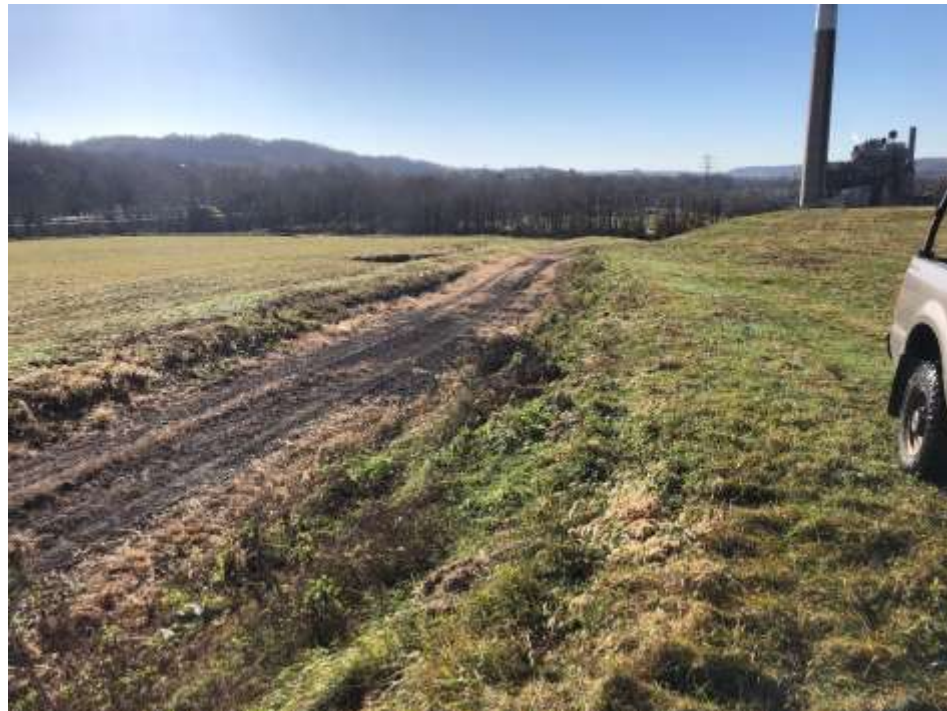
**Photograph 18:** Access road is well maintained.

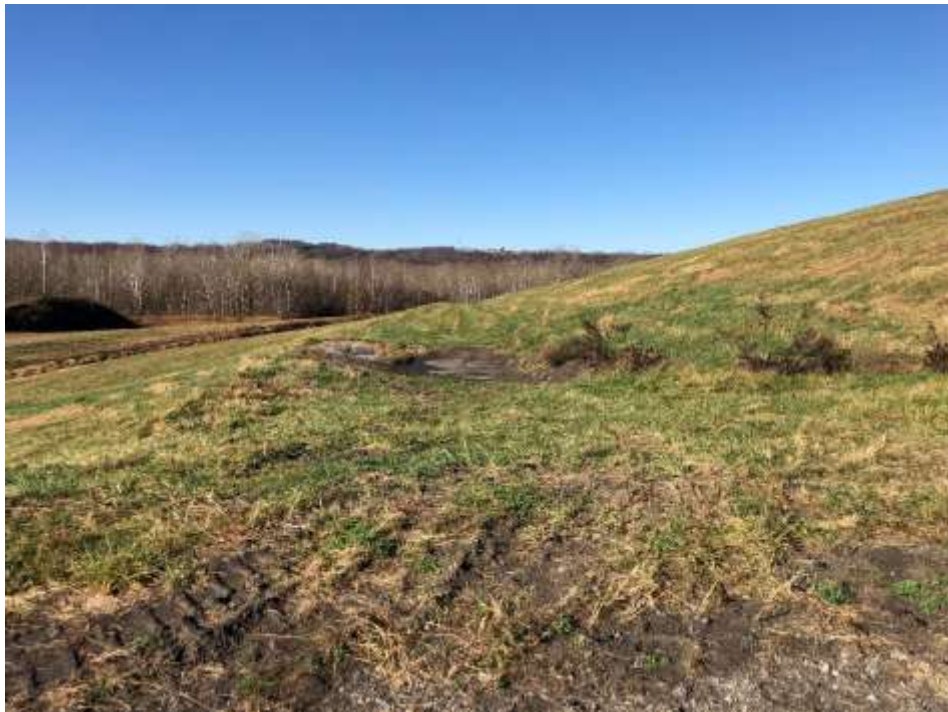
**Photograph 20:** South non-contact stormwater bench is clear of obstructions. South final cover upper slope is well vegetated and mowed annually. No evidence of animal burrows, erosion, or stability issues.

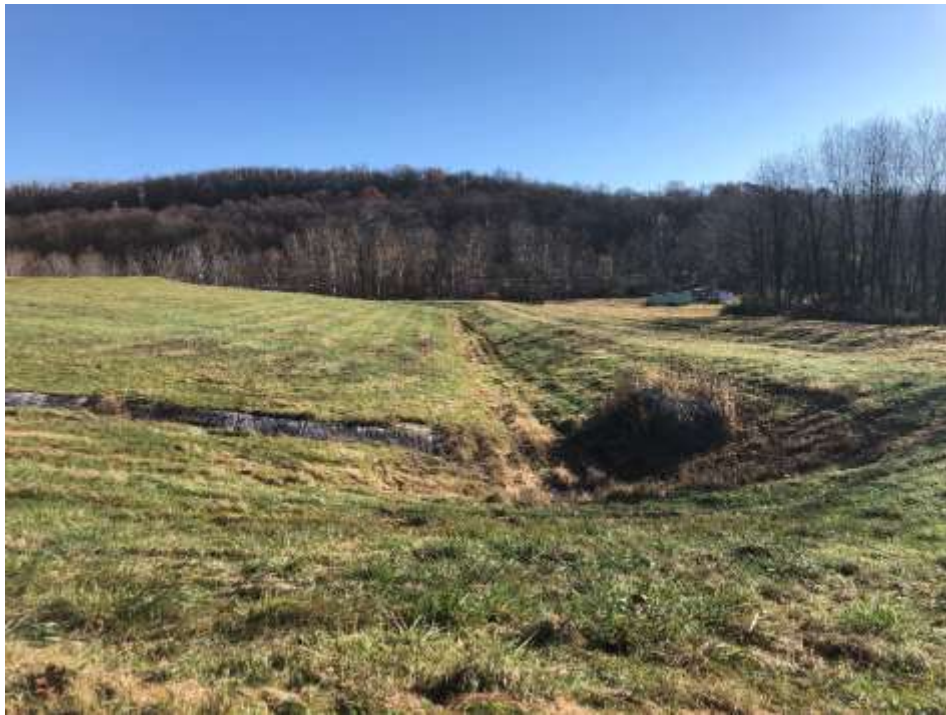
**Photograph 21:** South non-contact stormwater channel is clear of obstructions. South final cover lower slope is well vegetated and mowed annually. No evidence of animal burrows, erosion, or stability issues.

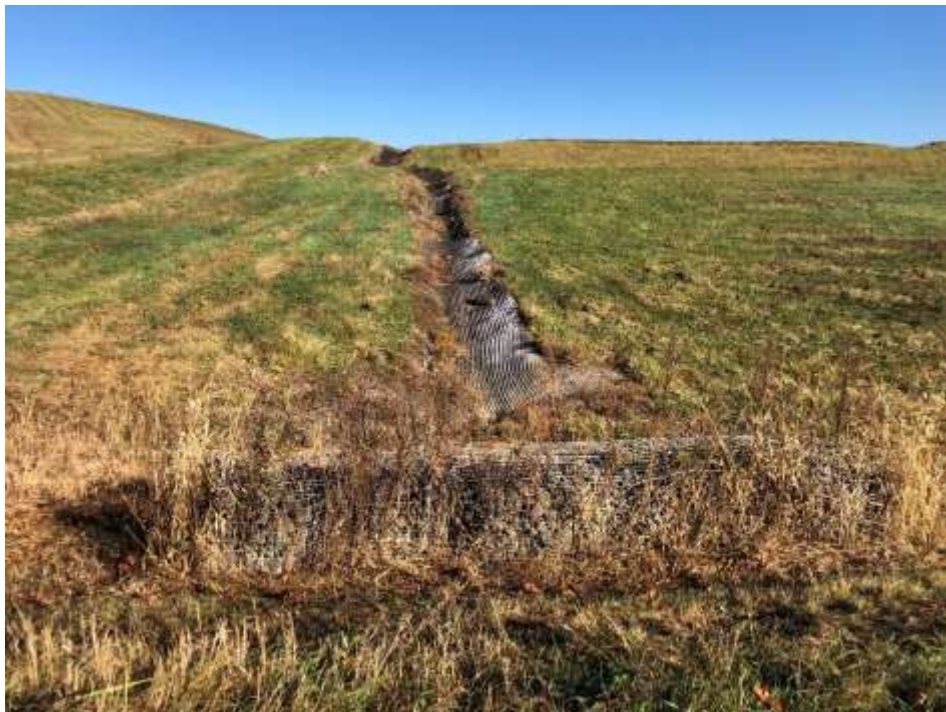
**Photograph 22:** Non-contact stormwater downchute is clear of obstructions. Gabion energy dissipator is installed at the junction with the stormwater (non-contact water) perimeter ditch.

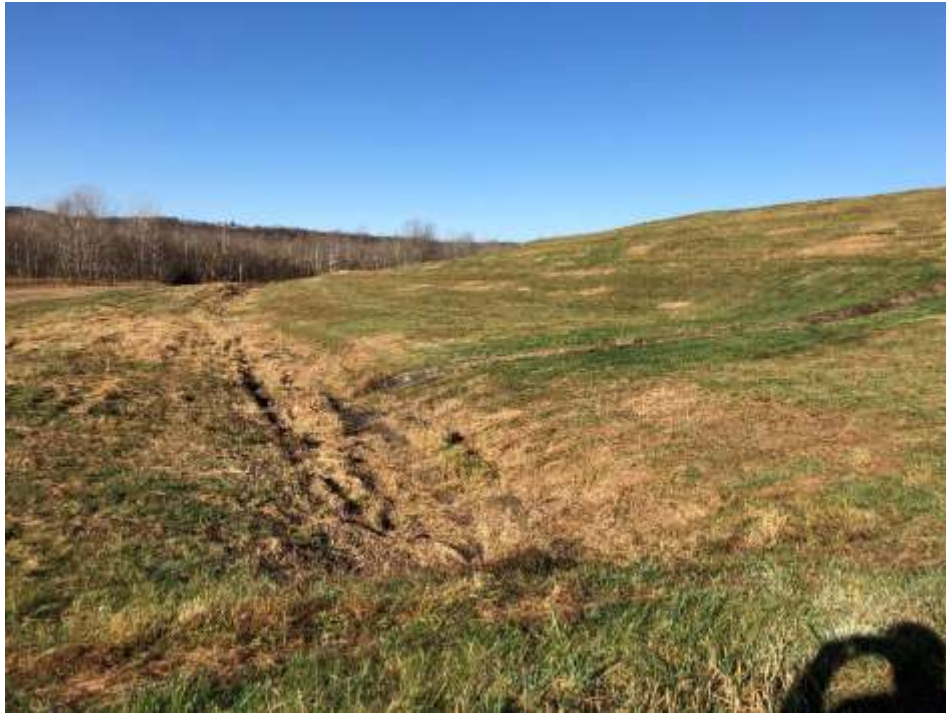
**Photograph 23:** South non-contact stormwater channel is clear of obstructions. South final cover lower slope is well vegetated and mowed annually. No evidence of animal burrows, erosion, or stability issues.

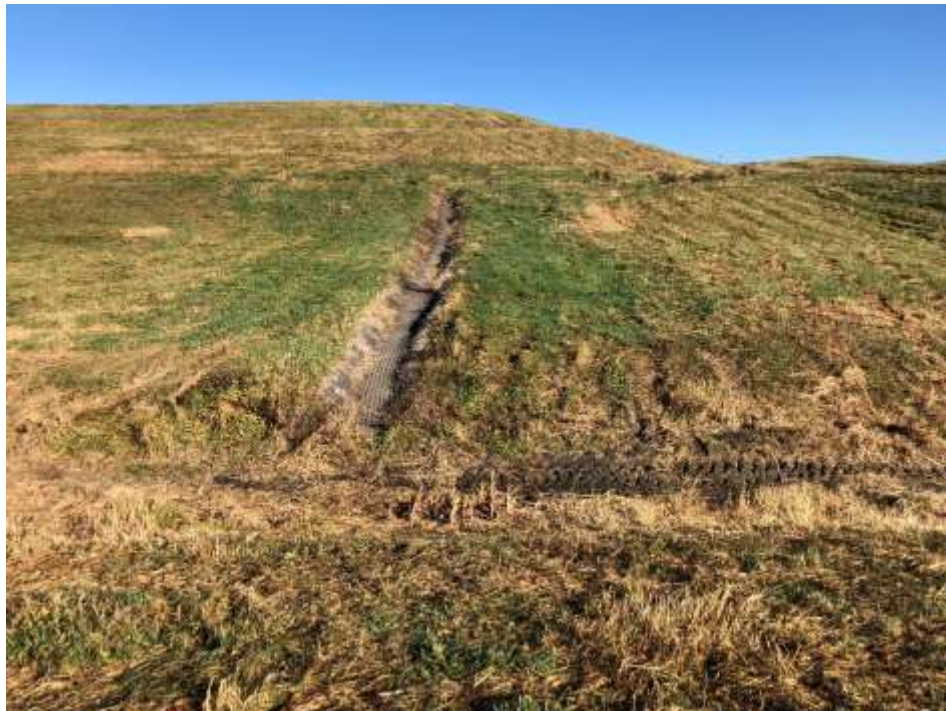
**Photograph 24:** Non-contact stormwater downchute is clear of obstructions.

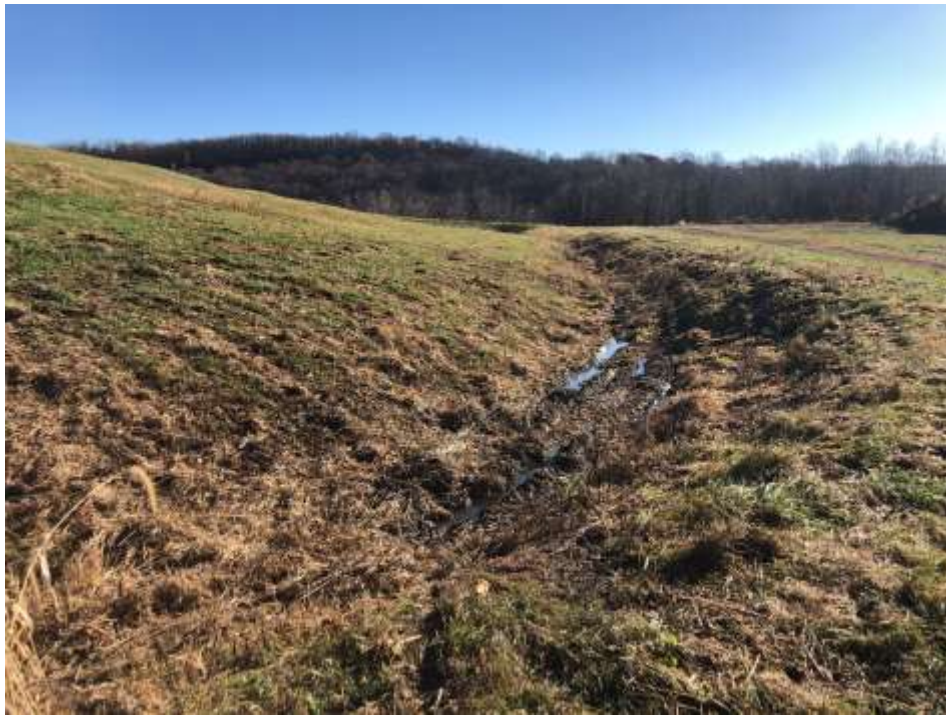
**Photograph 25:** South non-contact stormwater channel is clear of obstructions. South final cover lower slope is well vegetated and mowed annually. No evidence of animal burrows, erosion, or stability issues.

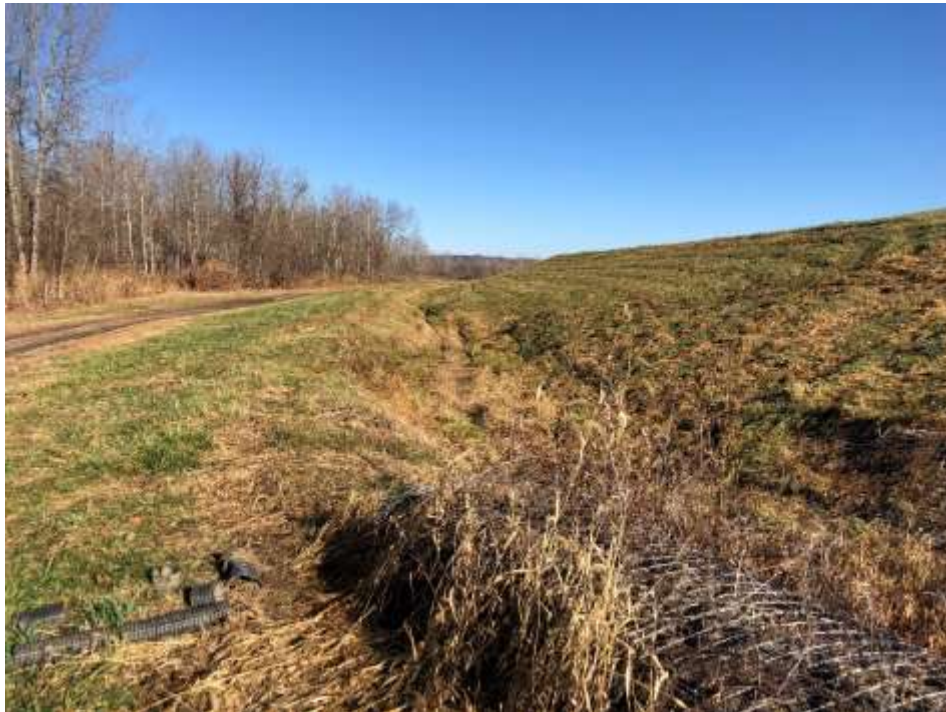
**Photograph 26:** West non-contact stormwater channel is clear of obstructions. West final cover lower slope is well vegetated and mowed annually. No evidence of animal burrows, erosion, or stability issues.

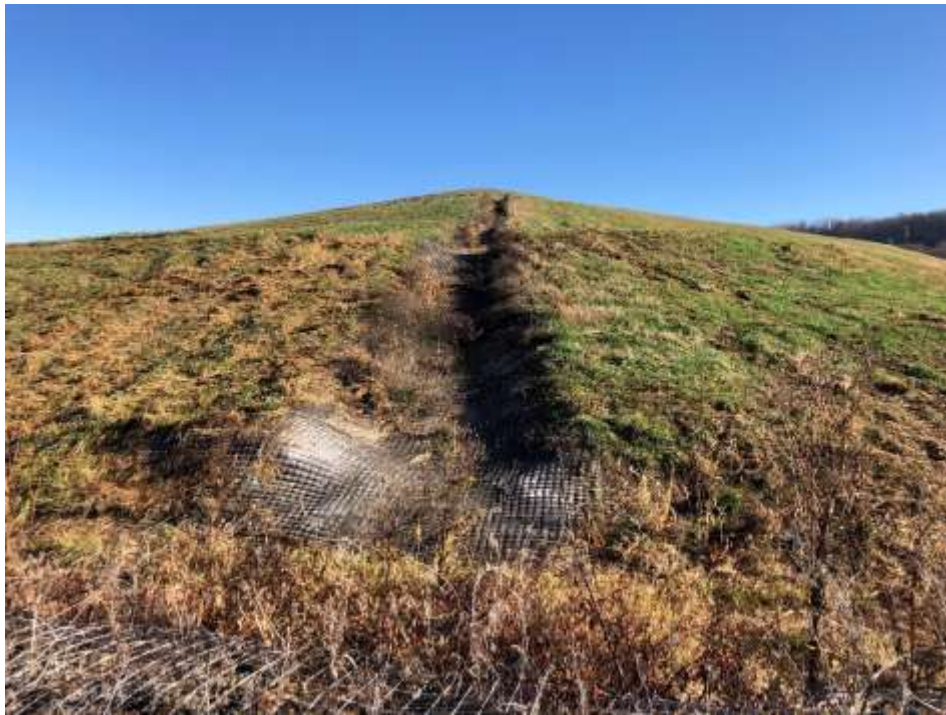
**Photograph 27:** Non-contact stormwater downchute is clear of obstructions. Gabion energy dissipator is installed at the junction with the stormwater perimeter ditch.

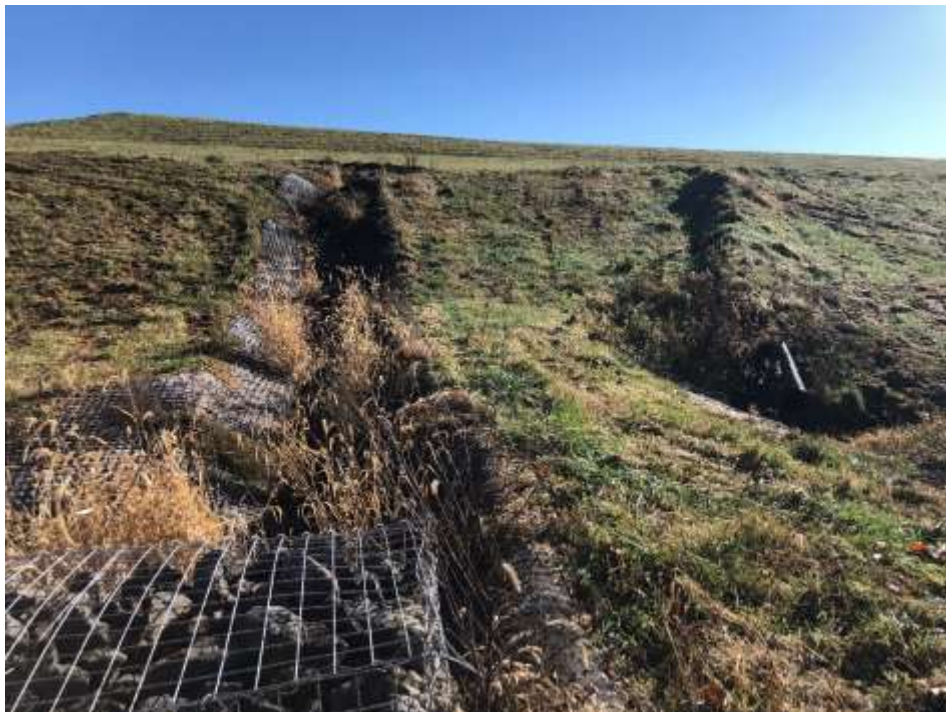
**Photograph 28:** Non-contact stormwater downchute is clear of obstructions. Gabion energy dissipator is installed at the junction with the stormwater perimeter ditch.

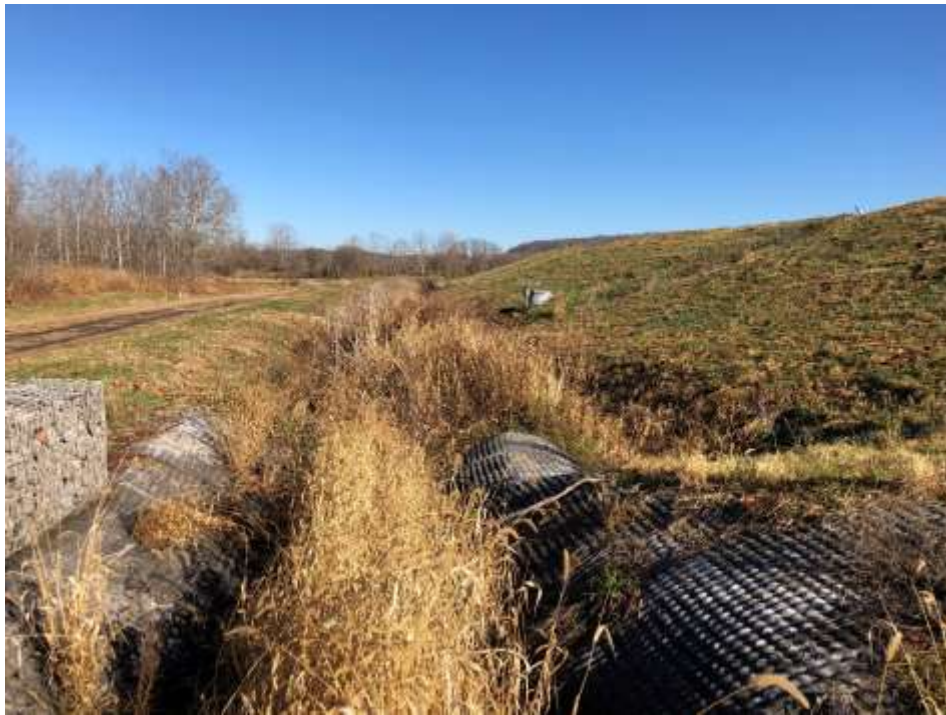
**Photograph 29:** West non-contact stormwater channel is clear of obstructions. West final cover lower slope is well vegetated and mowed annually. No evidence of animal burrows, erosion, or stability issues.

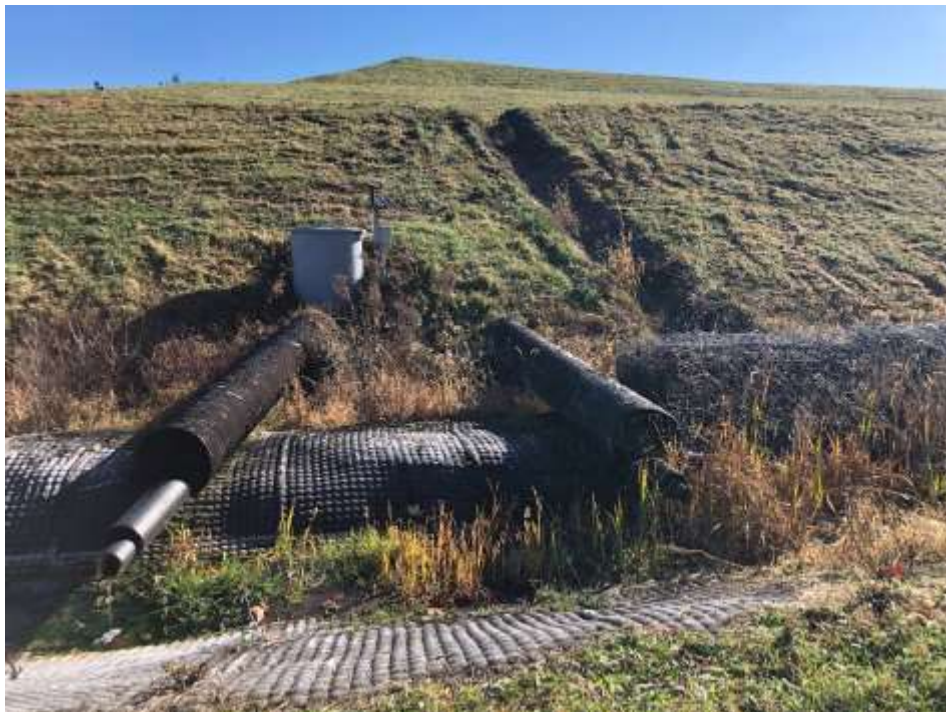
**Photograph 30:** Leachate collection zone and leak detection zone discharge pipes.

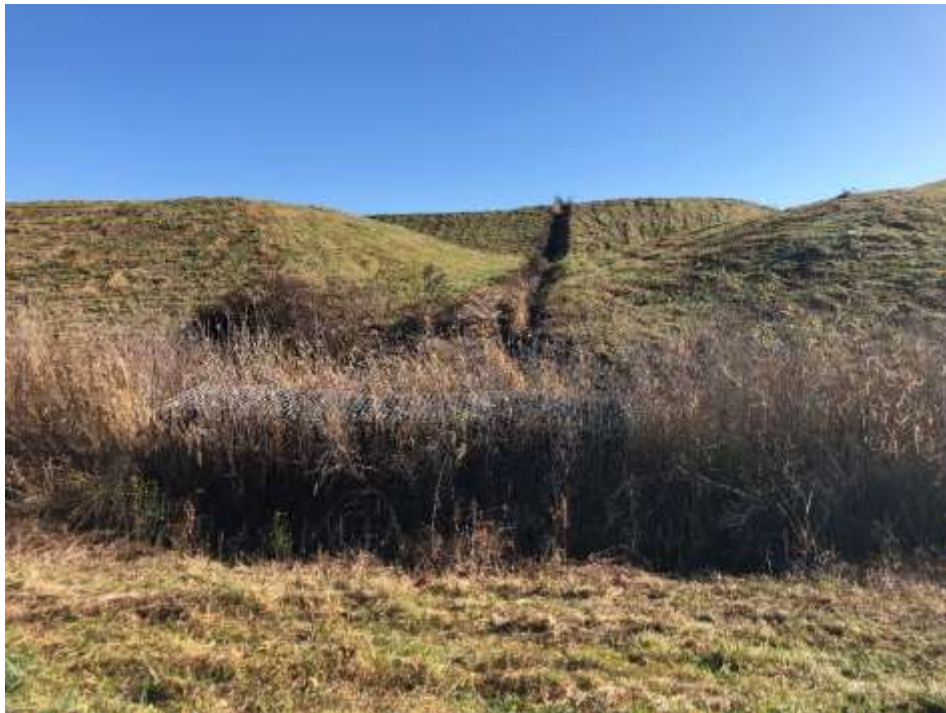
**Photograph 31:** Non-contact stormwater downchute is clear of obstructions. Gabion energy dissipator is installed at the junction with the stormwater perimeter ditch.

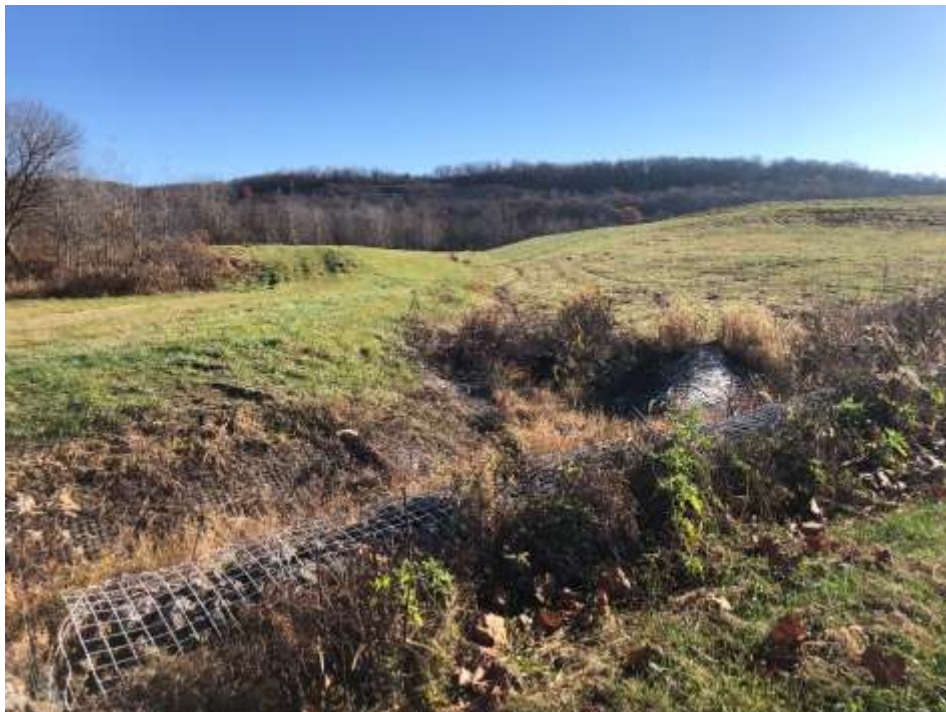
**Photograph 32:** North non-contact stormwater channel is clear of obstructions. North final cover lower slope is well vegetated and mowed annually. No evidence of animal burrows, erosion, or stability issues.

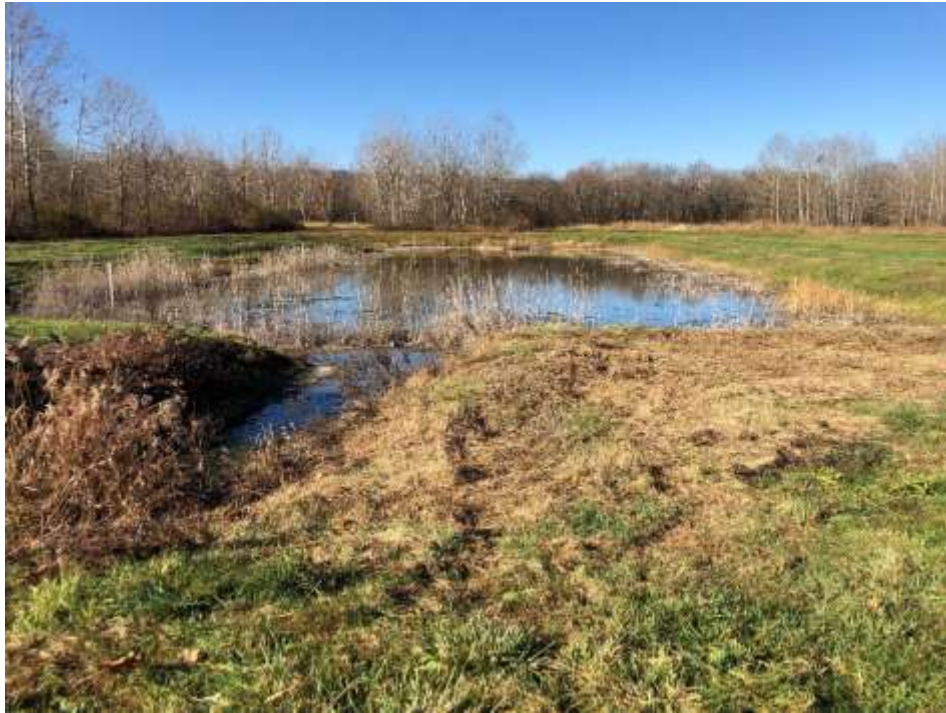
**Photograph 33:** Leachate (contact water) Pond. No evidence of animal burrows or liner damage.

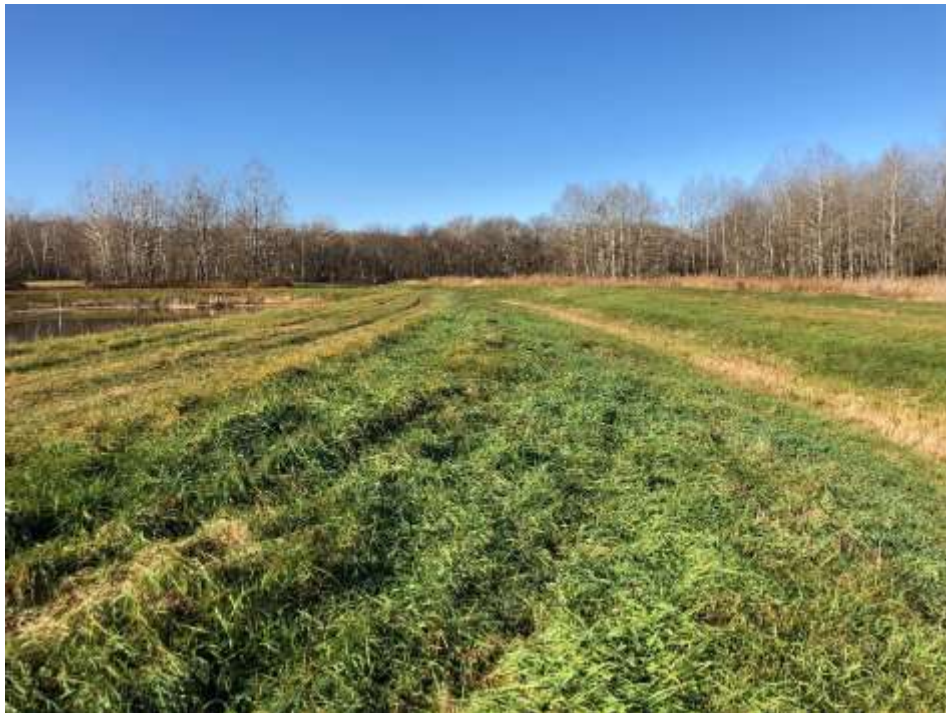
**Photograph 34:** North non-contact stormwater channel is clear of obstructions.

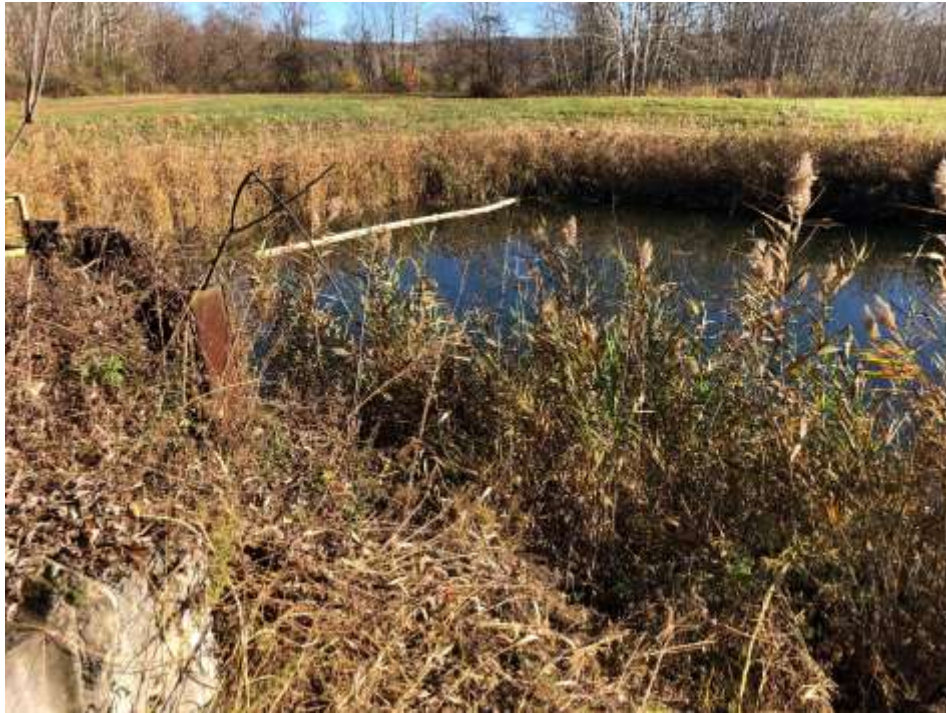
**Photograph 35:** Non-contact stormwater Sedimentation Pond.

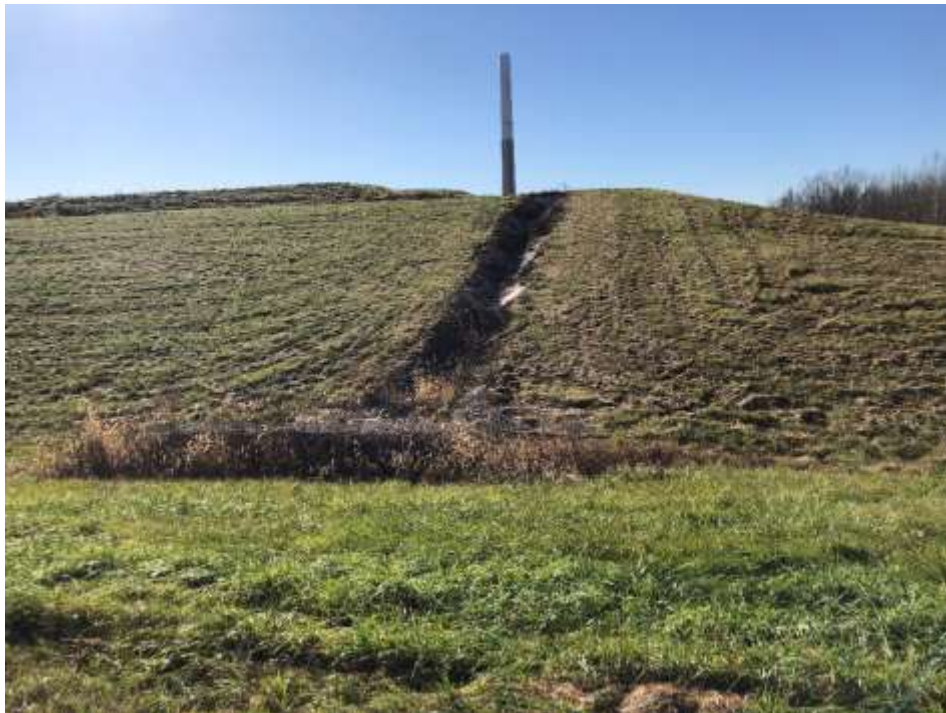
**Photograph 36:** Non-contact stormwater downchute is clear of obstructions. Gabion energy dissipator is installed at the junction with the stormwater (non-contact water) perimeter ditch.
