**ANNUAL CCR UNIT INSPECTION REPORT  
2022**

**NEW CASTLE STATION ASH LANDFILL  
WEST PITTSBURG, LAWRENCE COUNTY, PENNSYLVANIA**

**CEC Project 327-485.0001**

**INSPECTION DATE: 11/7/2022  
REPORT DATE: 1/13/2023**

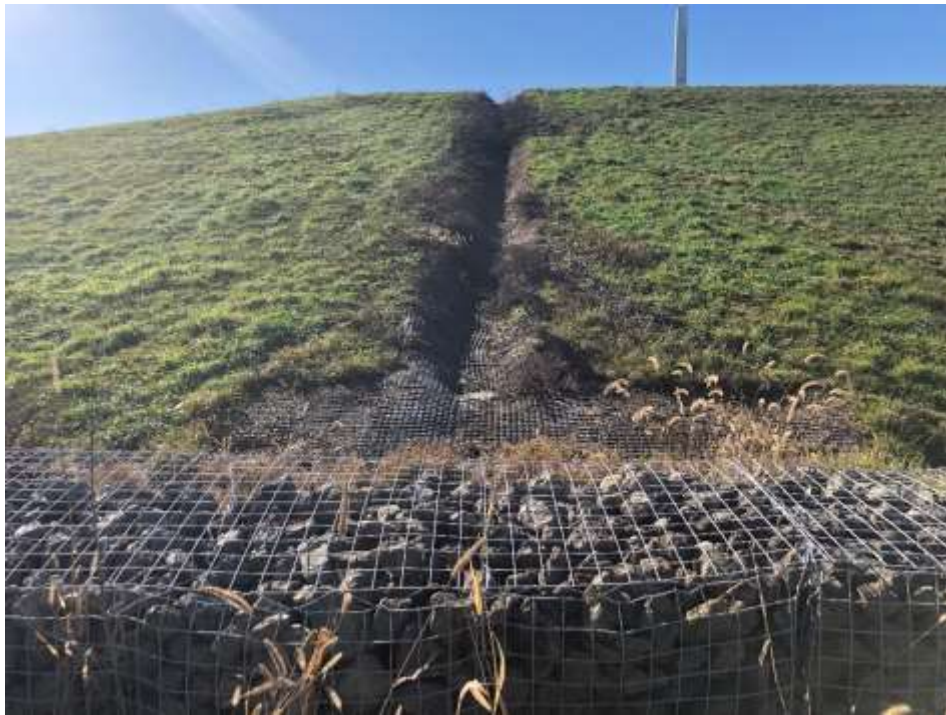
**Photograph 37:** Non-contact stormwater downchute is clear of obstructions. Gabion energy dissipator is installed at the junction with the stormwater (non-contact water) perimeter ditch.

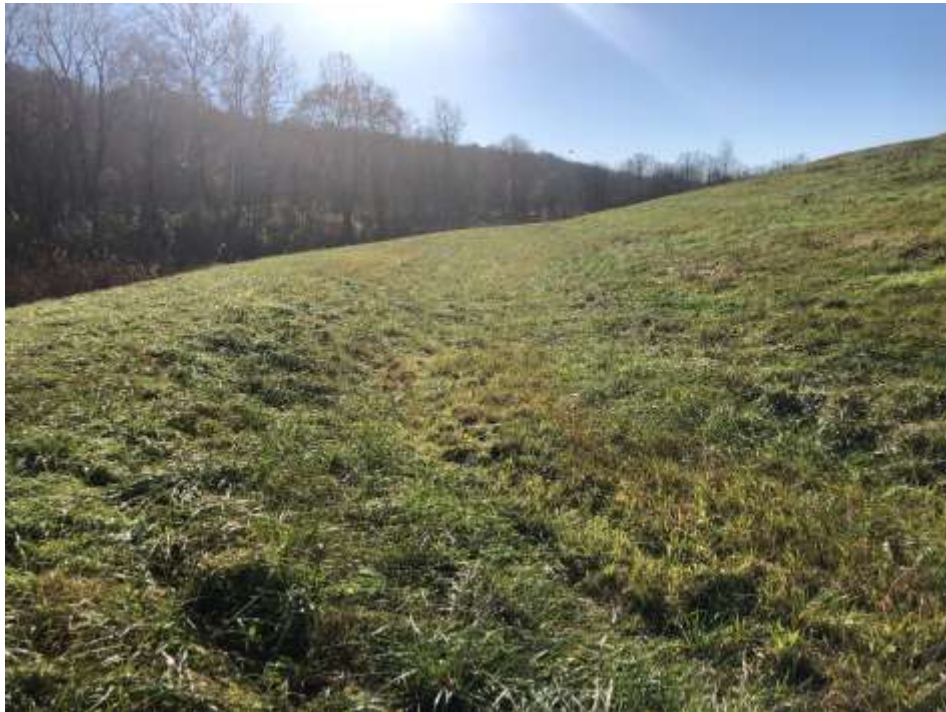
**Photograph 38:** East non-contact stormwater channel is clear of obstructions. East final cover lower slope is well vegetated and mowed annually. No evidence of animal burrows, erosion, or stability issues.

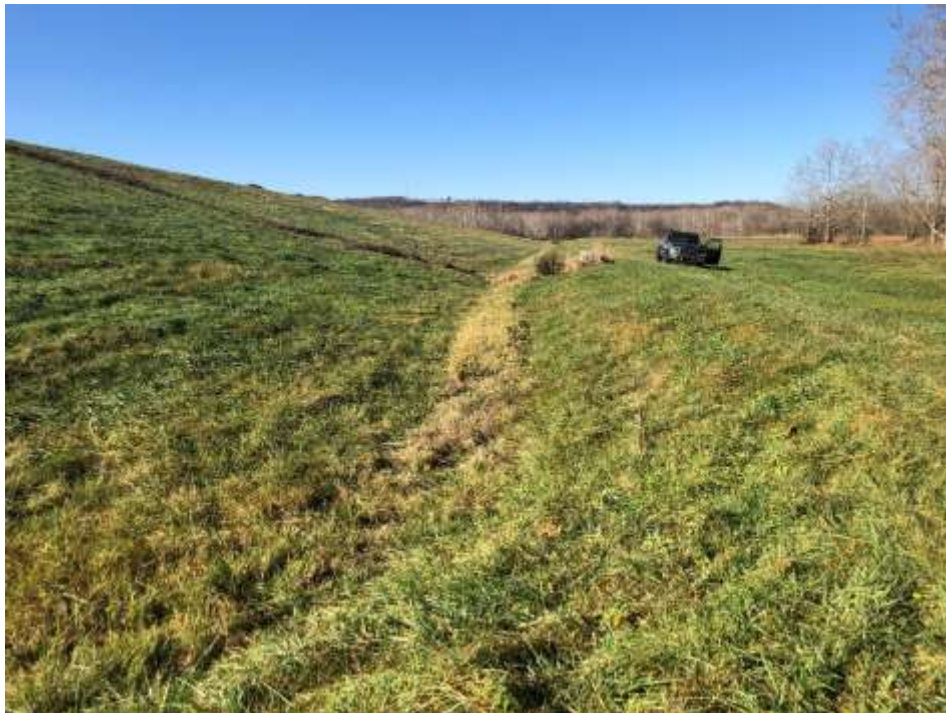
**Photograph 39:** North non-contact stormwater channel is clear of obstructions. North final cover lower slope is well vegetated and mowed annually. No evidence of animal burrows, erosion, or stability issues.

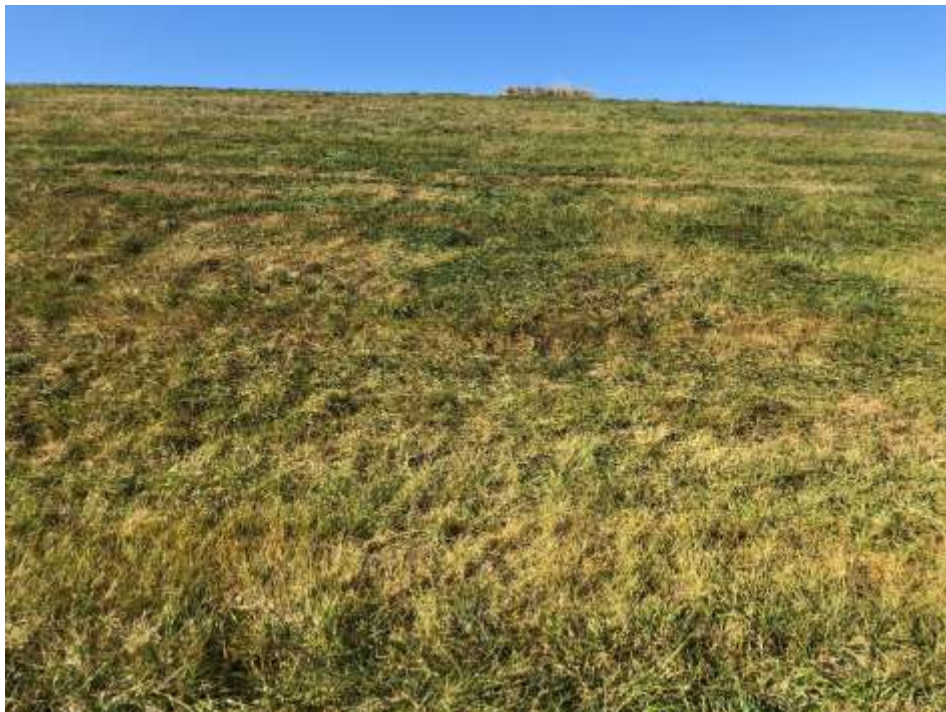
**Photograph 40:** East final cover lower slope is well vegetated and mowed annually. No evidence of animal burrows, erosion, or stability issues.

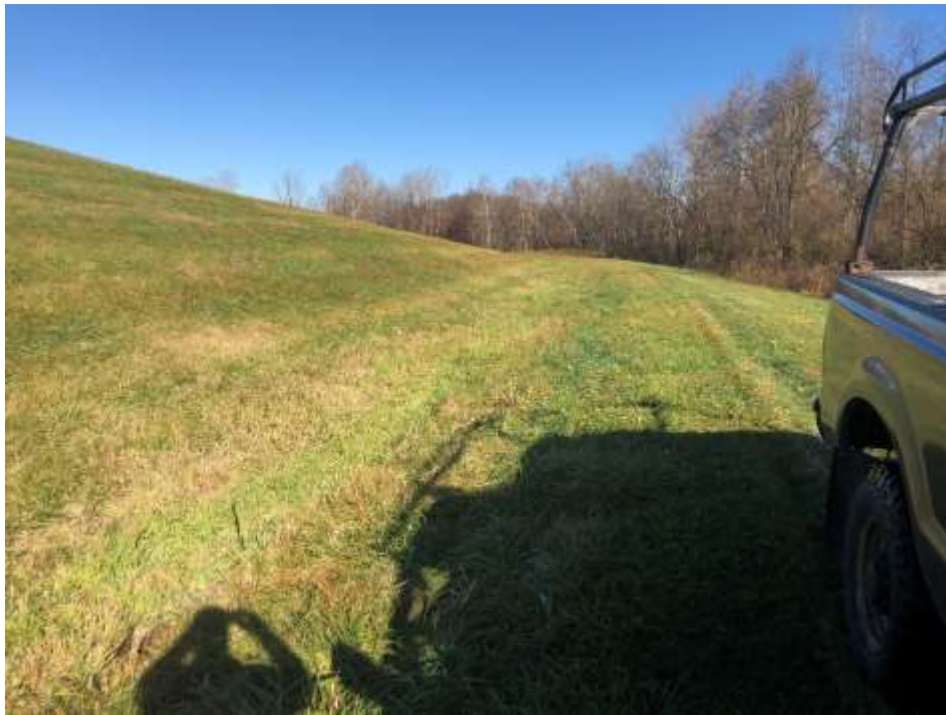
**Photograph 41:** East non-contact stormwater channel is clear of obstructions. East final cover lower slope is well vegetated and mowed annually. No evidence of animal burrows, erosion, or stability issues.

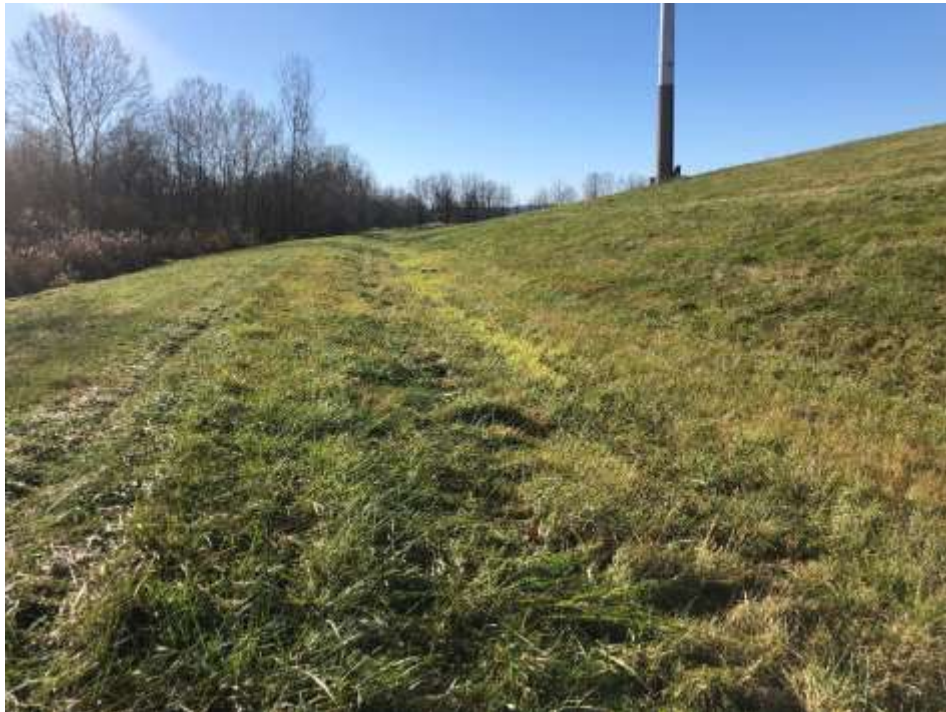
**Photograph 42:** East non-contact stormwater channel is clear of obstructions. East final cover lower slope is well vegetated and mowed annually. No evidence of animal burrows, erosion, or stability issues.

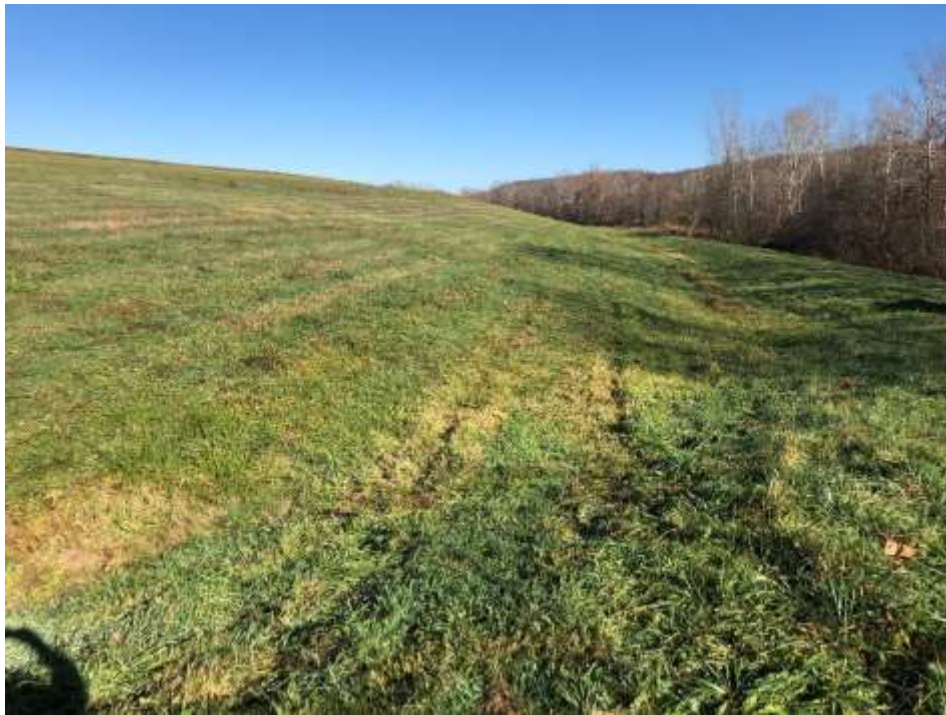
**Photograph 43:** East non-contact stormwater channel is clear of obstructions. East final cover lower slope is well vegetated and mowed annually. No evidence of animal burrows, erosion, or stability issues.

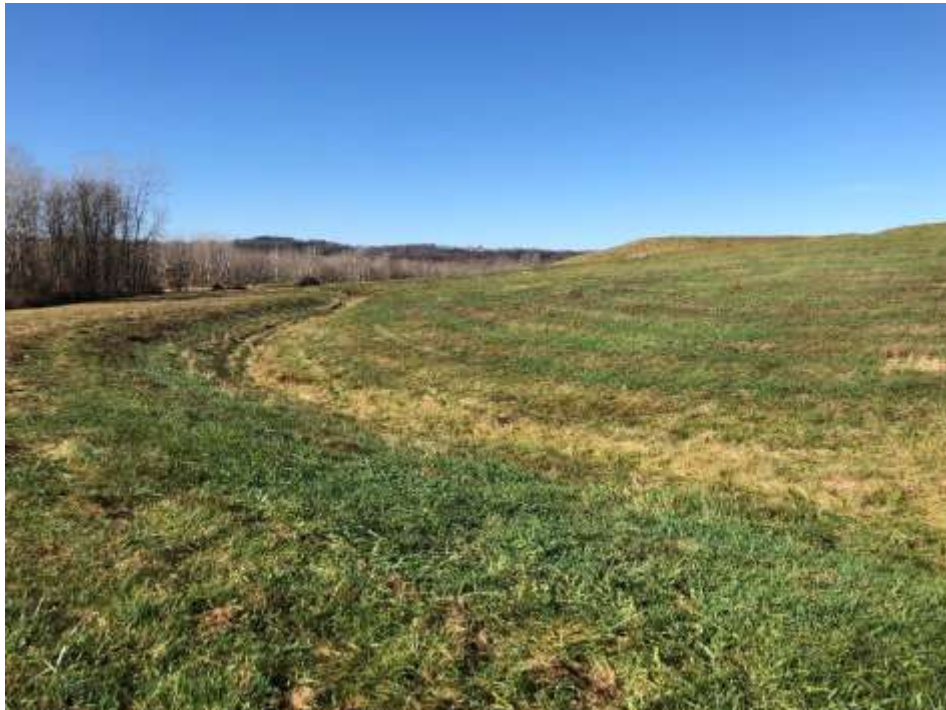
**Photograph 44:** South non-contact stormwater channel is clear of obstructions. South final cover lower slope is well vegetated and mowed annually. No evidence of animal burrows, erosion, or stability issues.
