**ANNUAL CCR UNIT INSPECTION REPORT
2023**

**NEW CASTLE STATION ASH LANDFILL
WEST PITTSBURG, LAWRENCE COUNTY, PENNSYLVANIA**

CEC Project 327-485.0003

**INSPECTION DATE: 11/21/2023
REPORT DATE: 1/15/2024**

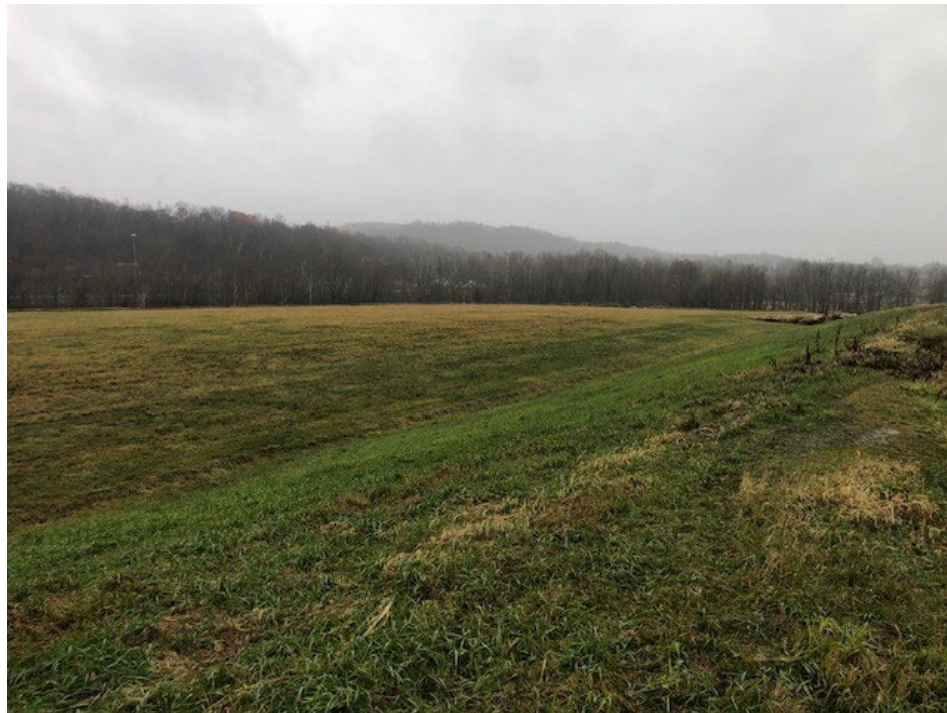
Photograph 1: Stage 6 final cover is well vegetated and mowed annually. No evidence of animal burrows, erosion, or stability issues.

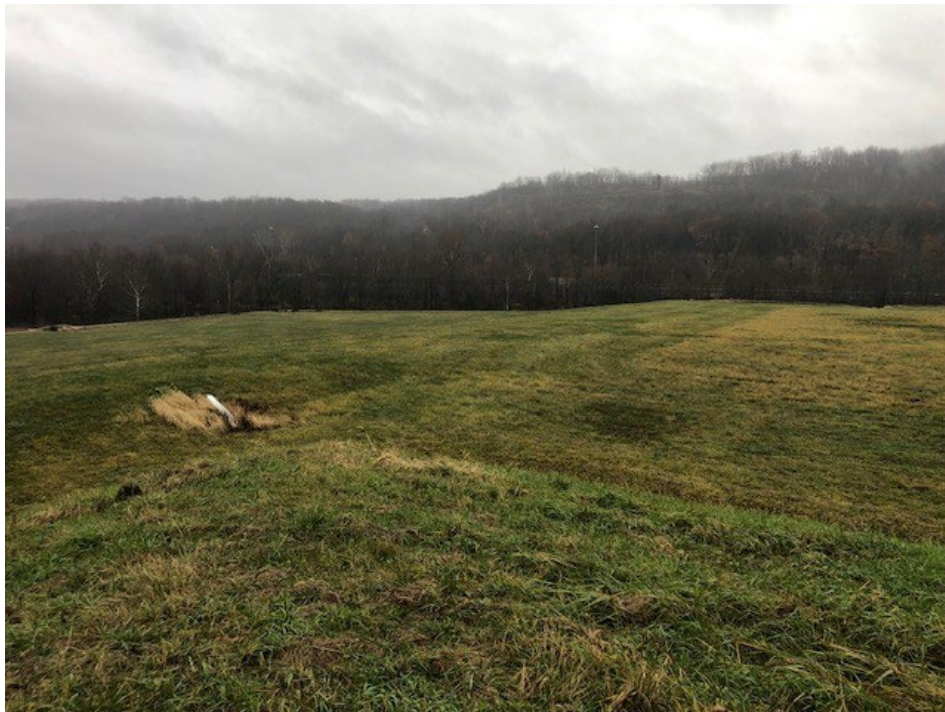
Photograph 2: Stage 5/Stage 6 final cover is well vegetated and mowed annually. No evidence of animal burrows, erosion, or stability issues.

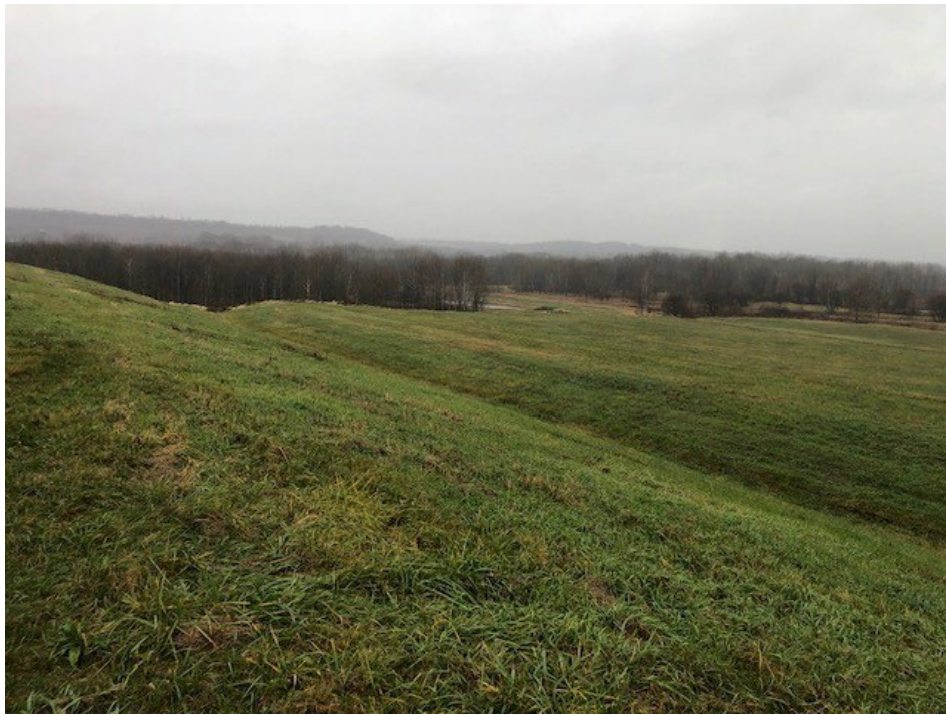
Photograph 3: Stage 5 final cover is well vegetated and mowed annually. No evidence of animal burrows, erosion, or stability issues.

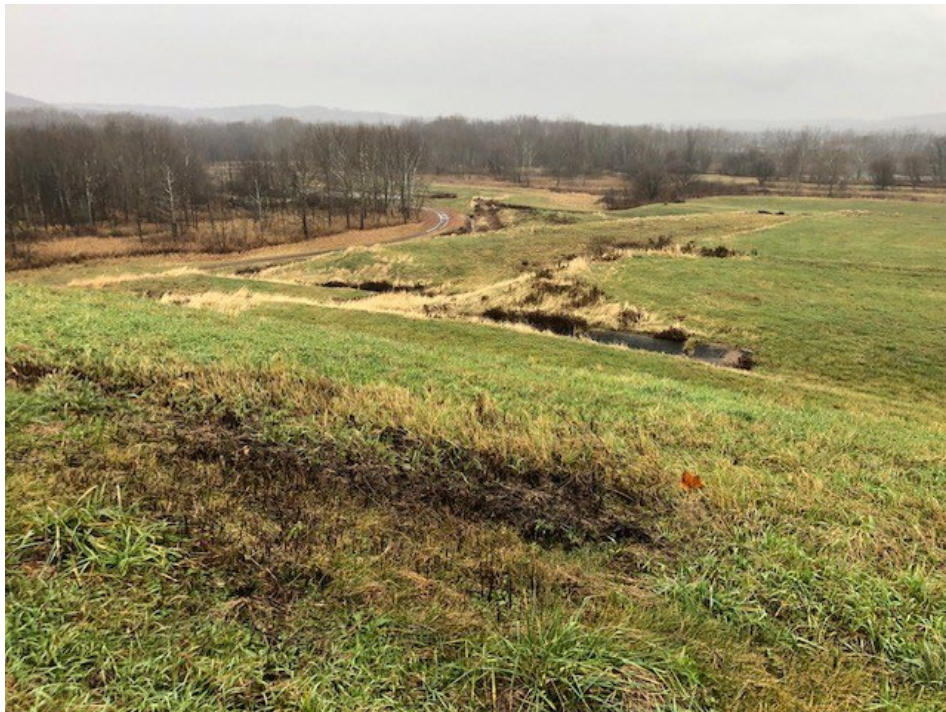
Photograph 4: Downchutes from west side of Stage 4 and Stage 5. No evidence of animal burrows, erosion, or stability issues.

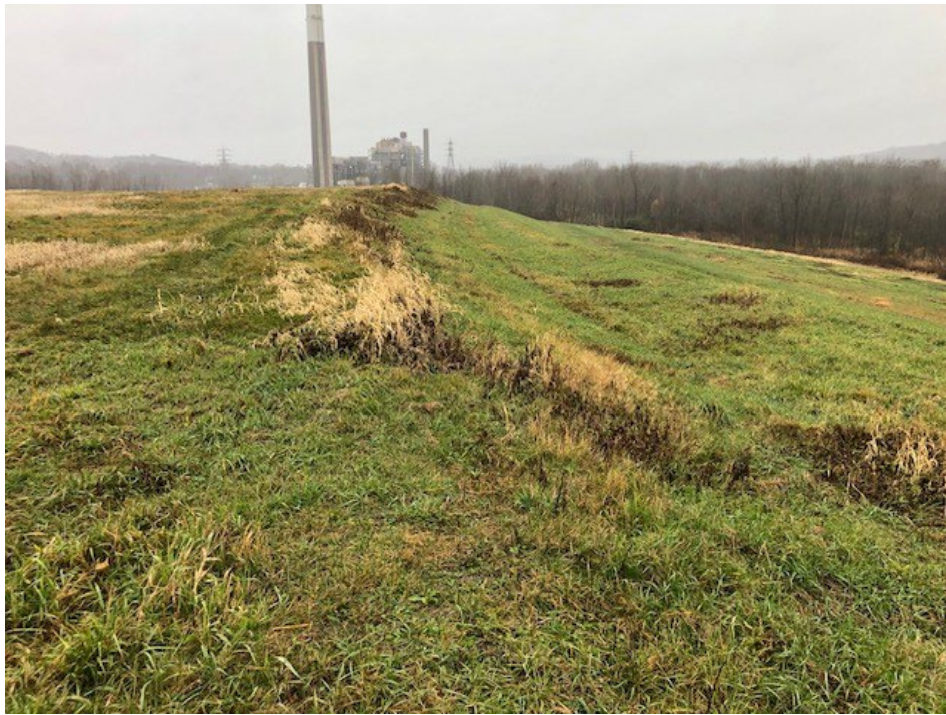
Photograph 5: Stage 4 west slope is well vegetated and mowed annually. No evidence of animal burrows, erosion, or stability issues.

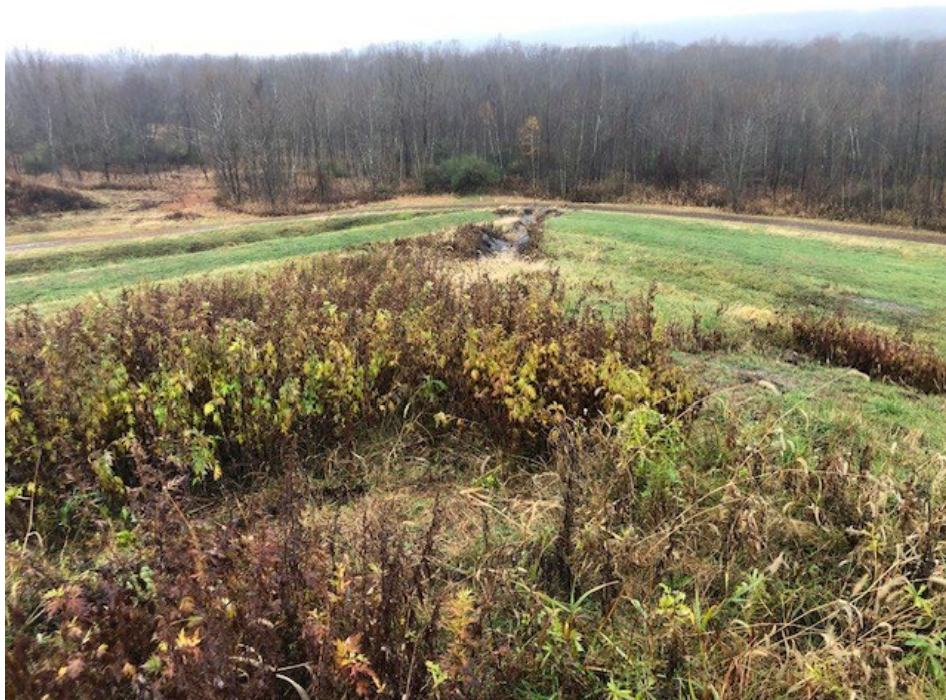
Photograph 6: Stage 4 southwest corner slope and downchute is well vegetated and mowed annually. No evidence of animal burrows, erosion, or stability issues.

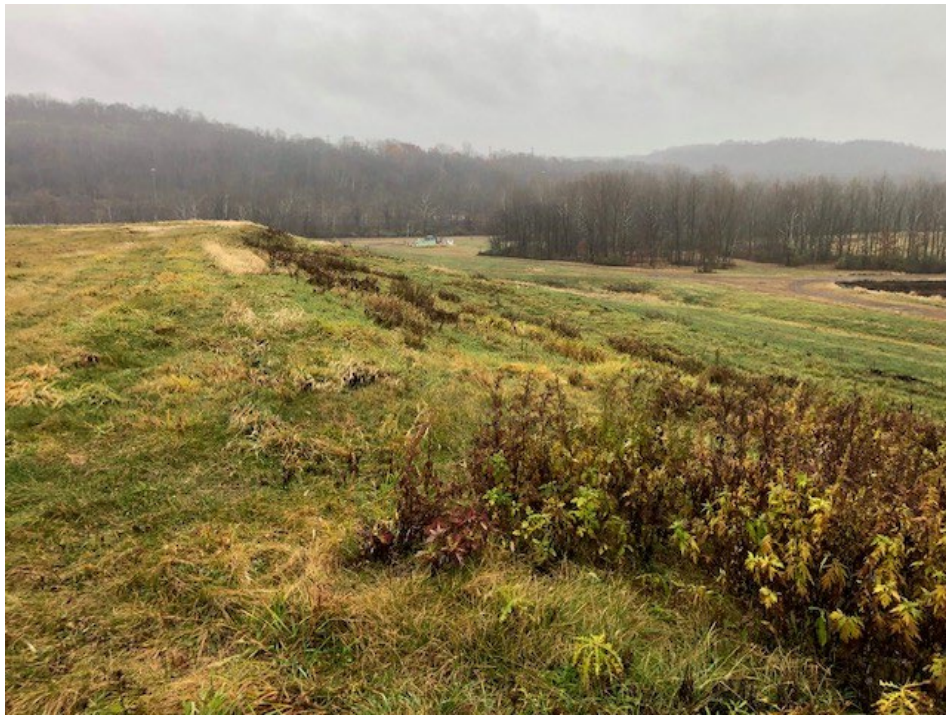
Photograph 7: Stage 4 south slope is well vegetated and mowed annually. No evidence of animal burrows, erosion, or stability issues.

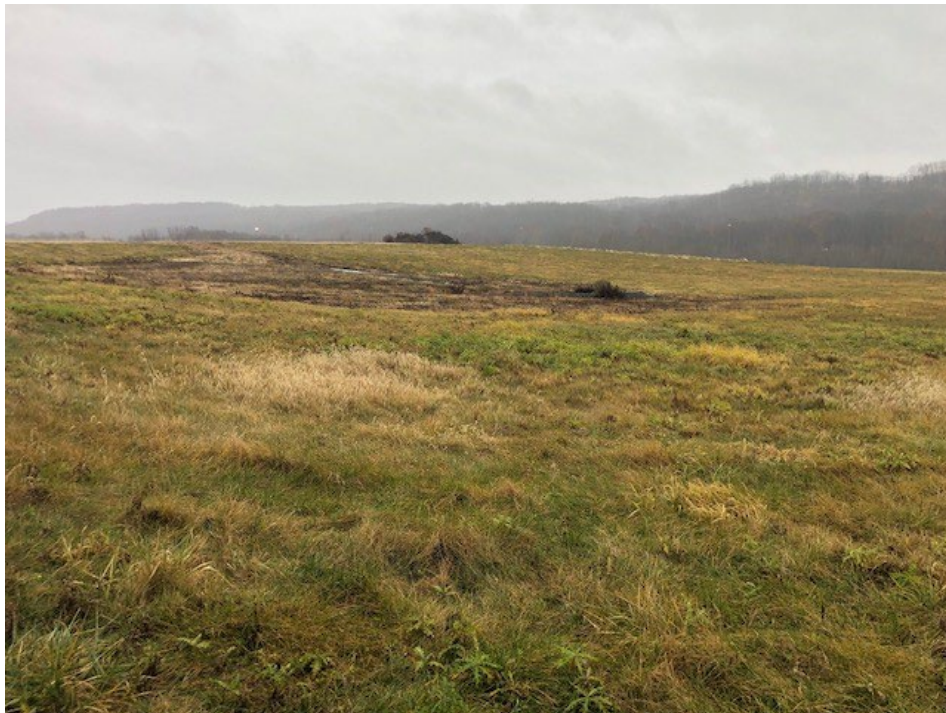
Photograph 8: Intermediate cover in Stage 4 active area looking northwest is well vegetated and mowed annually.

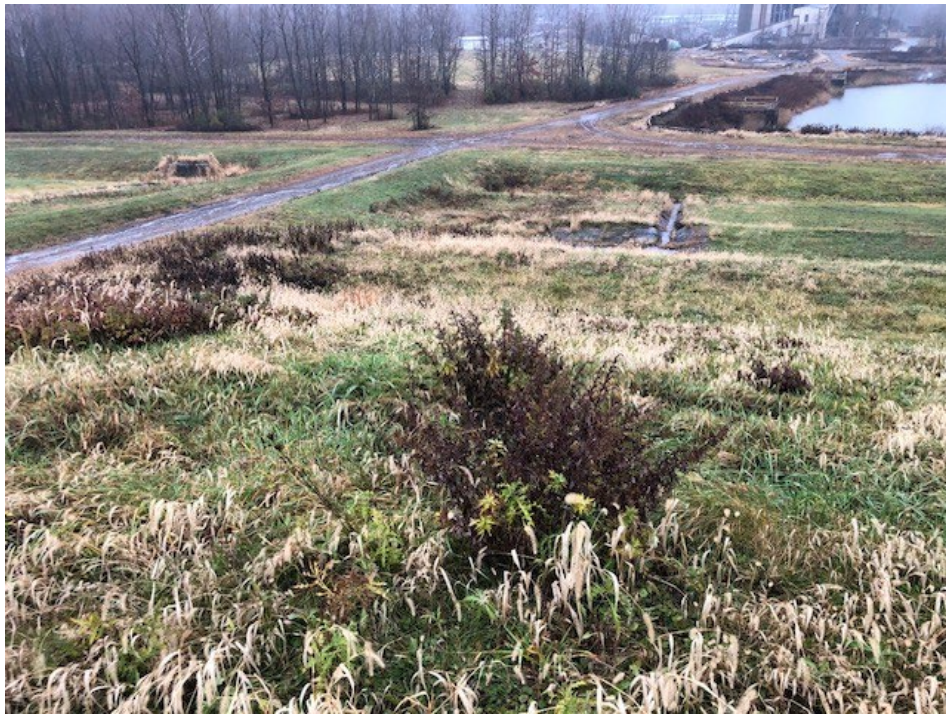
Photograph 9: Stage 4 south slope is well vegetated and mowed annually. No evidence of animal burrows, erosion, or stability issues.

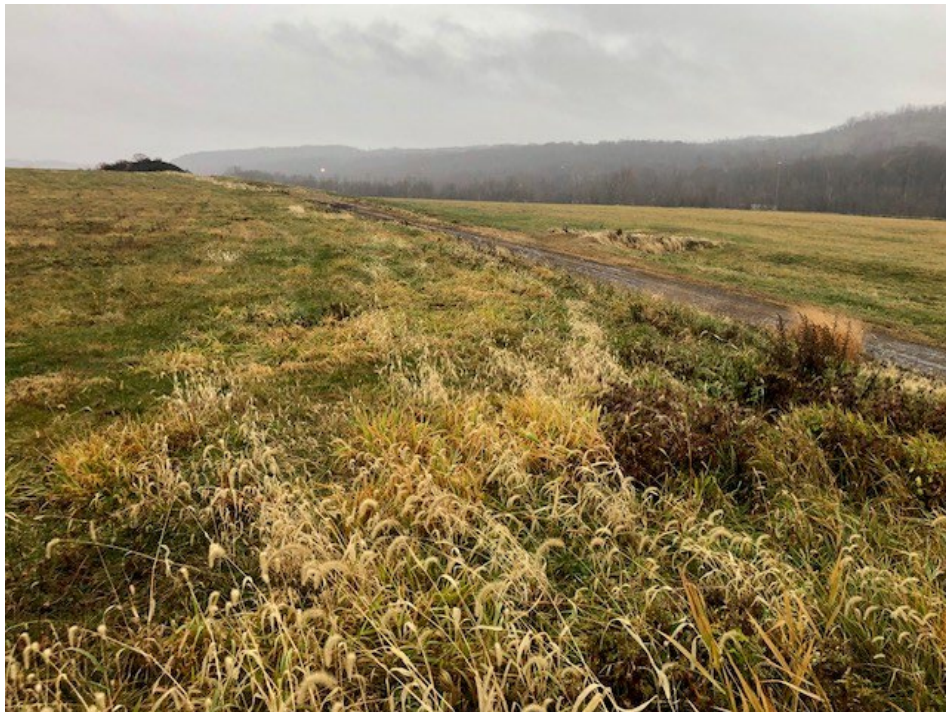
Photograph 10: Intermediate cover area in Stage 4 active area /Stage 6 final cover is well vegetated and mowed annually.

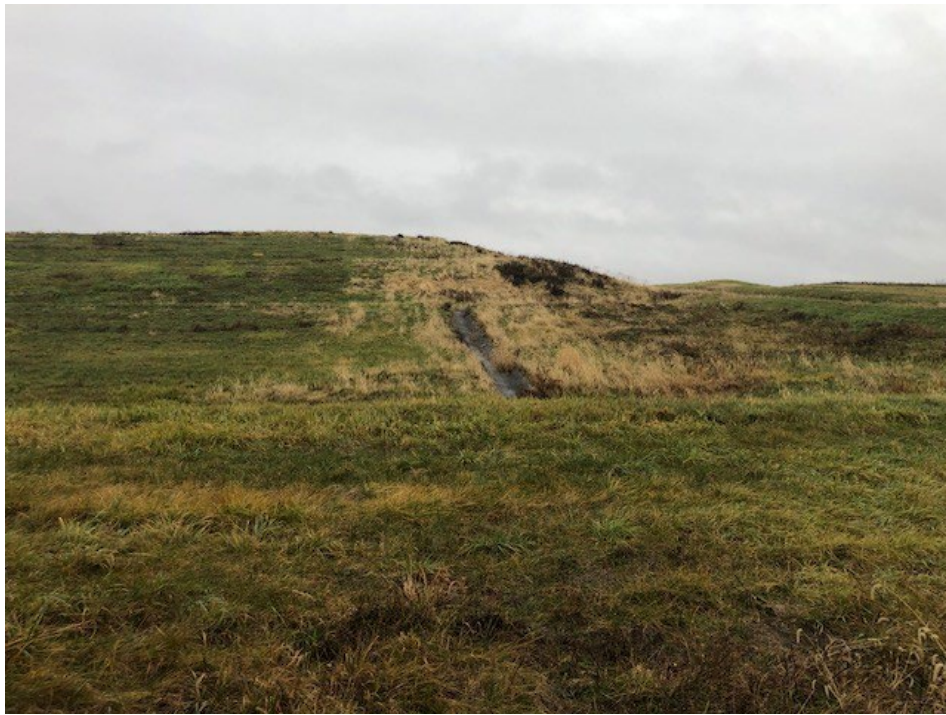
Photograph 11: Non-contact stormwater downchute on south slope is clear of obstructions. Gabion energy dissipator is installed at the junction with the stormwater (non-contact water) perimeter ditch.

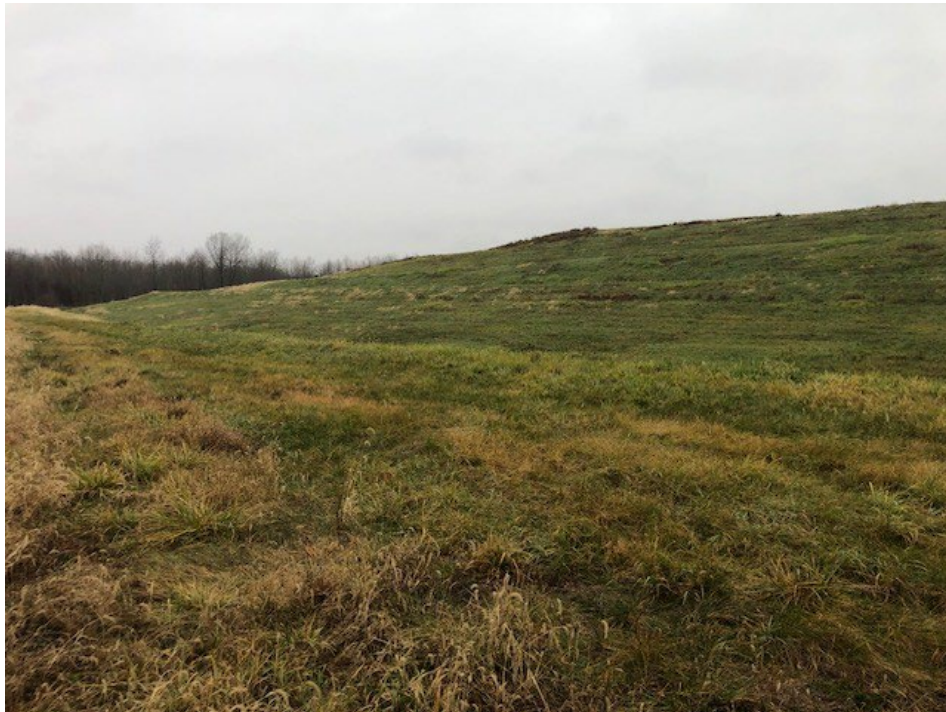
Photograph 12: Non-contact stormwater channel on south slope is clear of obstructions. The final cover south slope is well vegetated and mowed annually. No evidence of animal burrows, erosion, or stability issues.

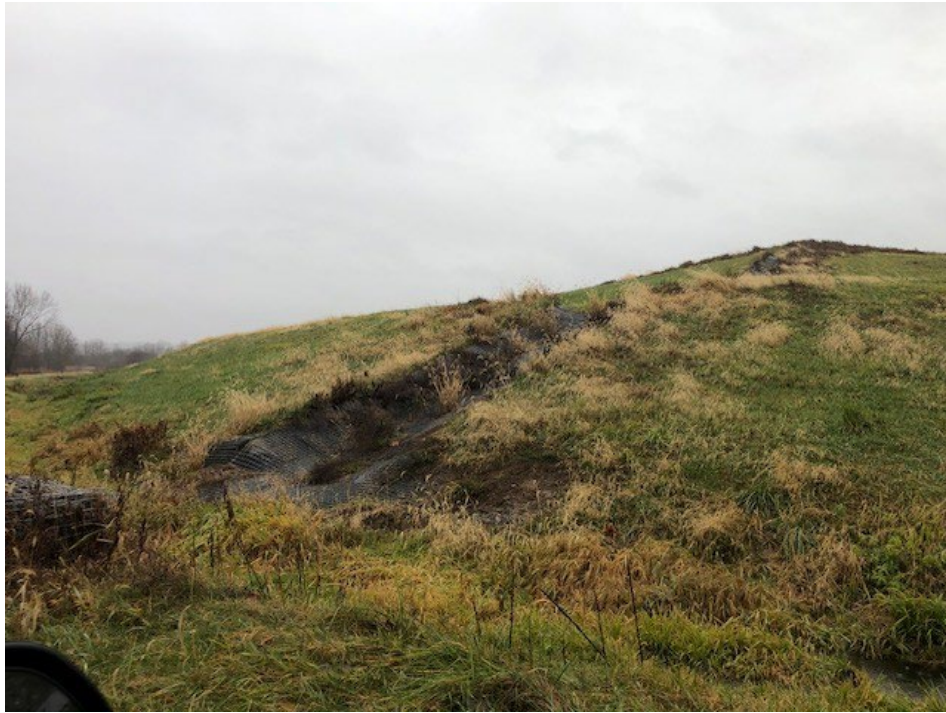
Photograph 13: Non-contact stormwater downchute in southwest corner is clear of obstructions. Gabion energy dissipator is installed at junction with the stormwater perimeter ditch.

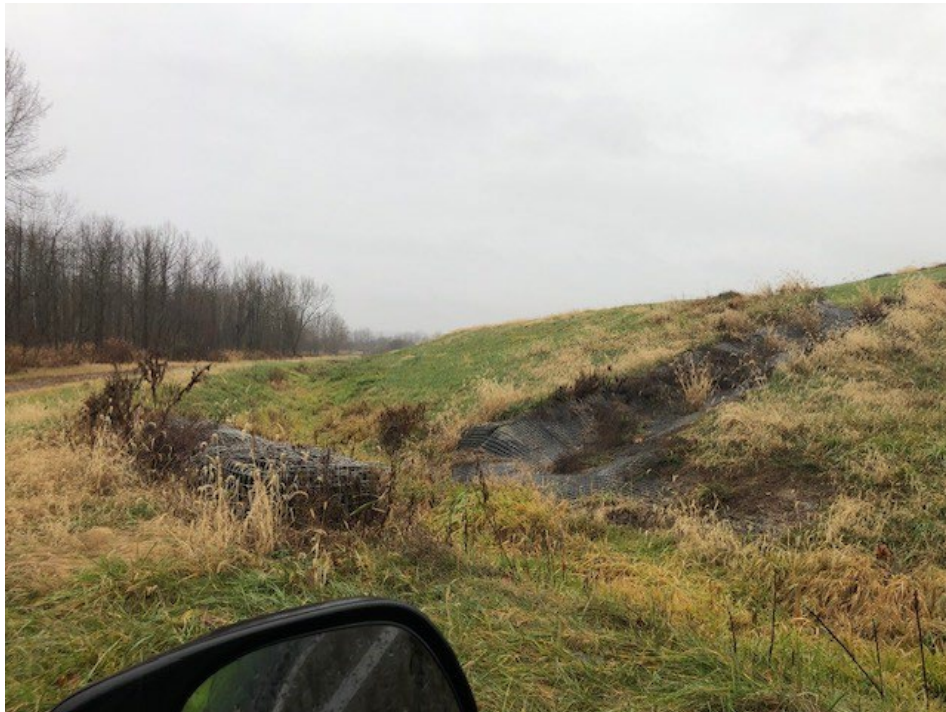
Photograph 14: West non-contact stormwater channel looking north is clear of obstructions. West final cover lower slope is well vegetated and mowed annually. No evidence of animal burrows, erosion, or stability issues.

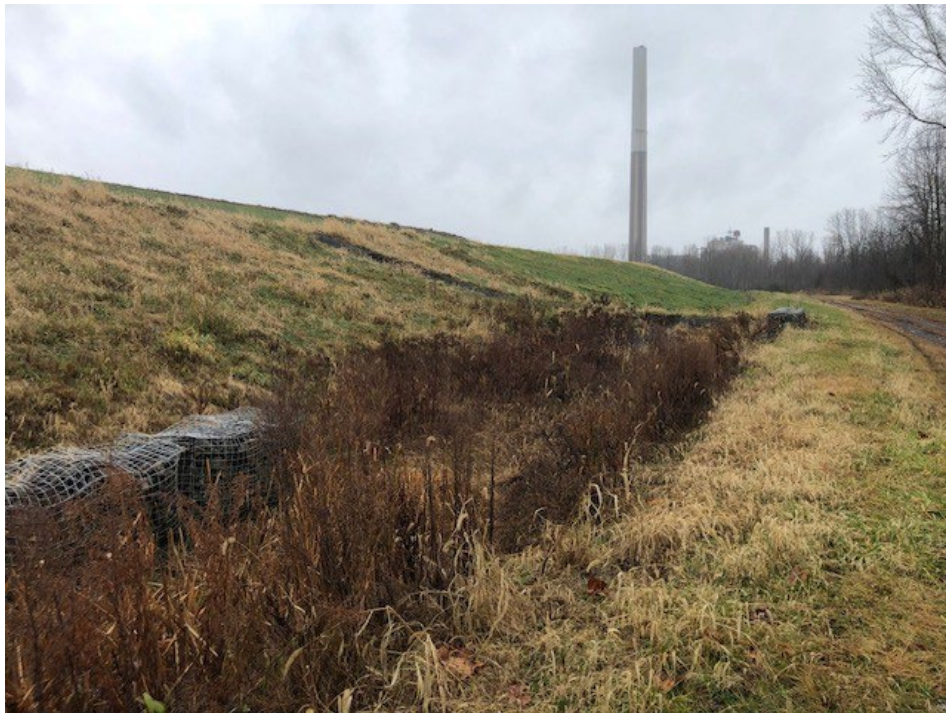
Photograph 15: West non-contact stormwater channel looking south is clear of obstructions. West final cover lower slope is well vegetated and mowed annually. No evidence of animal burrows, erosion, or stability issues.

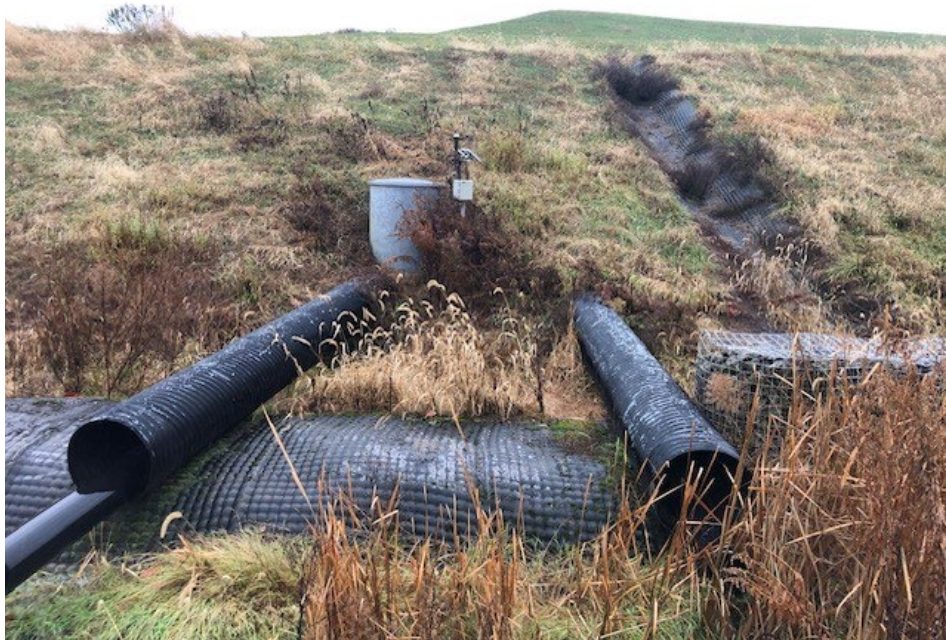
With no evidence to the contrary, the layover liner system at the active Stage 4 disposal area is believed to be in good operating condition and functioning as intended. At the time of the inspection, leachate and stormwater conveyance systems were operating as designed. A leachate leak detection pipe was reviewed during the inspection and was not flowing, indicating that the bottom liner system of Stage 4 is not leaking.

Photograph 16: Leachate collection zone and leak detection zone discharge pipes.

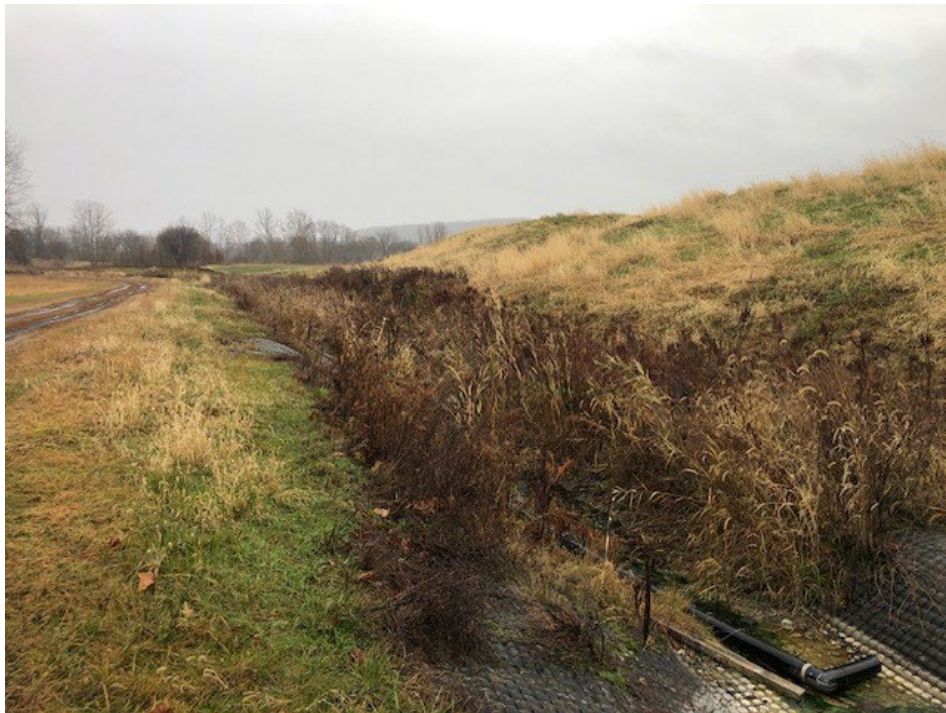
Photograph 17: West non-contact stormwater channel looking north is clear of obstructions. West final cover lower slope is well vegetated and mowed annually. No evidence of animal burrows, erosion, or stability issues.

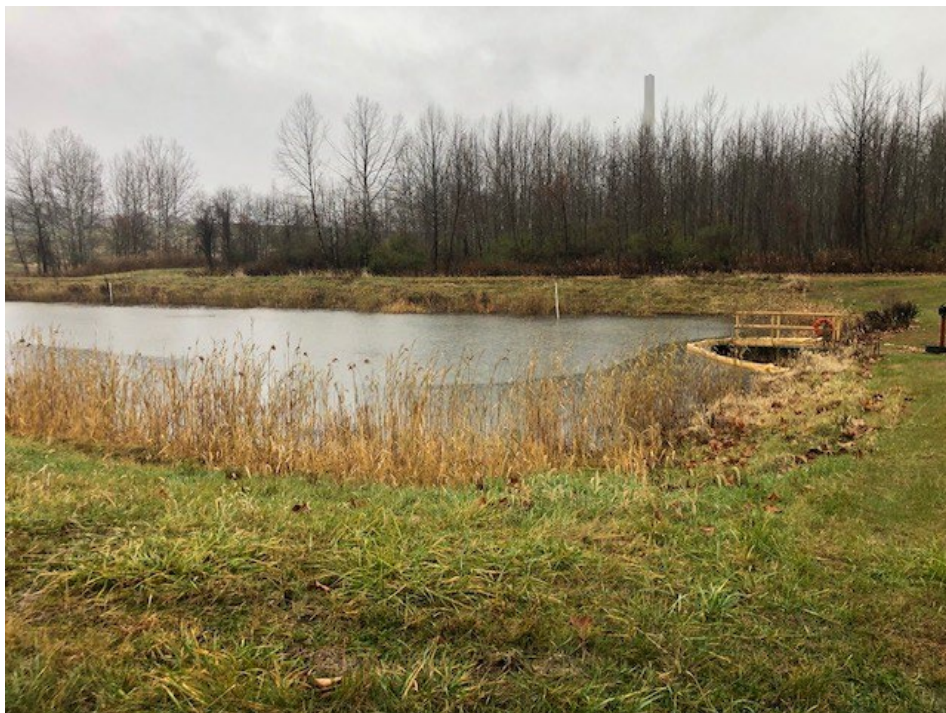
Photograph 18: Leachate (contact water) Pond. No evidence of animal burrows or liner damage.

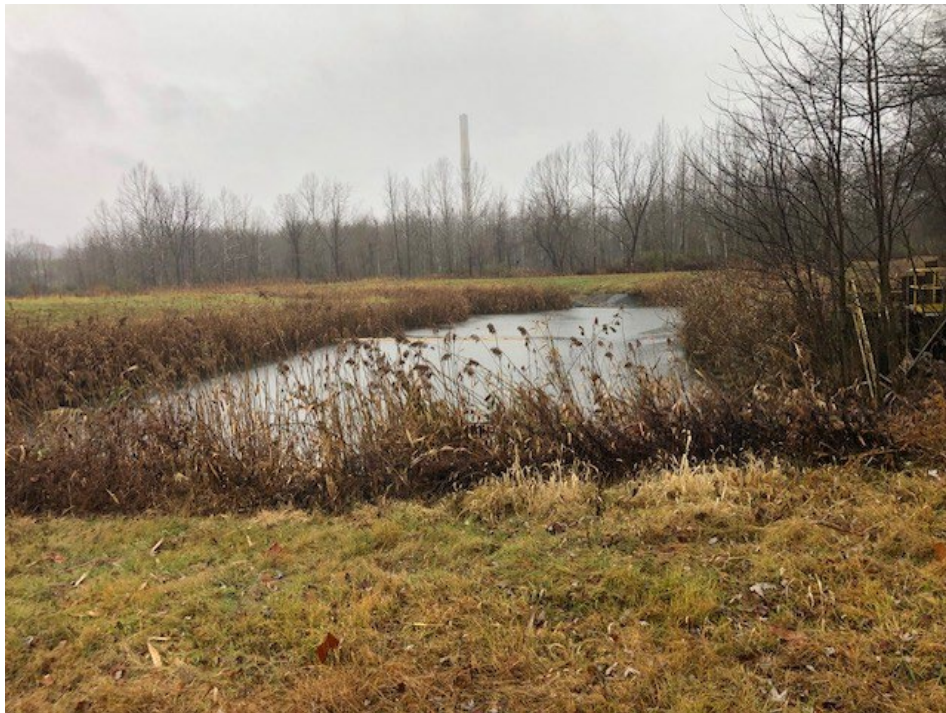
Photograph 19: Non-contact stormwater Sedimentation Pond.

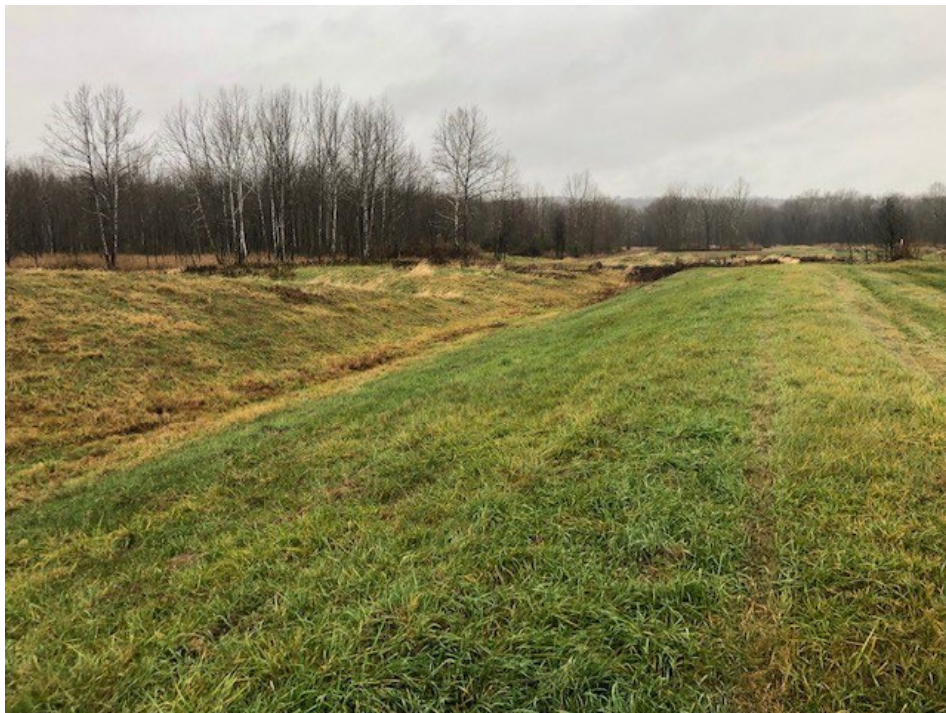
Photograph 20: North non-contact stormwater channel is clear of obstructions. North final cover lower slope is well vegetated and mowed annually. No evidence of animal burrows, erosion, or stability issues.

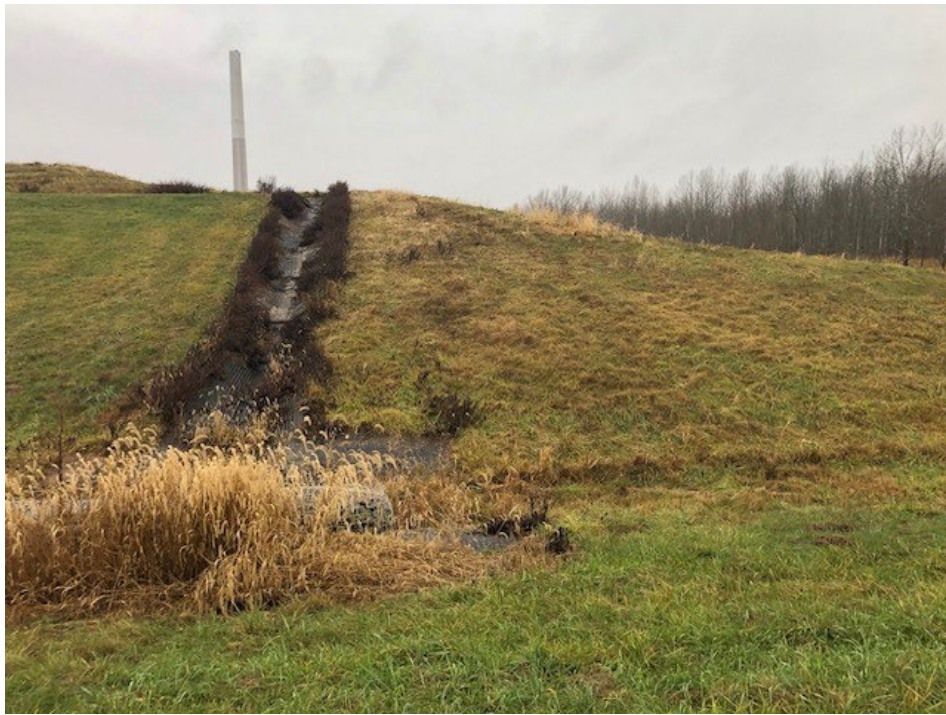
Photograph 21: Non-contact stormwater downchute in northwest corner is clear of obstructions. Gabion energy dissipator is installed at the junction with the stormwater (non-contact water) perimeter ditch.

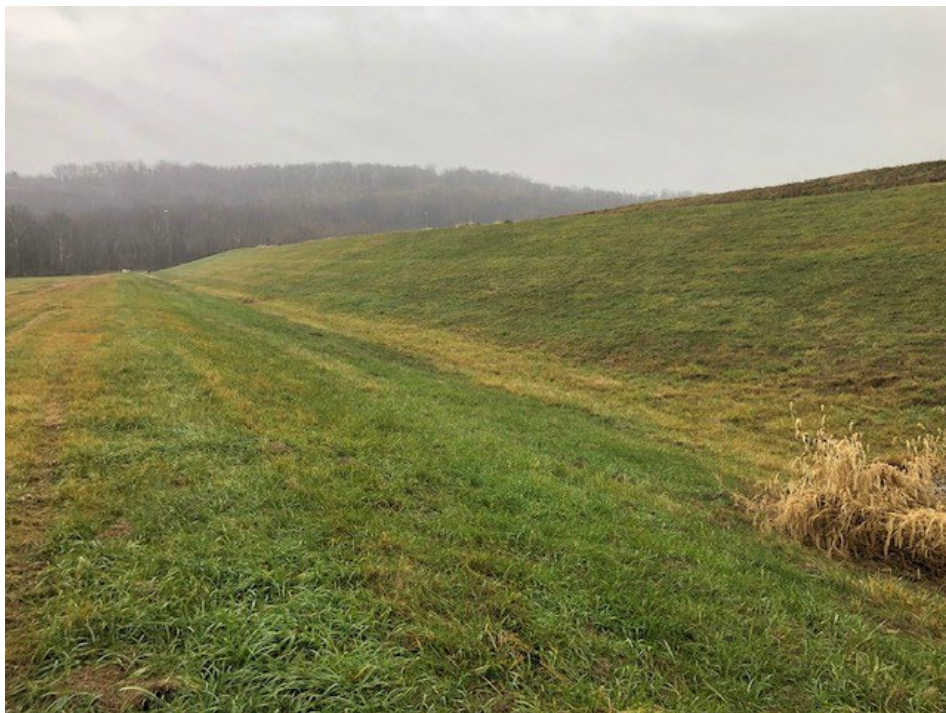
Photograph 22: North non-contact stormwater channel is clear of obstructions. North final cover lower slope is well vegetated and mowed annually. No evidence of animal burrows, erosion, or stability issues.

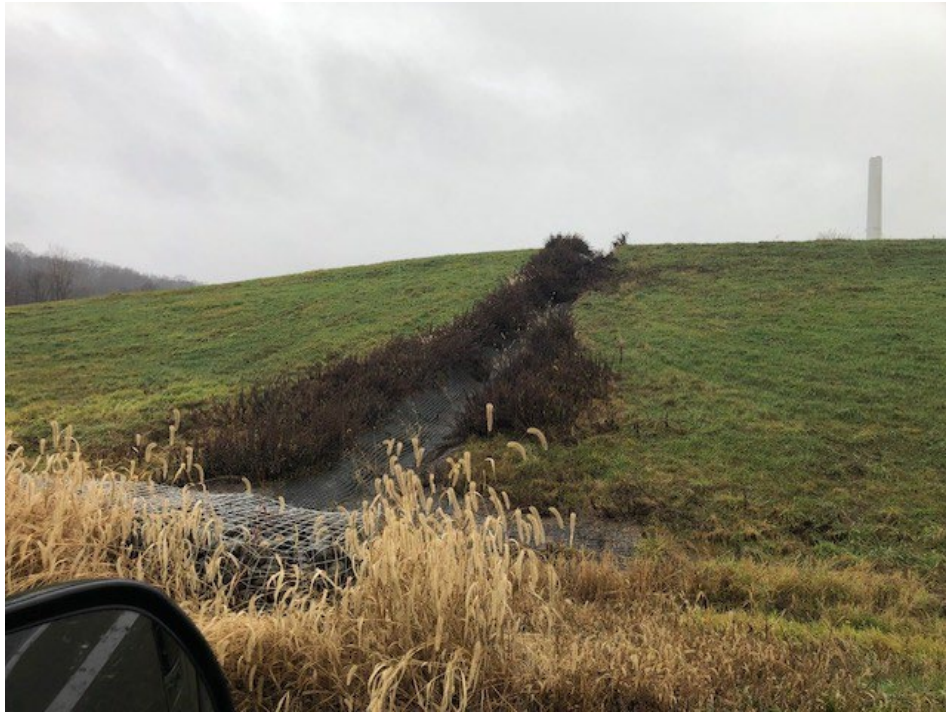
Photograph 23: Non-contact stormwater downchute in northeast corner is clear of obstructions. Gabion energy dissipator is installed at the junction with the stormwater (non-contact water) perimeter ditch.

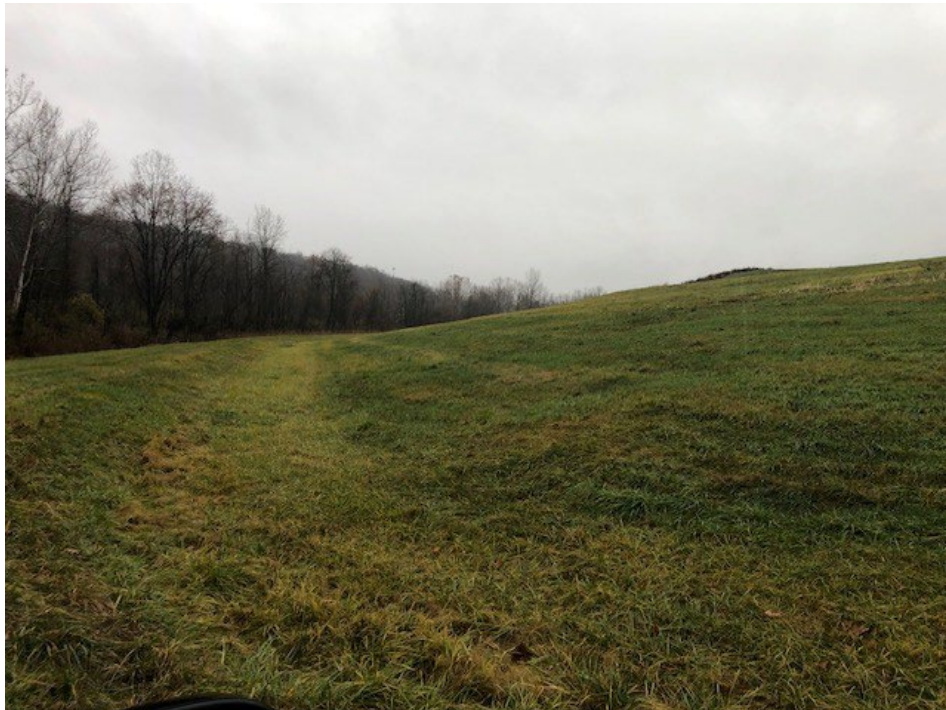
Photograph 24: East non-contact stormwater channel looking south is clear of obstructions. East final cover lower slope is well vegetated and mowed annually. No evidence of animal burrows, erosion, or stability issues.

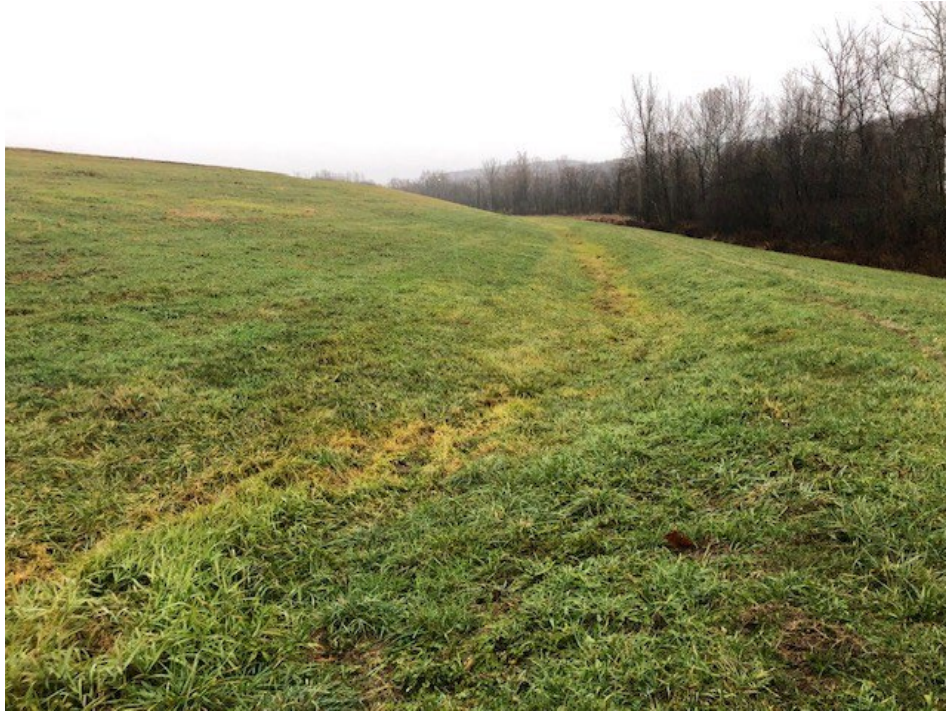
Photograph 25: East non-contact stormwater channel looking north is clear of obstructions. East final cover lower slope is well vegetated and mowed annually. No evidence of animal burrows, erosion, or stability issues.

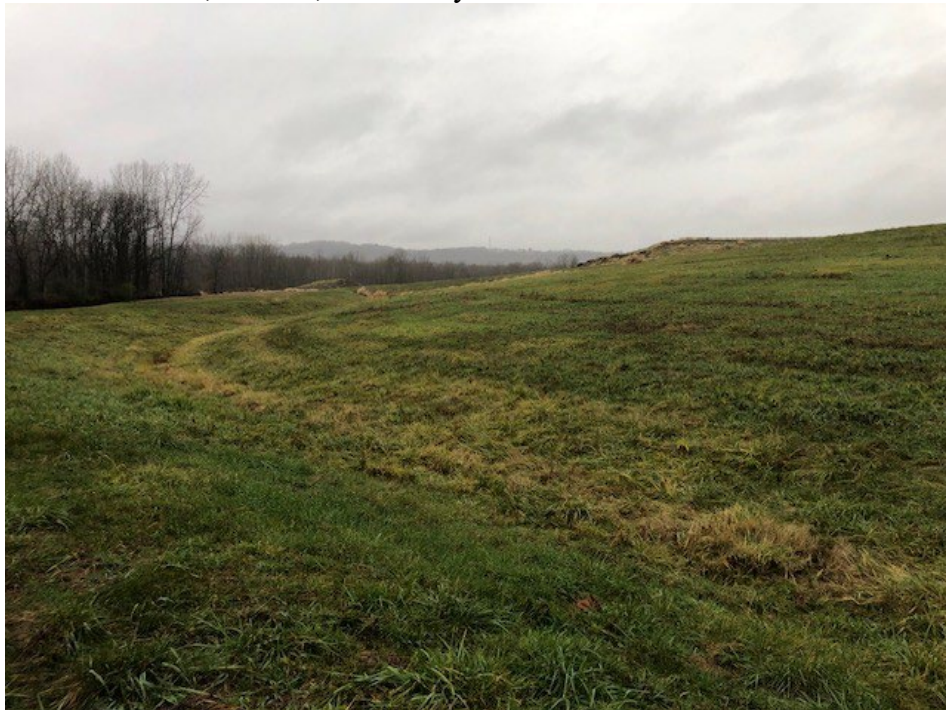
Photograph 26: South non-contact stormwater channel looking west is clear of obstructions. South final cover lower slope is well vegetated and mowed annually. No evidence of animal burrows, erosion, or stability issues.

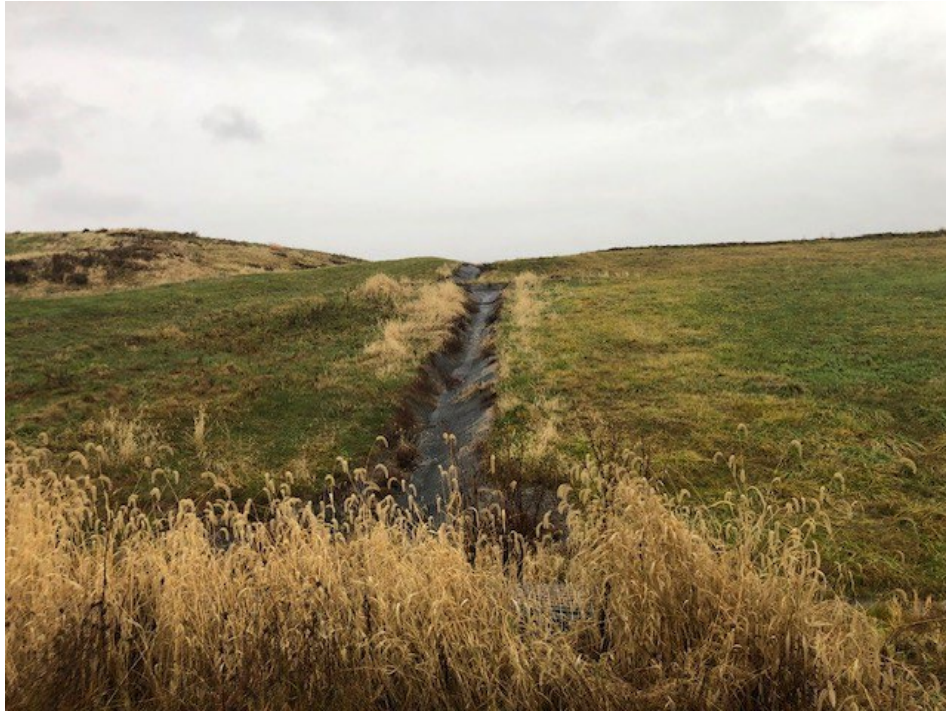
Photograph 27: Non-contact stormwater downchute on south slope is clear of obstructions. Gabion energy dissipator is installed at the junction with the stormwater (non-contact water) perimeter ditch.
