**ANNUAL CCR UNIT INSPECTION REPORT  
2024**

**NEW CASTLE STATION ASH LANDFILL  
WEST PITTSBURGH, LAWRENCE COUNTY, PENNSYLVANIA**

**CEC Project 327-485.0004**

**INSPECTION DATE: 12/17/2024  
REPORT DATE: 1/15/2025**

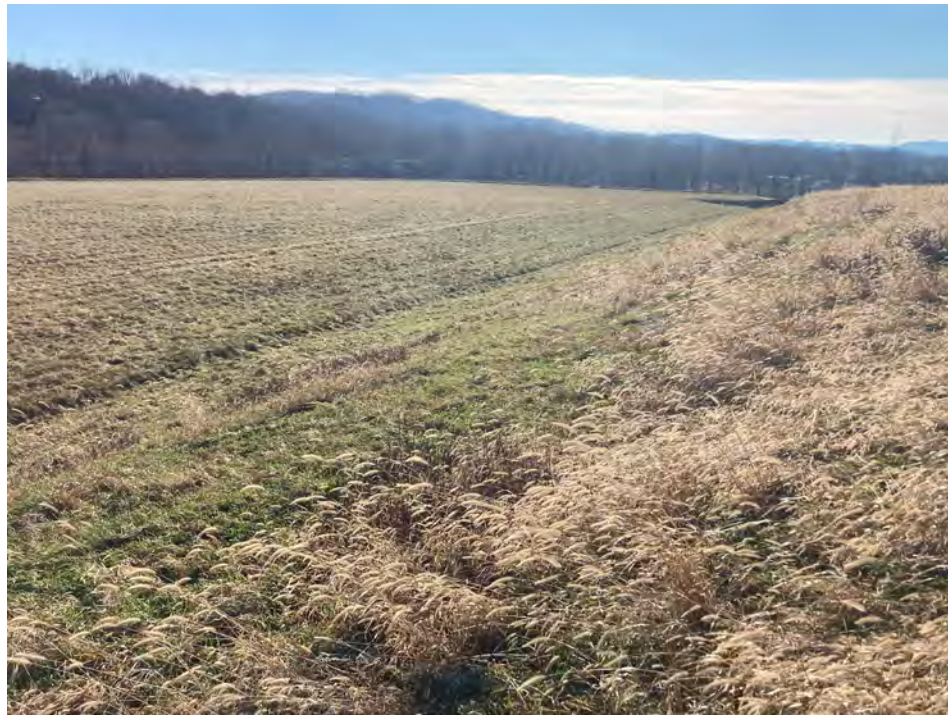
**Photograph 1:** Stage 6 final cover is well vegetated and mowed annually. No evidence of animal burrows, erosion, or stability issues.

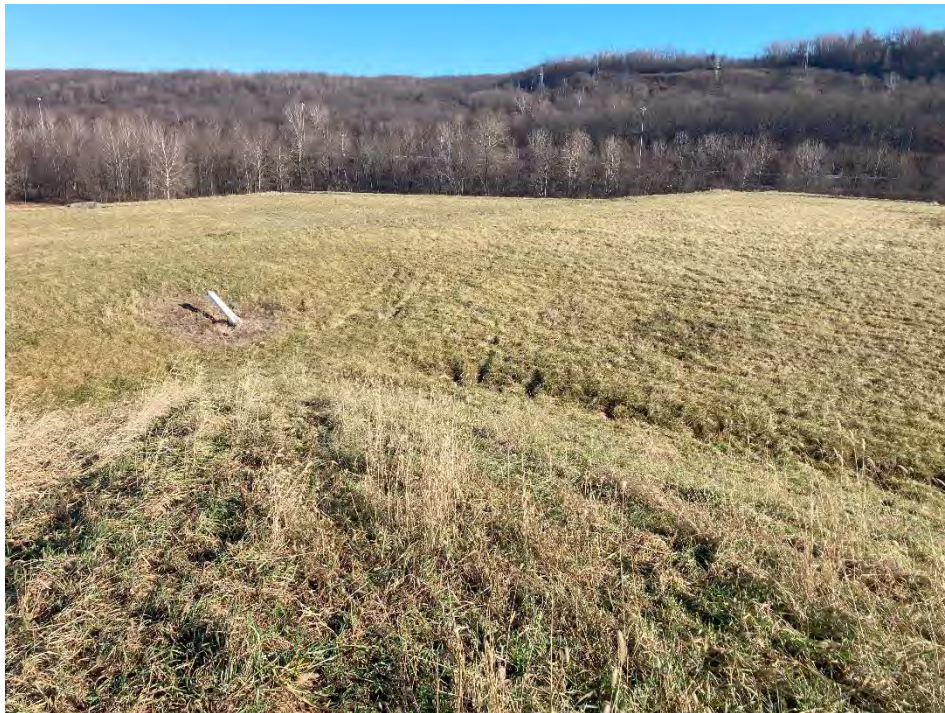
**Photograph 2:** Stage 5/Stage 6 final cover is well vegetated and mowed annually. No evidence of animal burrows, erosion, or stability issues.

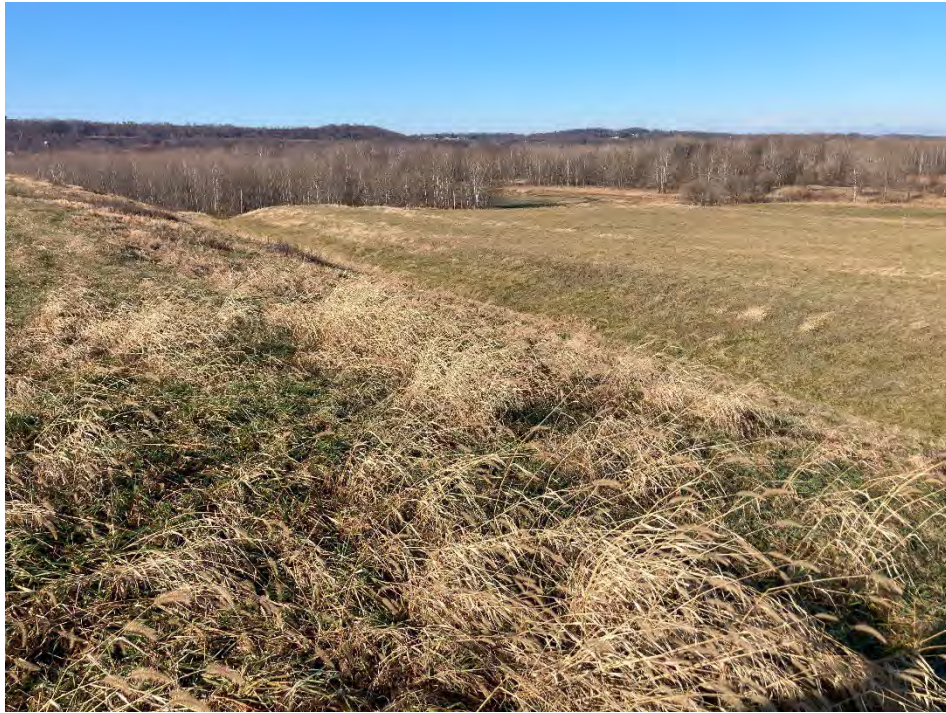
**Photograph 3:** Stage 5 final cover is well vegetated and mowed annually. No evidence of animal burrows, erosion, or stability issues.

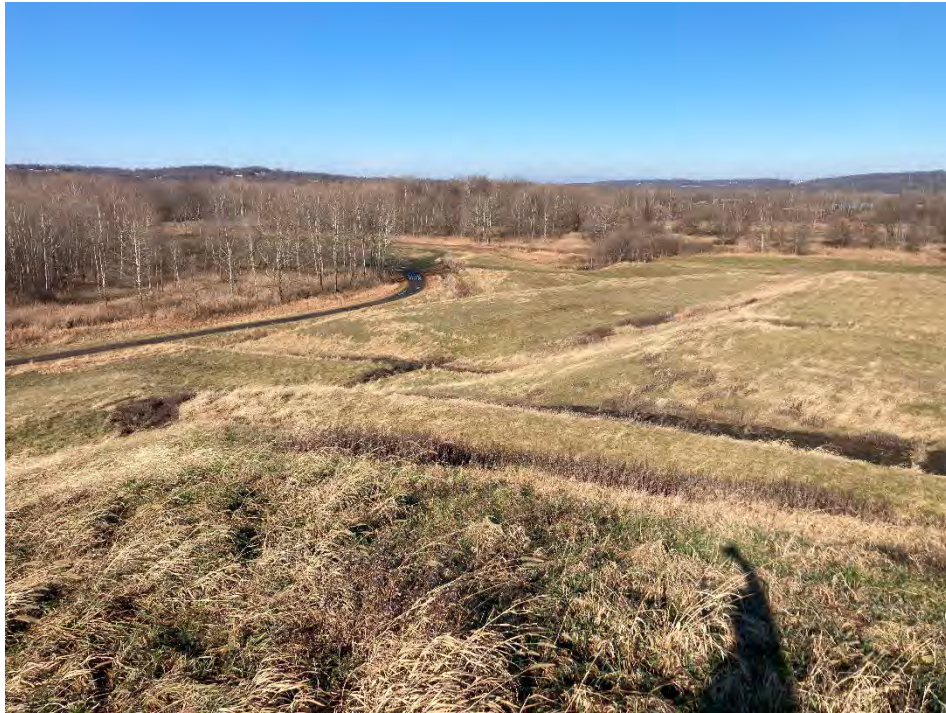
**Photograph 4:** Downchutes from west side of Stage 4 and Stage 5. No evidence of animal burrows, erosion, or stability issues.

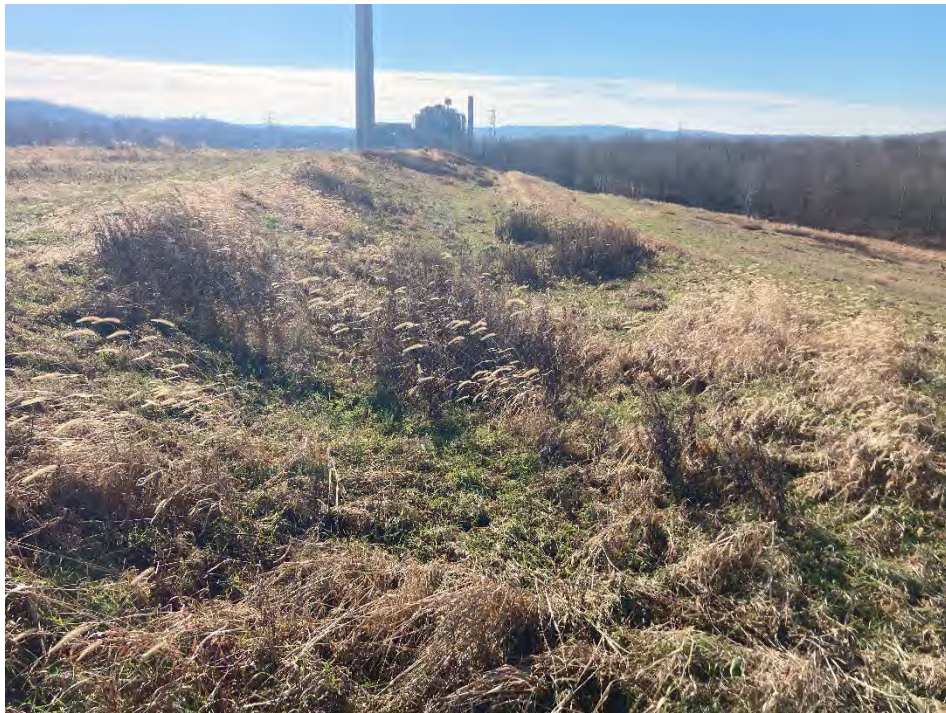
**Photograph 5:** Stage 4 west slope is well vegetated and mowed annually. No evidence of animal burrows, erosion, or stability issues.

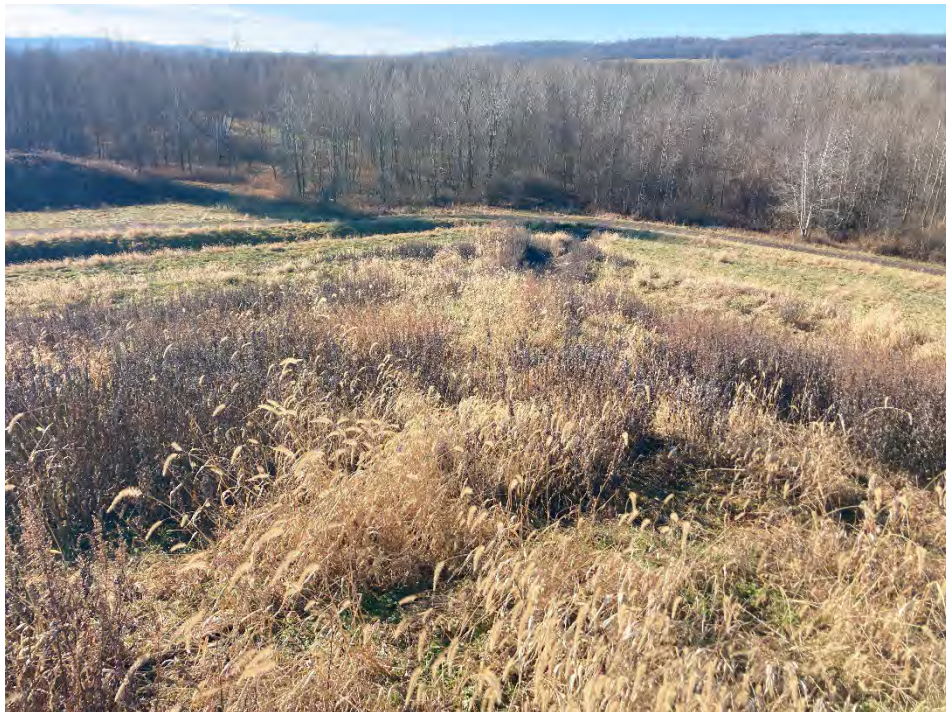
**Photograph 6:** Stage 4 southwest corner slope and downchute is well vegetated and mowed annually. No evidence of animal burrows, erosion, or stability issues.

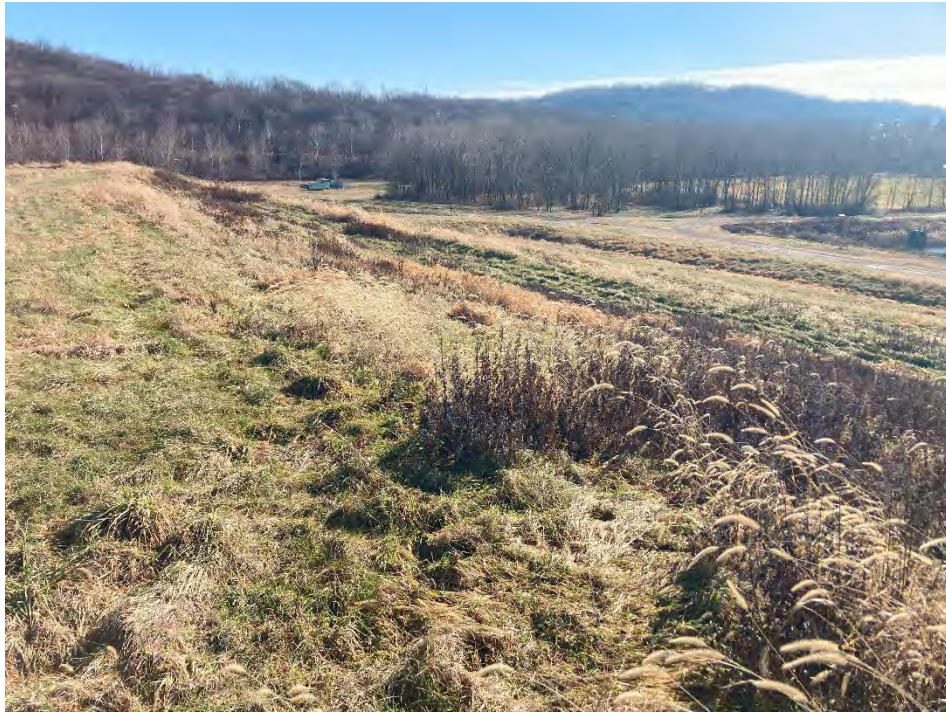
**Photograph 7:** Stage 4 south slope is well vegetated and mowed annually. No evidence of animal burrows, erosion, or stability issues.

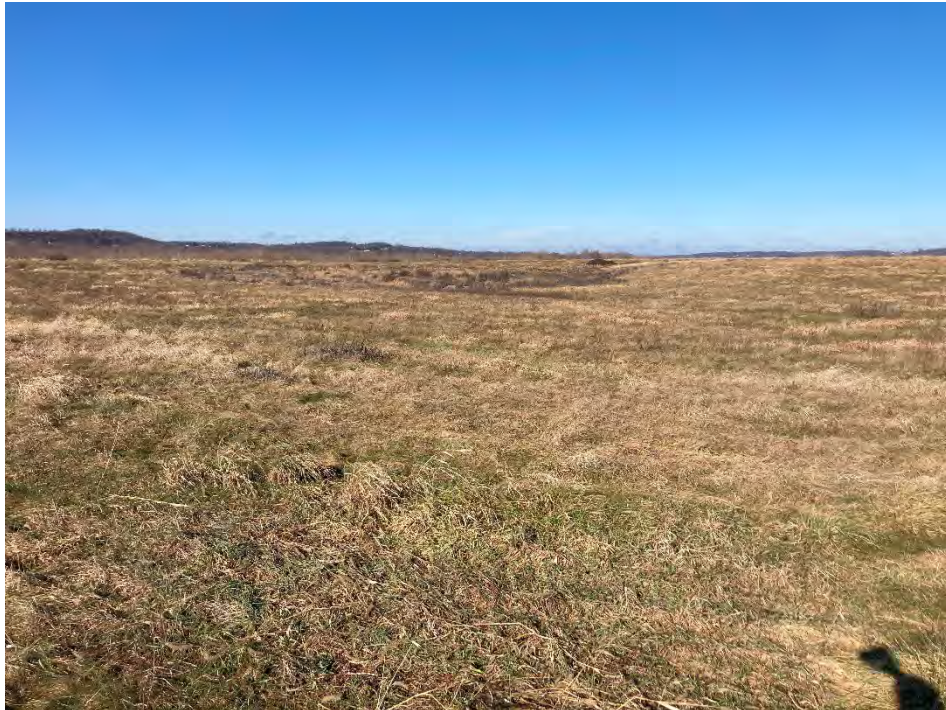
**Photograph 8:** Intermediate cover in Stage 4 active area looking northwest is well vegetated and mowed annually.

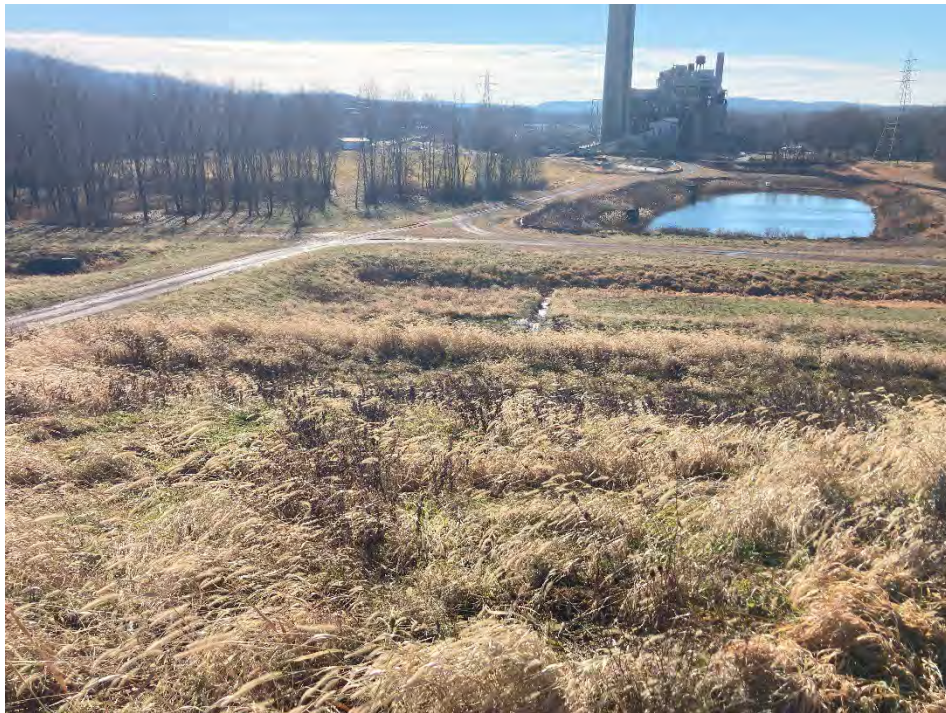
**Photograph 9:** Stage 4 south slope is well vegetated and mowed annually. No evidence of animal burrows, erosion, or stability issues.

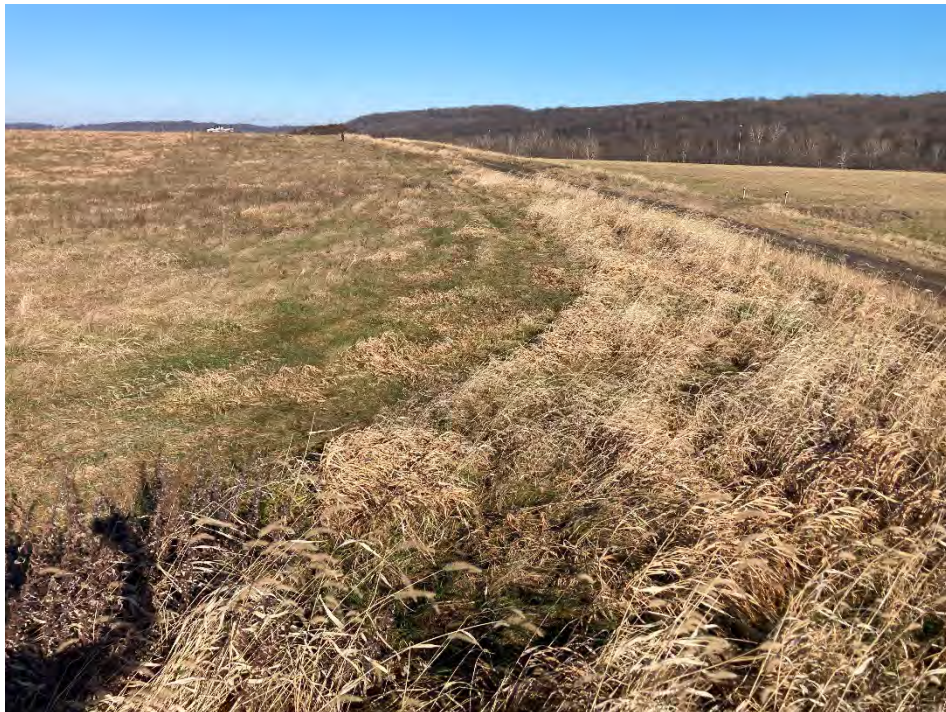
**Photograph 10:** Intermediate cover area in Stage 4 active area /Stage 6 final cover is well vegetated and mowed annually.

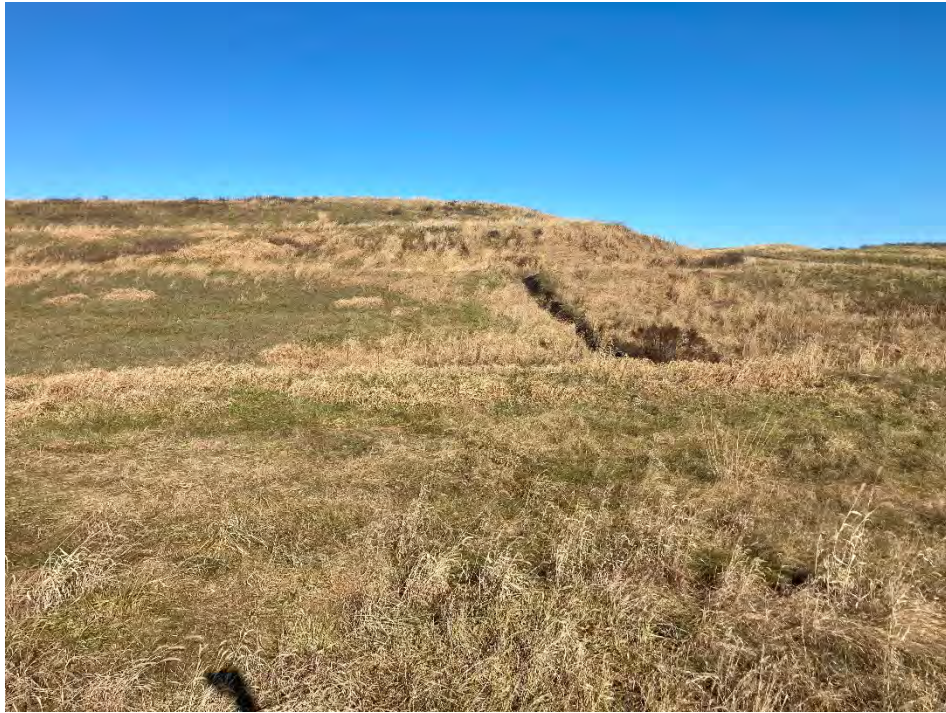
**Photograph 11:** Non-contact stormwater downchute on south slope is clear of obstructions. Gabion energy dissipator is installed at the junction with the stormwater (non-contact water) perimeter ditch.

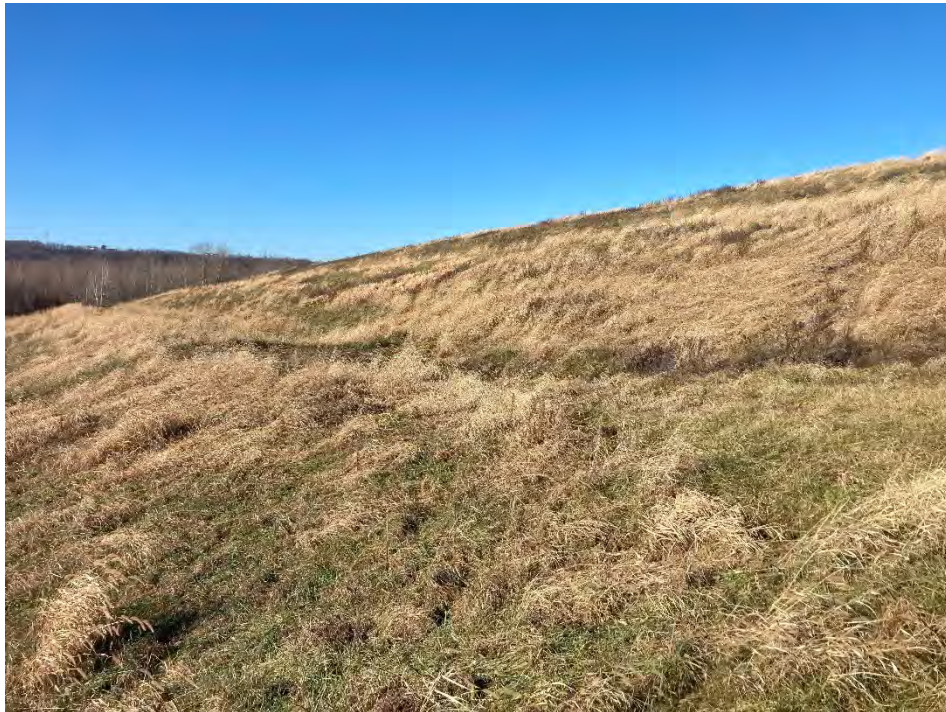
**Photograph 12:** Non-contact stormwater channel on south slope is clear of obstructions. The final cover south slope is well vegetated and mowed annually. No evidence of animal burrows, erosion, or stability issues.

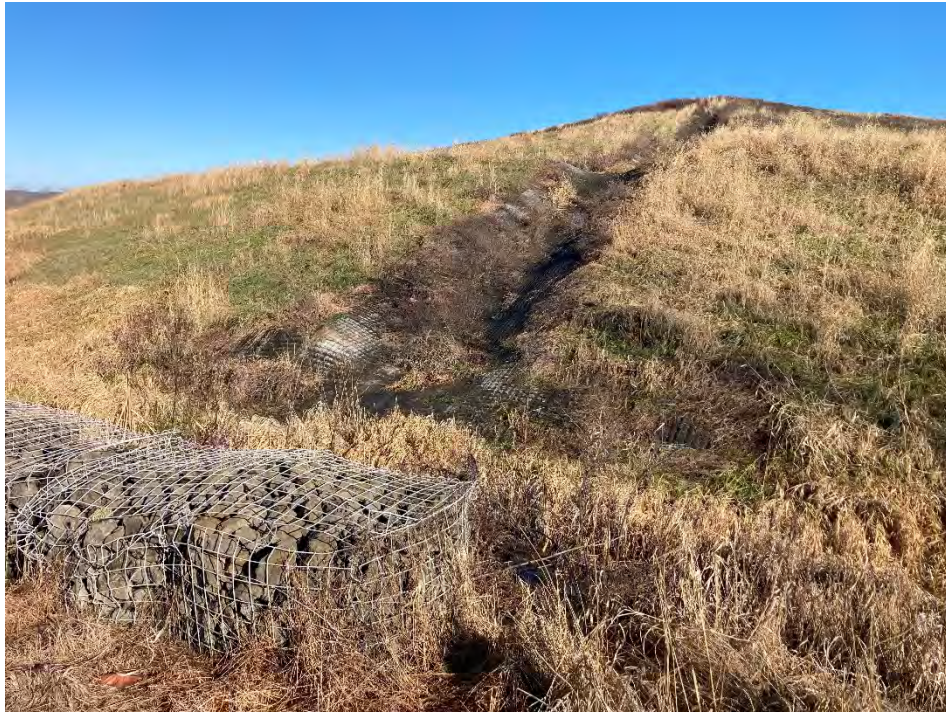
**Photograph 13:** Non-contact stormwater downchute in southwest corner is clear of obstructions. Gabion energy dissipator is installed at junction with the stormwater perimeter ditch.

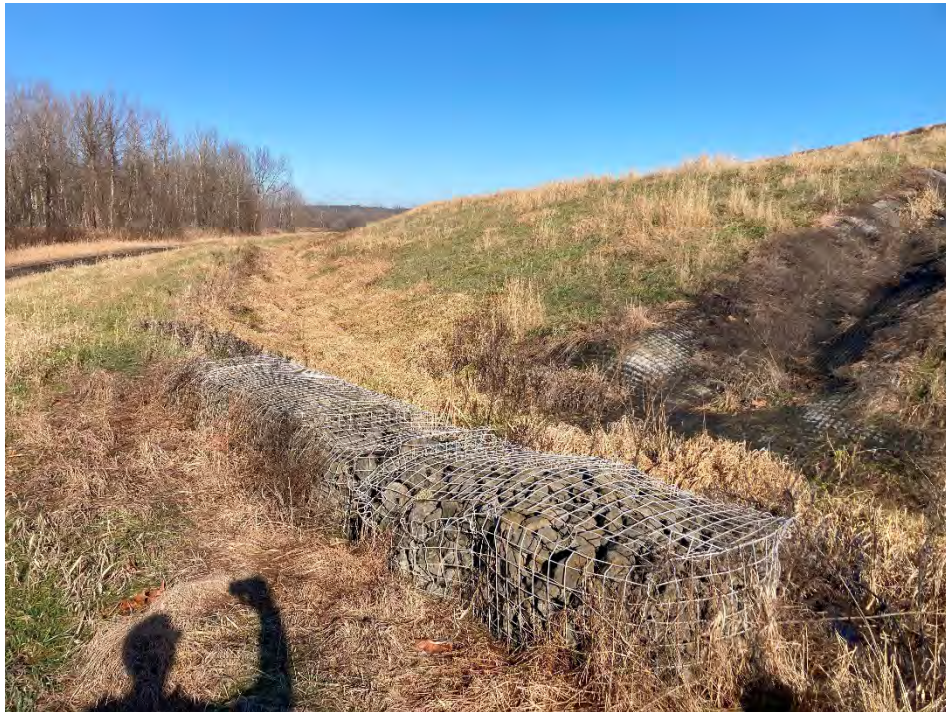
**Photograph 14:** West non-contact stormwater channel looking north is clear of obstructions. West final cover lower slope is well vegetated and mowed annually. No evidence of animal burrows, erosion, or stability issues.

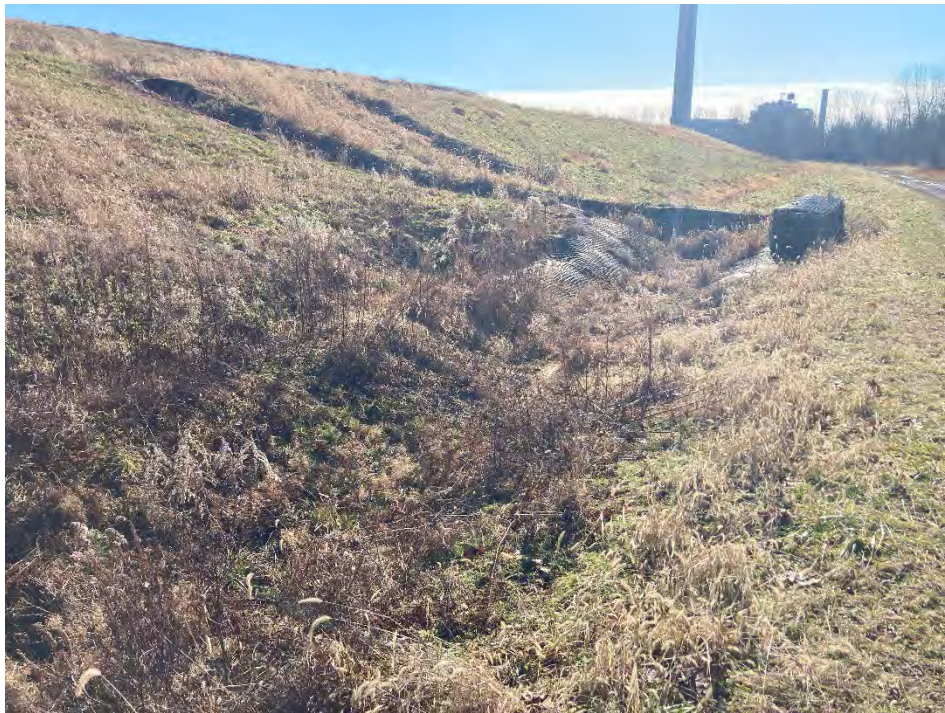
**Photograph 15:** West non-contact stormwater channel looking south is clear of obstructions. West final cover lower slope is well vegetated and mowed annually. No evidence of animal burrows, erosion, or stability issues.

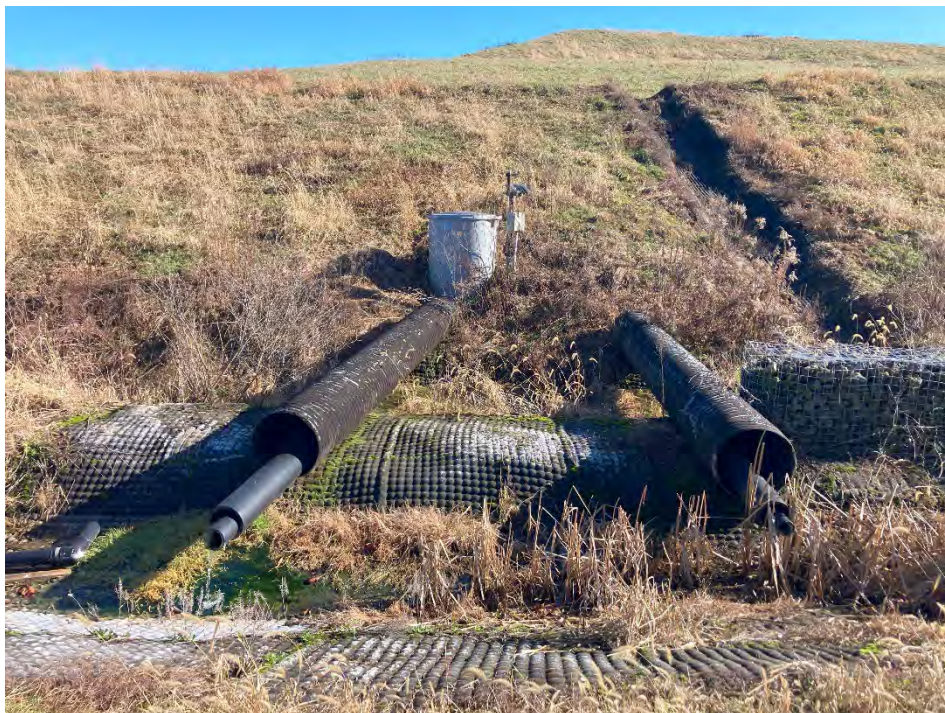
**Photograph 16:** Leachate collection zone and leak detection zone discharge pipes.

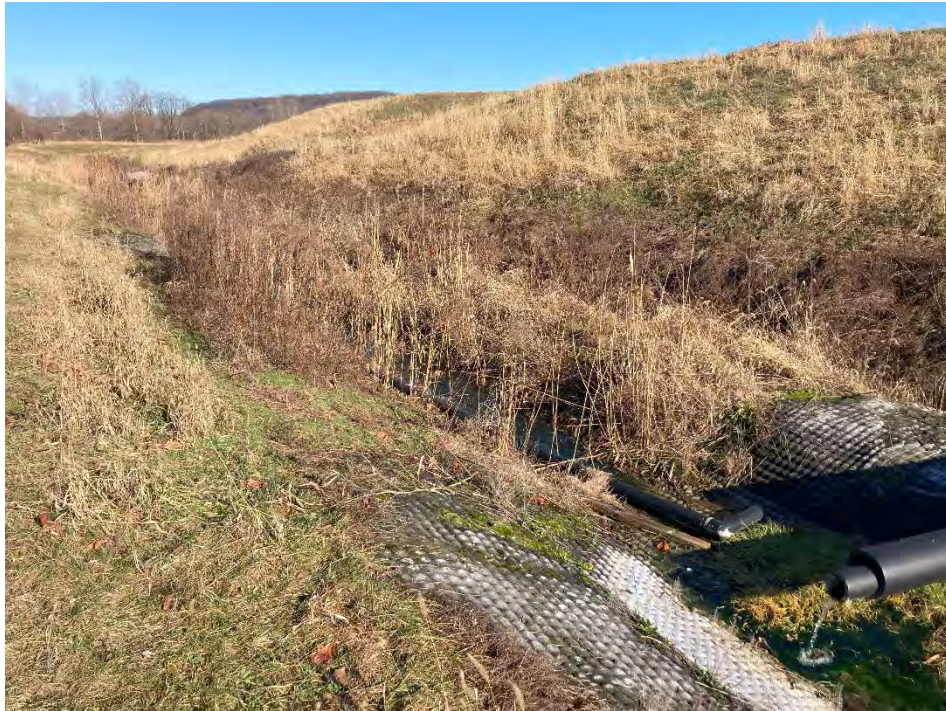
**Photograph 17:** West non-contact stormwater channel looking north is clear of obstructions. West final cover lower slope is well vegetated and mowed annually. No evidence of animal burrows, erosion, or stability issues.

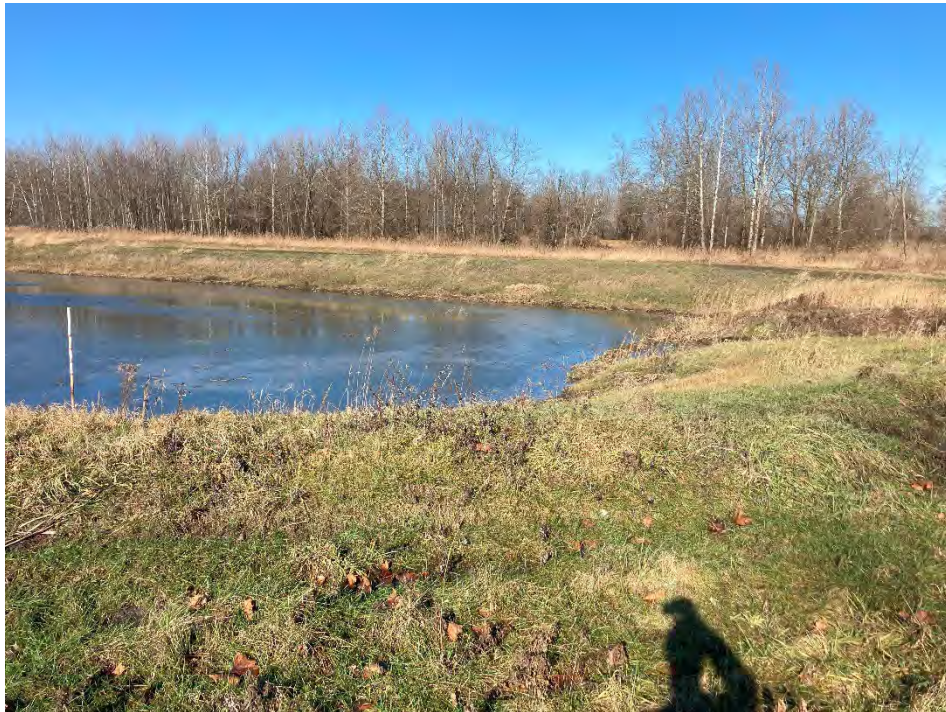
**Photograph 18:** Leachate (contact water) Pond. No evidence of animal burrows or liner damage.

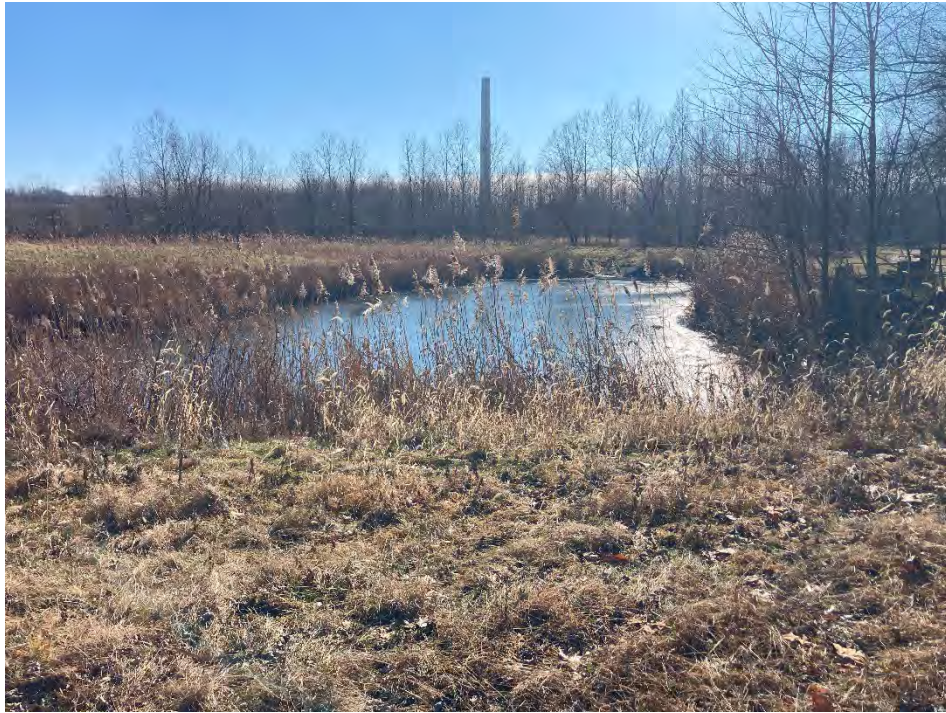
**Photograph 19:** Non-contact stormwater Sedimentation Pond.

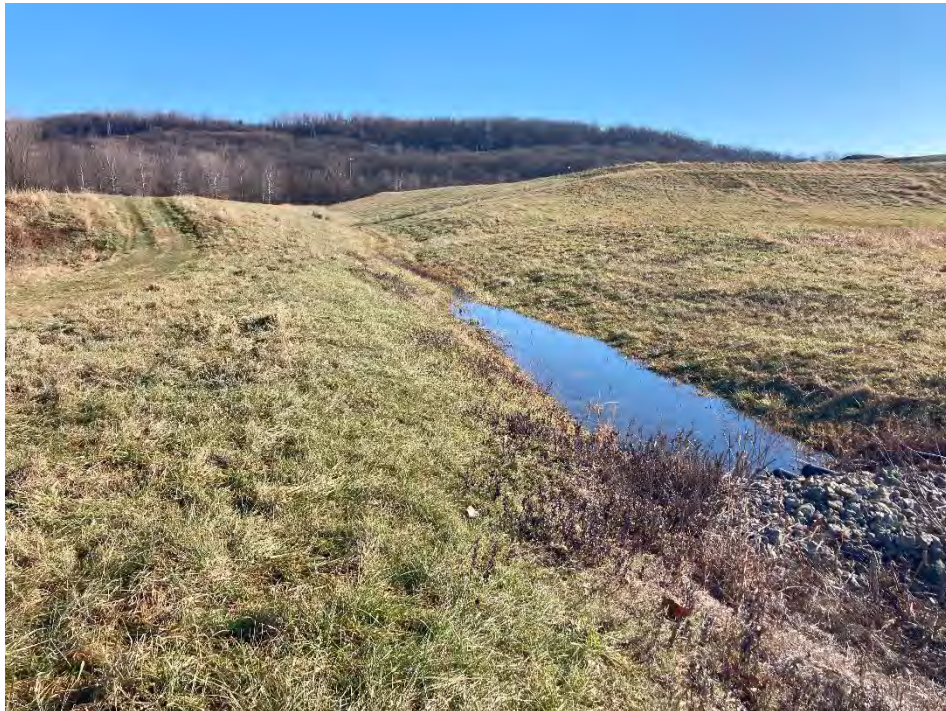
**Photograph 20:** North non-contact stormwater channel is clear of obstructions. North final cover lower slope is well vegetated and mowed annually. No evidence of animal burrows, erosion, or stability issues.

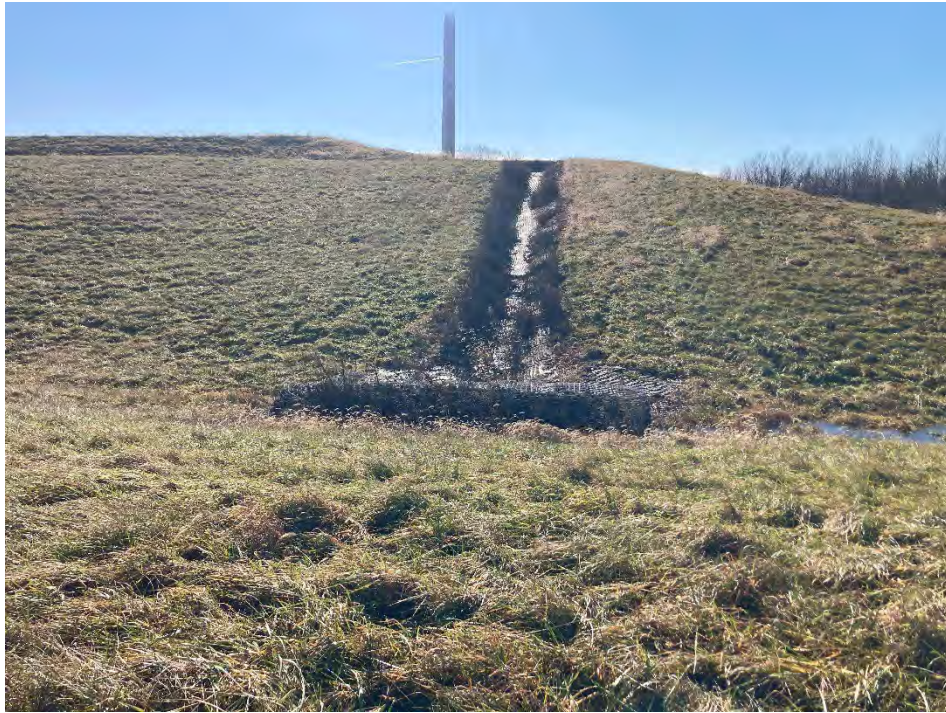
**Photograph 21:** Non-contact stormwater downchute in northwest corner is clear of obstructions. Gabion energy dissipator is installed at the junction with the stormwater (non-contact water) perimeter ditch.

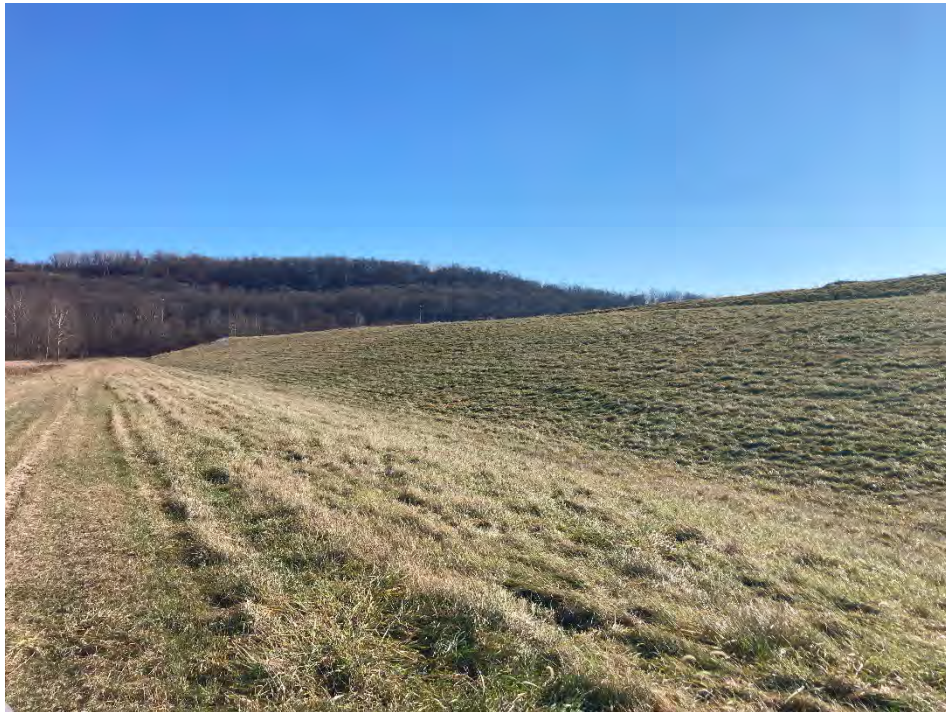
**Photograph 22:** North non-contact stormwater channel is clear of obstructions. North final cover lower slope is well vegetated and mowed annually. No evidence of animal burrows, erosion, or stability issues.

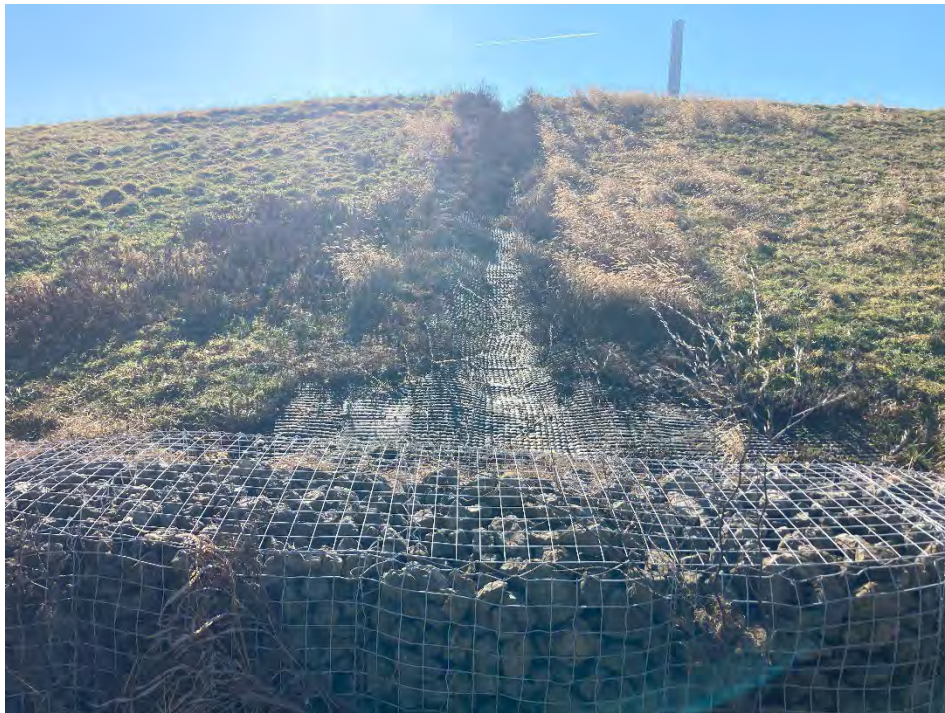
**Photograph 23:** Non-contact stormwater downchute in northeast corner is clear of obstructions. Gabion energy dissipator is installed at the junction with the stormwater (non-contact water) perimeter ditch.

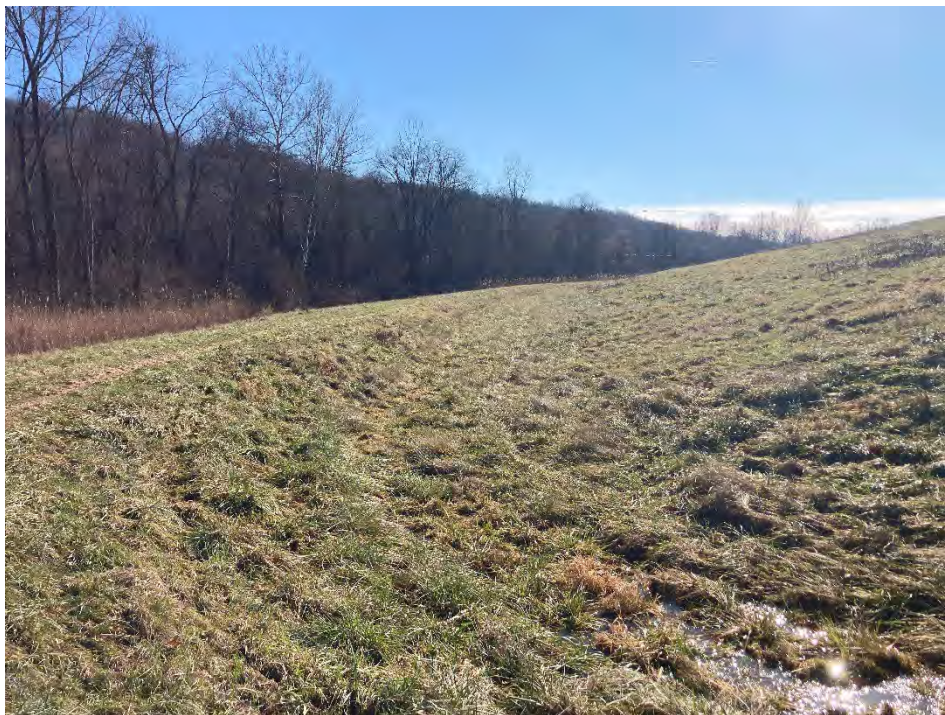
**Photograph 24:** East non-contact stormwater channel looking south is clear of obstructions. East final cover lower slope is well vegetated and mowed annually. No evidence of animal burrows, erosion, or stability issues.

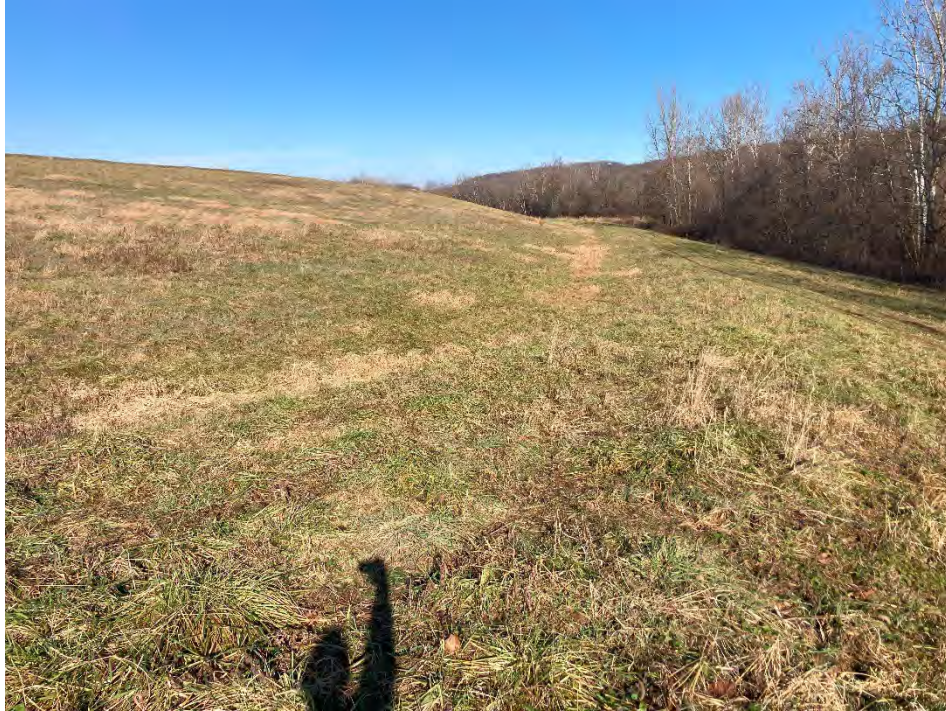
**Photograph 25:** East non-contact stormwater channel looking north is clear of obstructions. East final cover lower slope is well vegetated and mowed annually. No evidence of animal burrows, erosion, or stability issues.

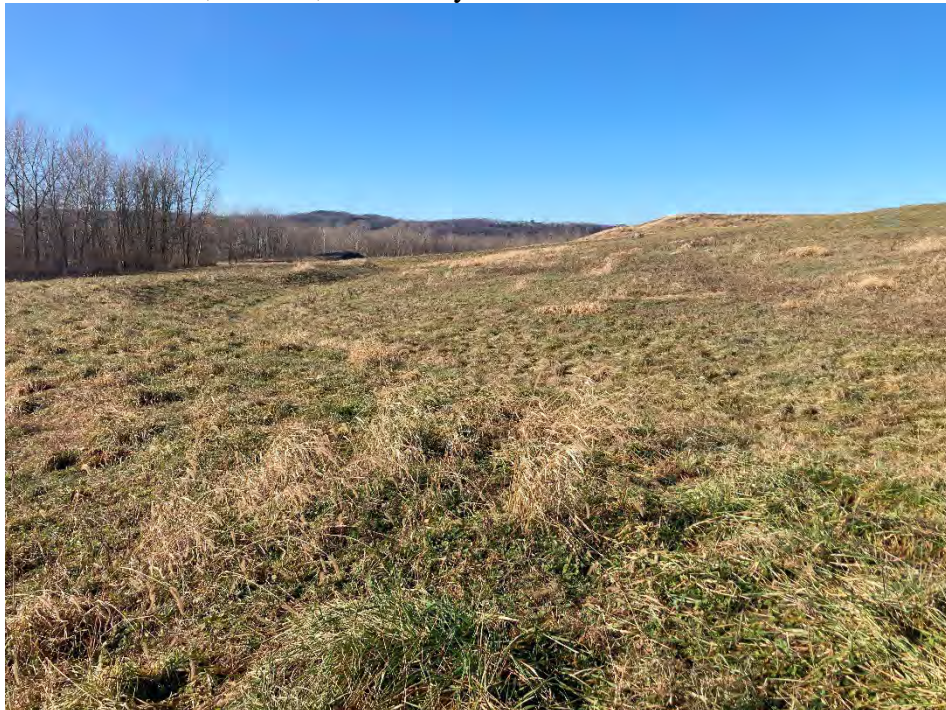
**Photograph 26:** South non-contact stormwater channel looking west is clear of obstructions. South final cover lower slope is well vegetated and mowed annually. No evidence of animal burrows, erosion, or stability issues.

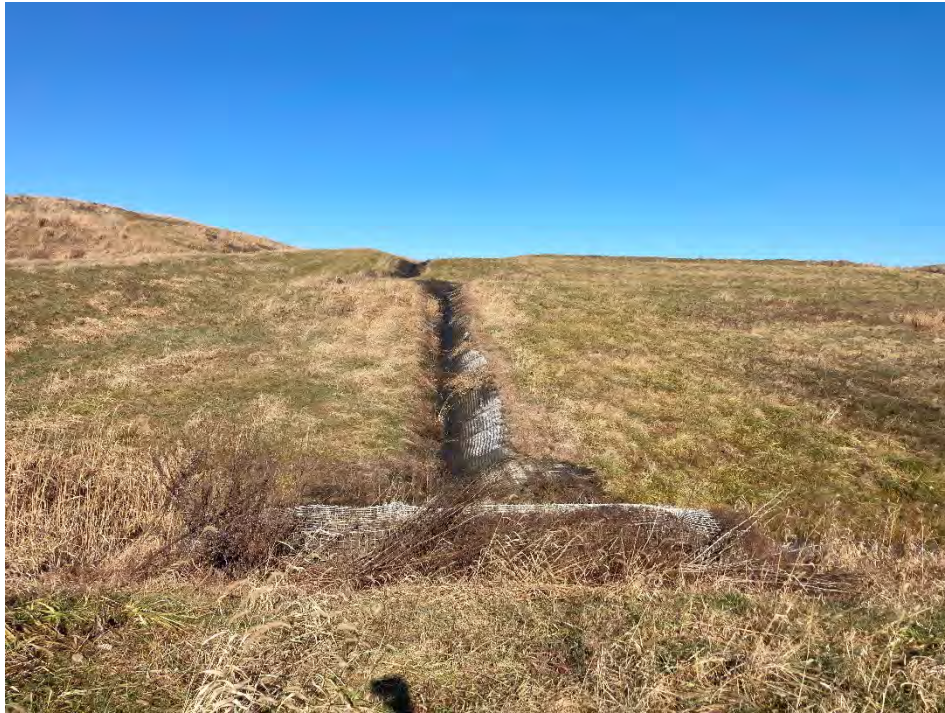
**Photograph 27:** Non-contact stormwater downchute on south slope is clear of obstructions. Gabion energy dissipator is installed at the junction with the stormwater (non-contact water) perimeter ditch.

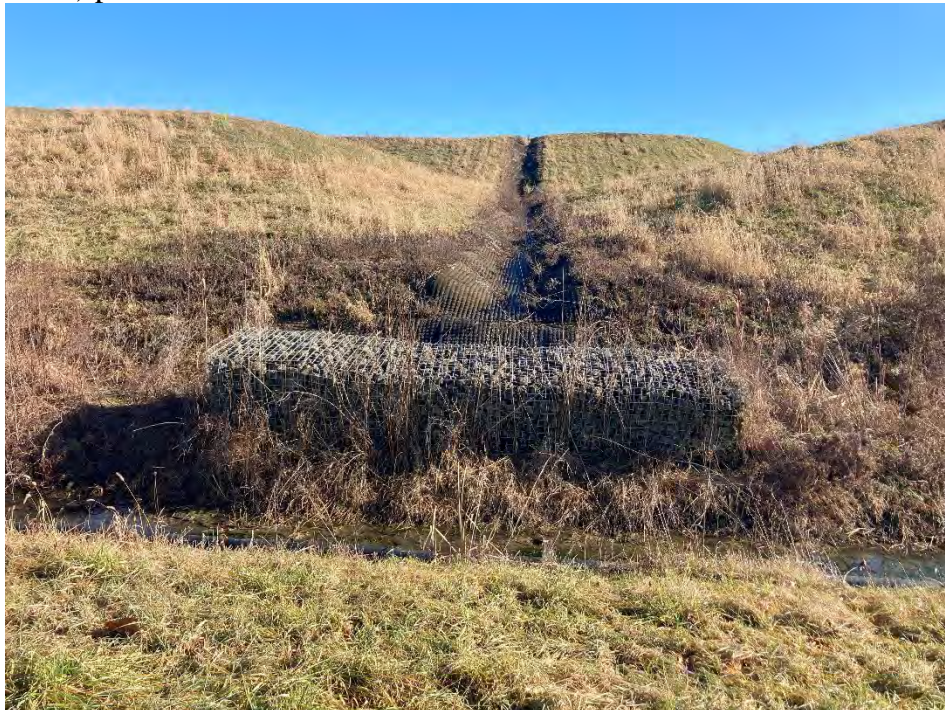
**Photograph 28:** Non-contact stormwater downchute on west slope is clear of obstructions. Gabion energy dissipator is installed at base of downchute before the stormwater perimeter ditch.
