**ANNUAL CCR UNIT INSPECTION REPORT
2021**

**NEW CASTLE STATION ASH LANDFILL
WEST PITTSBURGH, LAWRENCE COUNTY, PENNSYLVANIA**

**INSPECTION DATE: 11/18/2021
REPORT DATE: 1/14/2022**

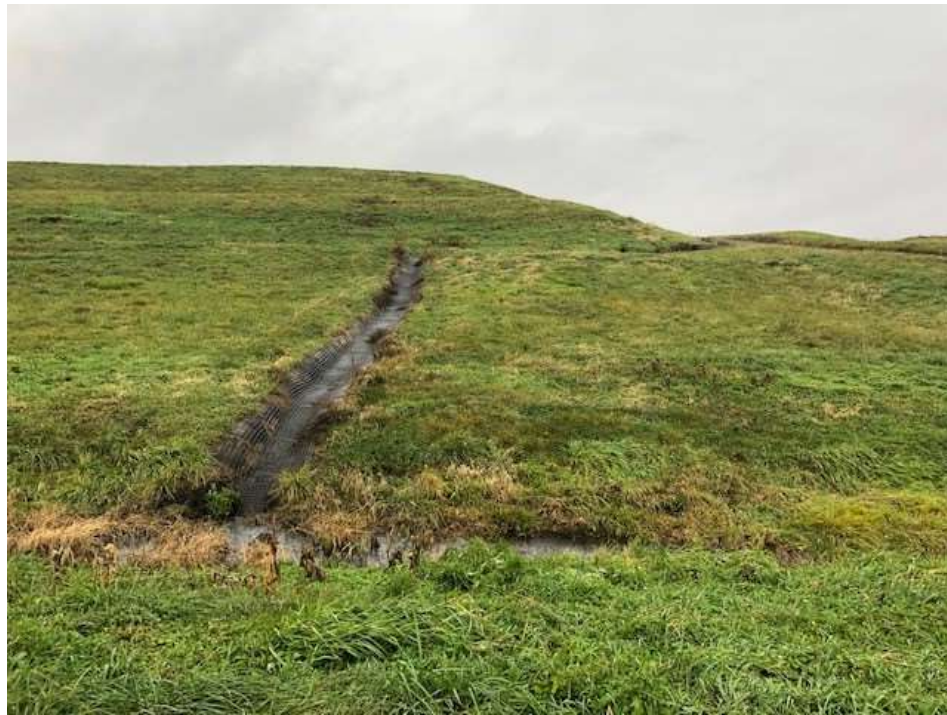
Photograph 1: Non-contact stormwater downchute is clear of obstructions.

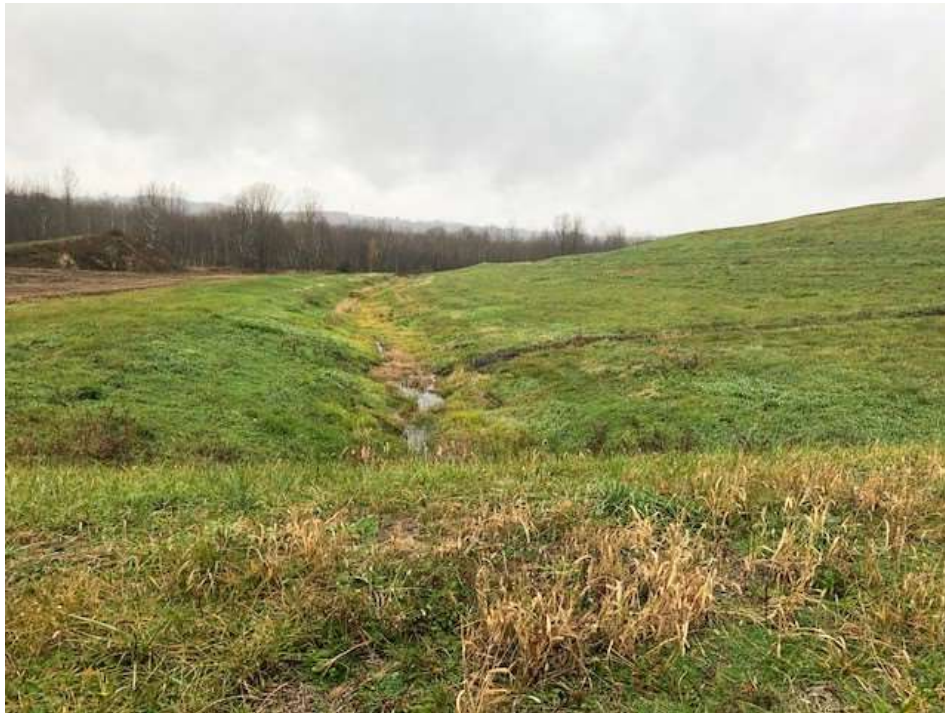
Photograph 2: South non-contact stormwater channel is clear of obstructions. South final cover lower slope is well vegetated and mowed annually. No evidence of animal burrows, erosion, or stability issues.

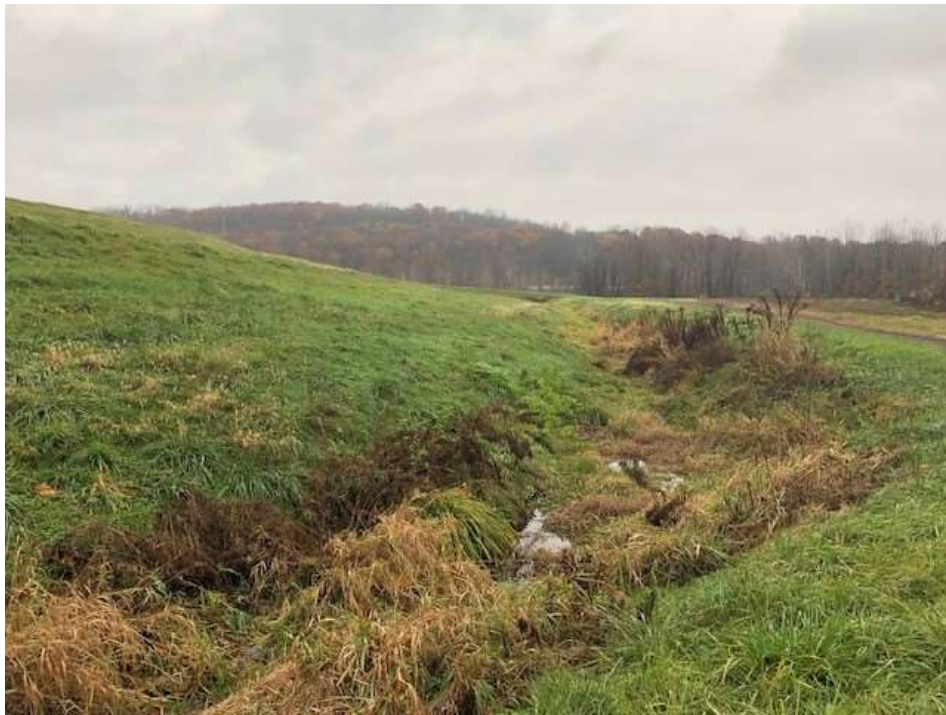
Photograph 3: South non-contact stormwater channel is clear of obstructions. South final cover lower slope is well vegetated and mowed annually. No evidence of animal burrows, erosion, or stability issues.

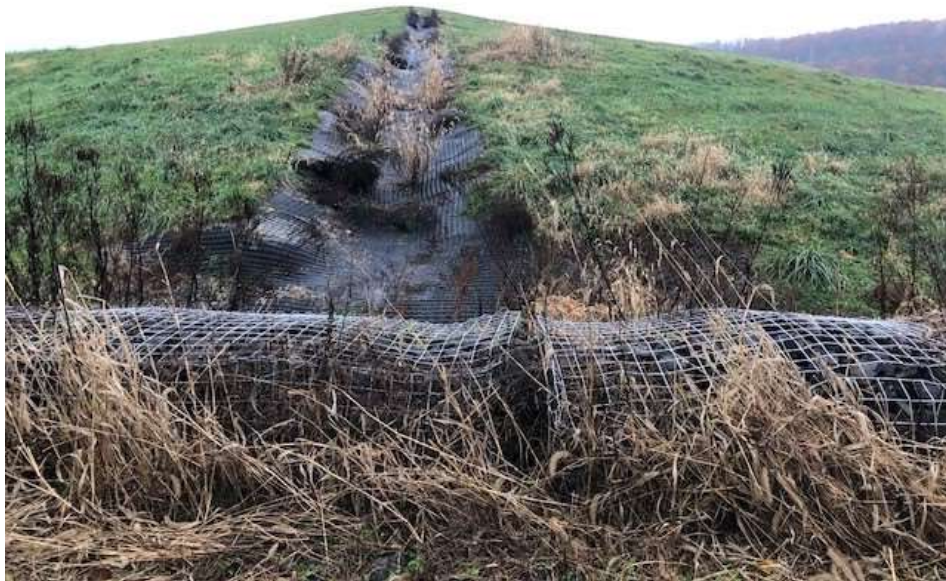
Photograph 4: Non-contact stormwater downchute is clear of obstructions. Gabion energy dissipator is installed at the junction with the stormwater (non-contact water) perimeter ditch.

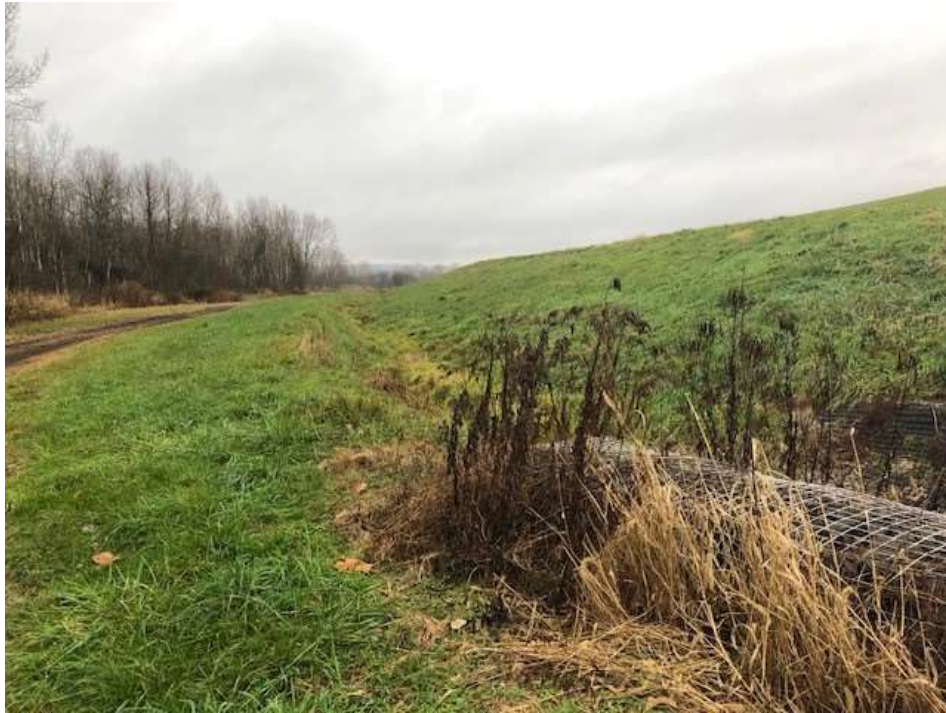
Photograph 5: West non-contact stormwater channel is clear of obstructions. West final cover lower slope is well vegetated and mowed annually. No evidence of animal burrows, erosion, or stability issues.

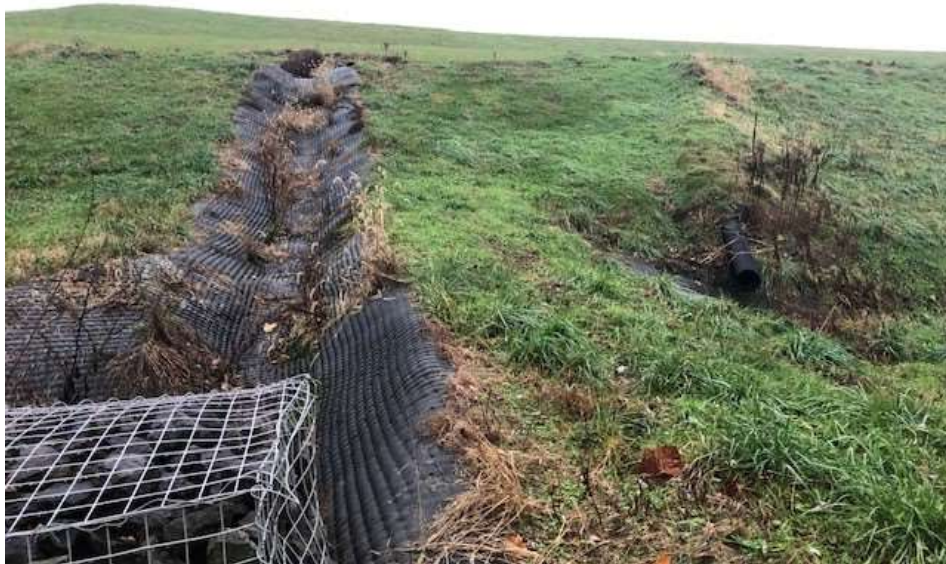
Photograph 6: Non-contact stormwater downchute is clear of obstructions. Gabion energy dissipator is installed at the junction with the stormwater (non-contact water) perimeter ditch.

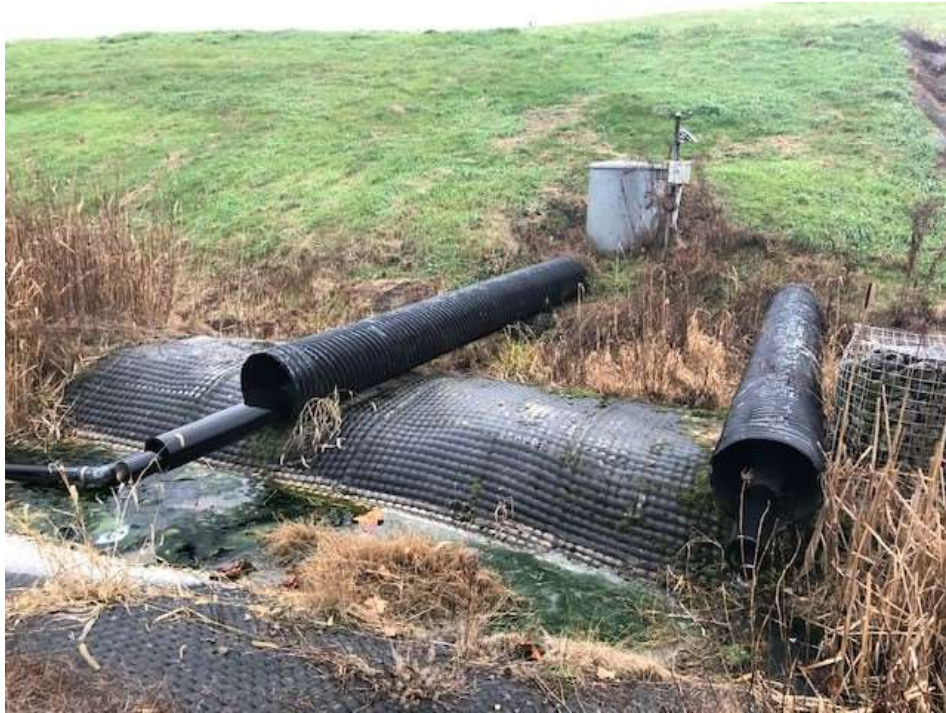
Photograph 7: Leachate collection zone and leak detection zone discharge pipes.

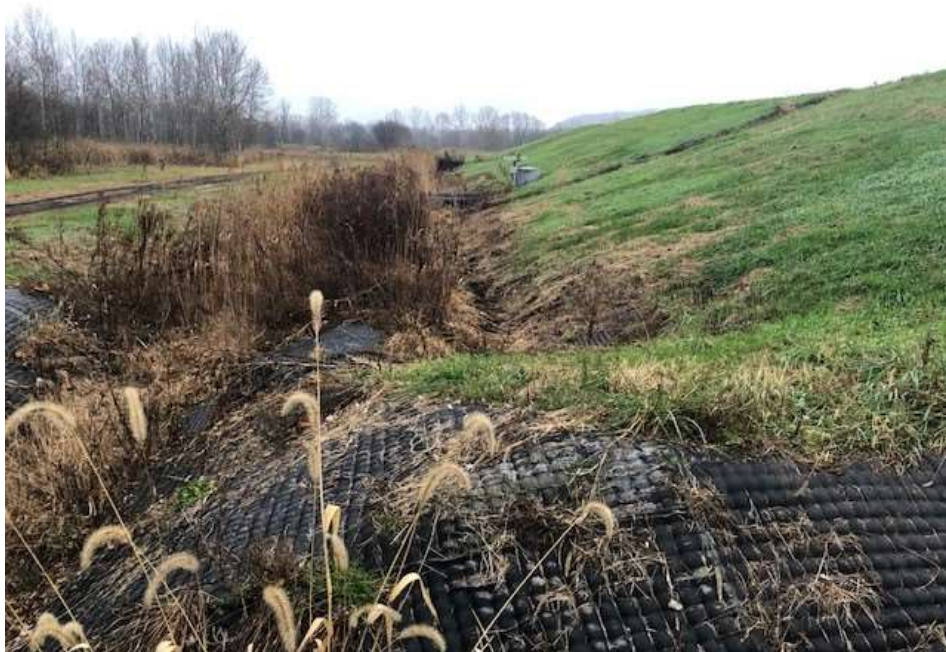
Photograph 8: West non-contact stormwater channel is clear of obstructions. West final cover lower slope is well vegetated and mowed annually. No evidence of animal burrows, erosion, or stability issues.

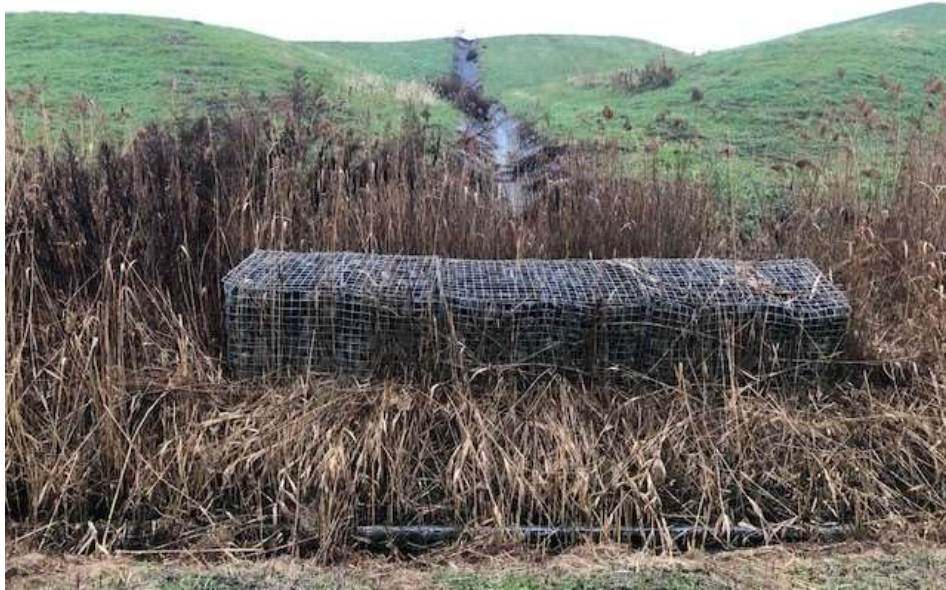
Photograph 9: Non-contact stormwater downchute is clear of obstructions. Gabion energy dissipator is installed at the junction with the stormwater (non- contact water) perimeter ditch.

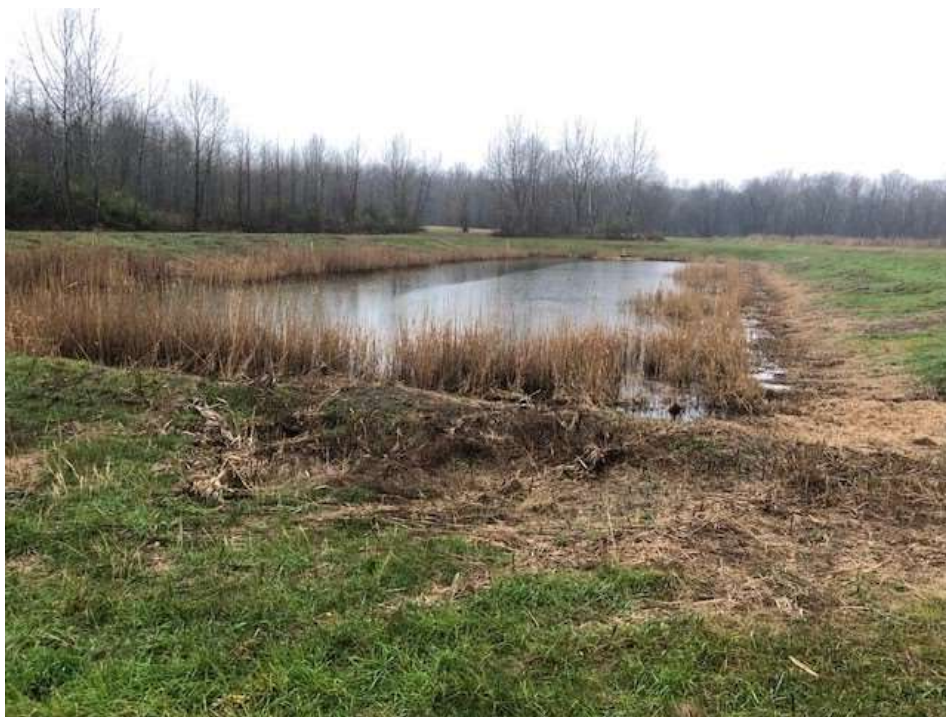
Photograph 10: Leachate (contact water) Pond. No evidence of animal burrows or liner damage.

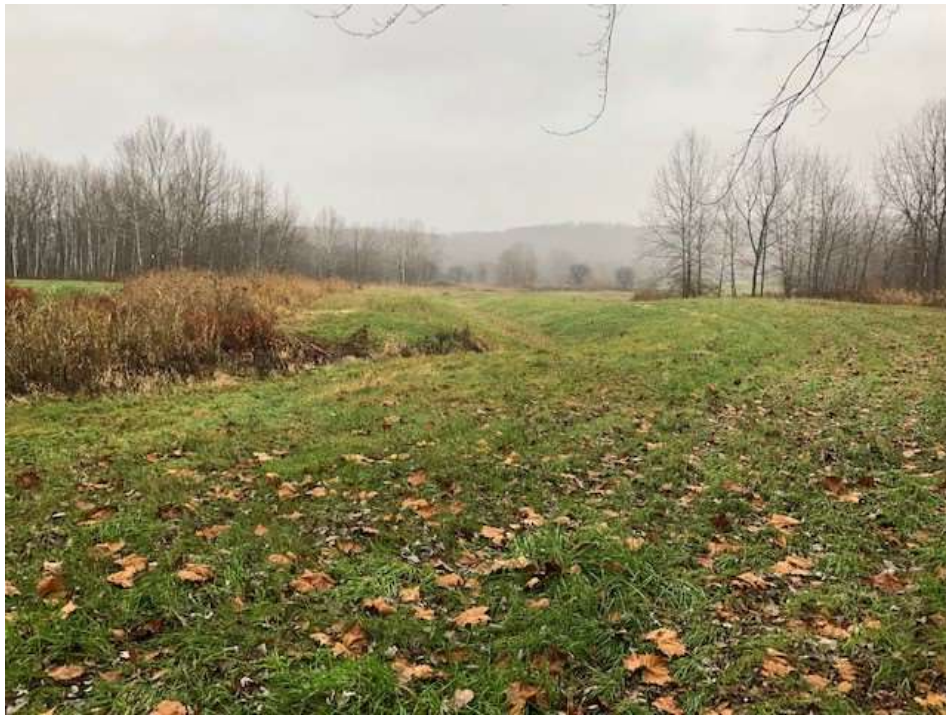
Photograph 11: North non-contact stormwater channel is clear of obstructions.

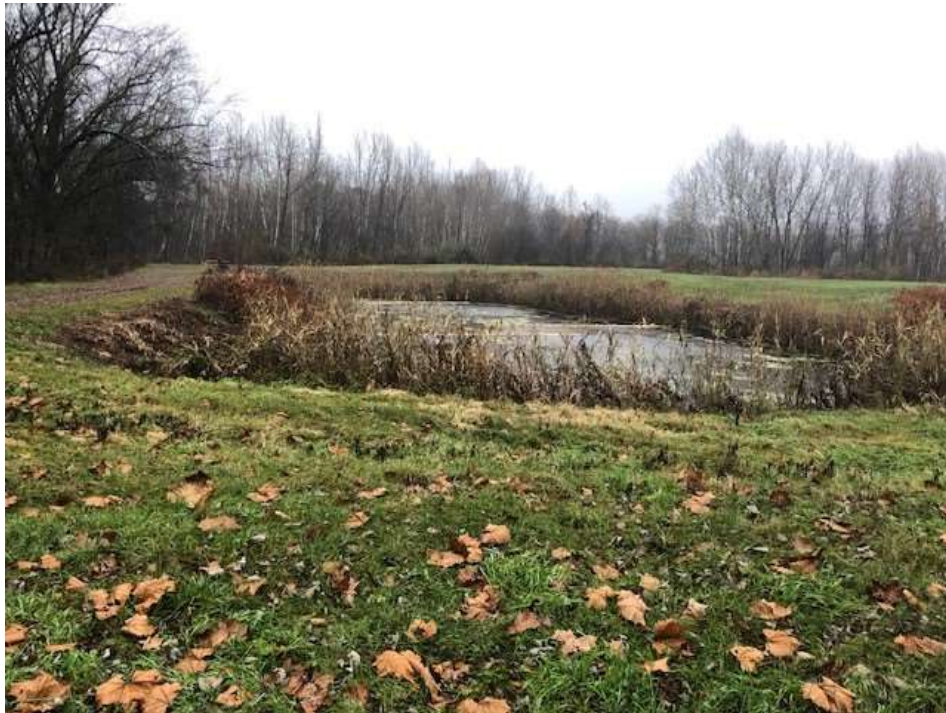
Photograph 12: Non-contact stormwater Sedimentation Pond. No evidence of animal burrows.

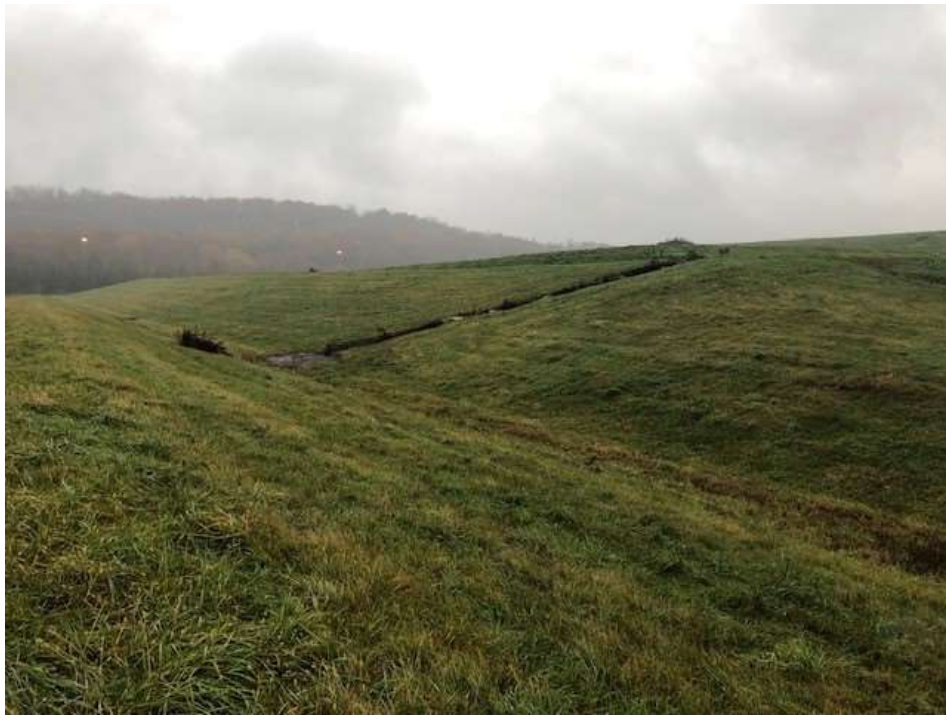
Photograph 13: North non-contact stormwater channel is clear of obstructions. North final cover lower slope is well vegetated and mowed annually. No evidence of animal burrows, erosion, or stability issues.

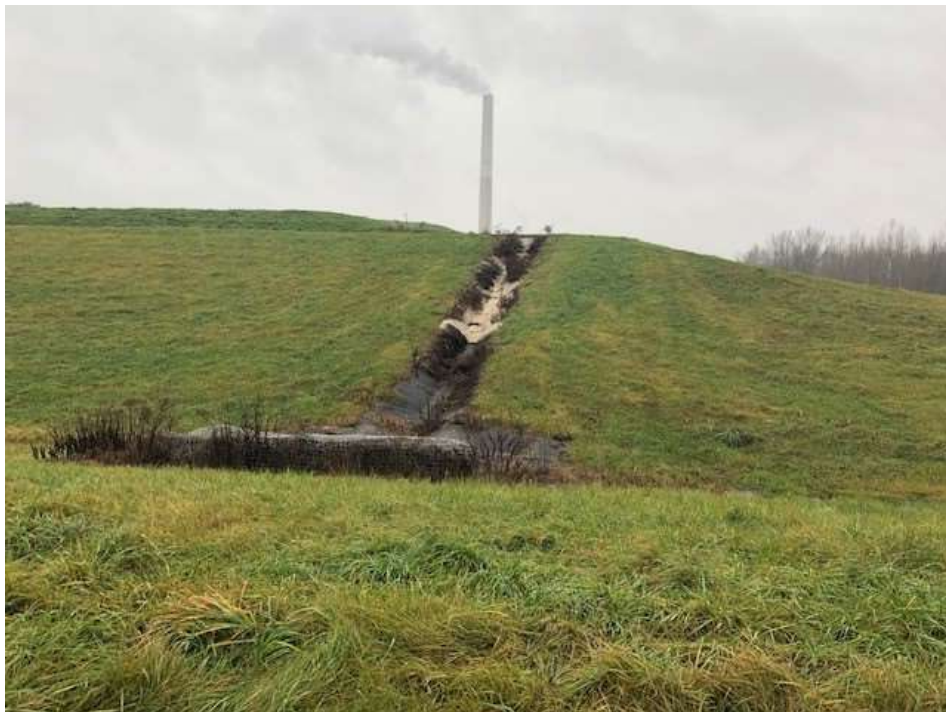
Photograph 14: Non-contact stormwater downchute is clear of obstructions. Gabion energy dissipator is installed at the junction with the stormwater (non-contact water) perimeter ditch.

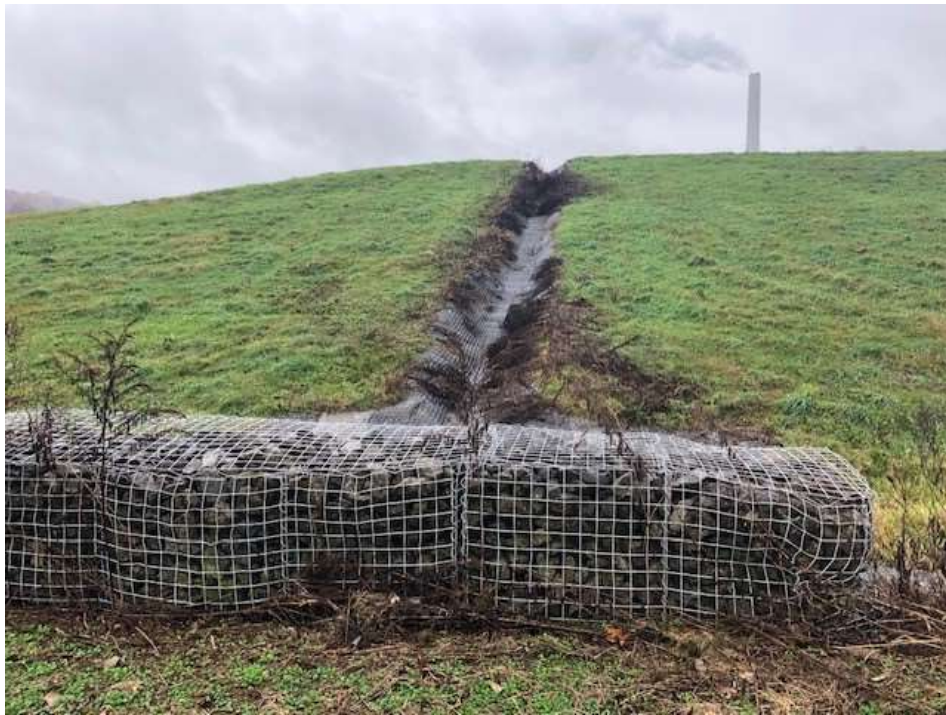
Photograph 15: Non-contact stormwater downchute is clear of obstructions. Gabion energy dissipator is installed at the junction with the stormwater (non- contact water) perimeter ditch.

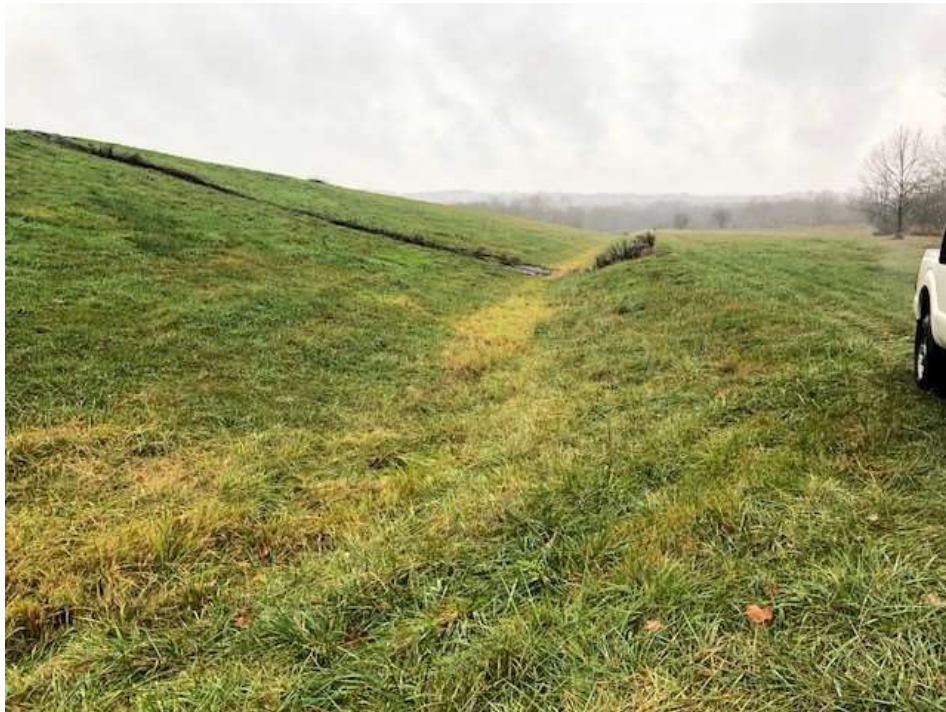
Photograph 16: North non-contact stormwater channel is clear of obstructions. North final cover lower slope is well vegetated and mowed annually. No evidence of animal burrows, erosion, or stability issues.

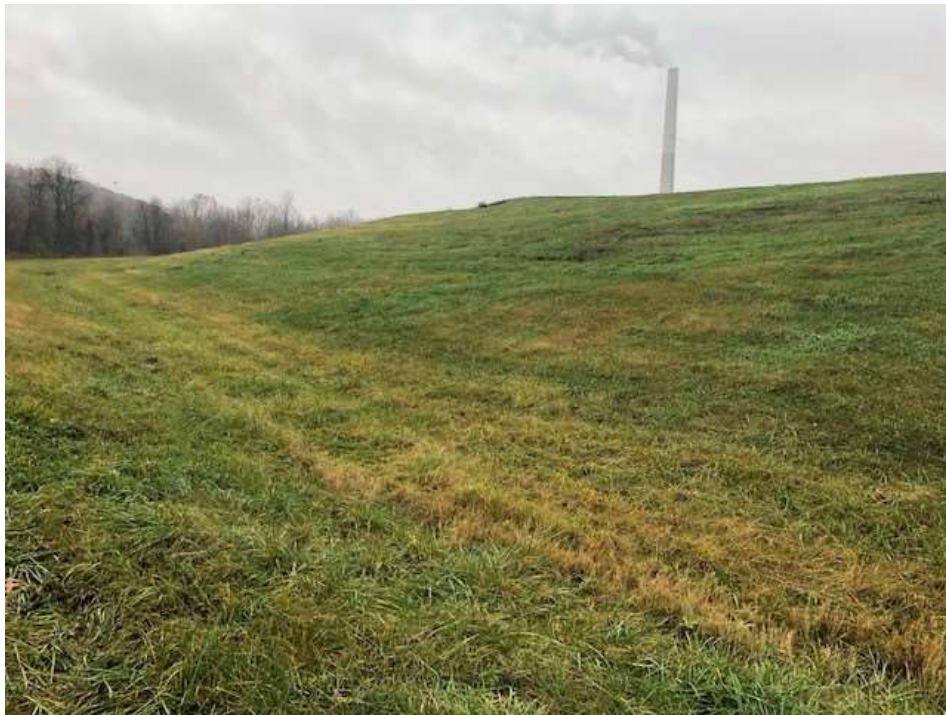
Photograph 17: East non-contact stormwater channel is clear of obstructions. East final cover lower slope is well vegetated and mowed annually. No evidence of animal burrows, erosion, or stability issues.

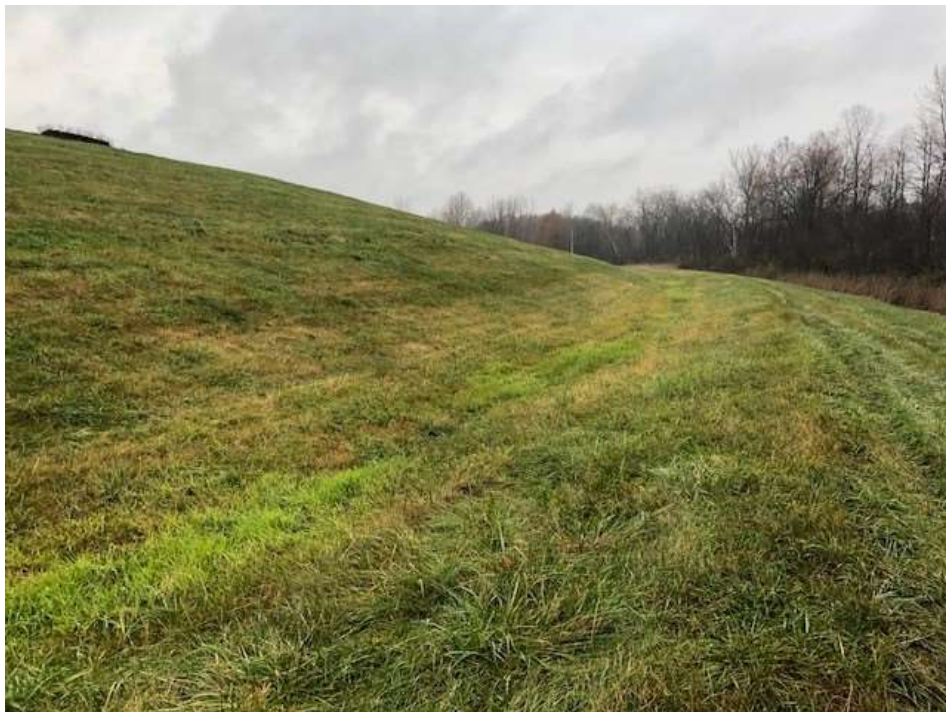
Photograph 18: East non-contact stormwater channel is clear of obstructions. East final cover lower slope is well vegetated and mowed annually. No evidence of animal burrows, erosion, or stability issues.

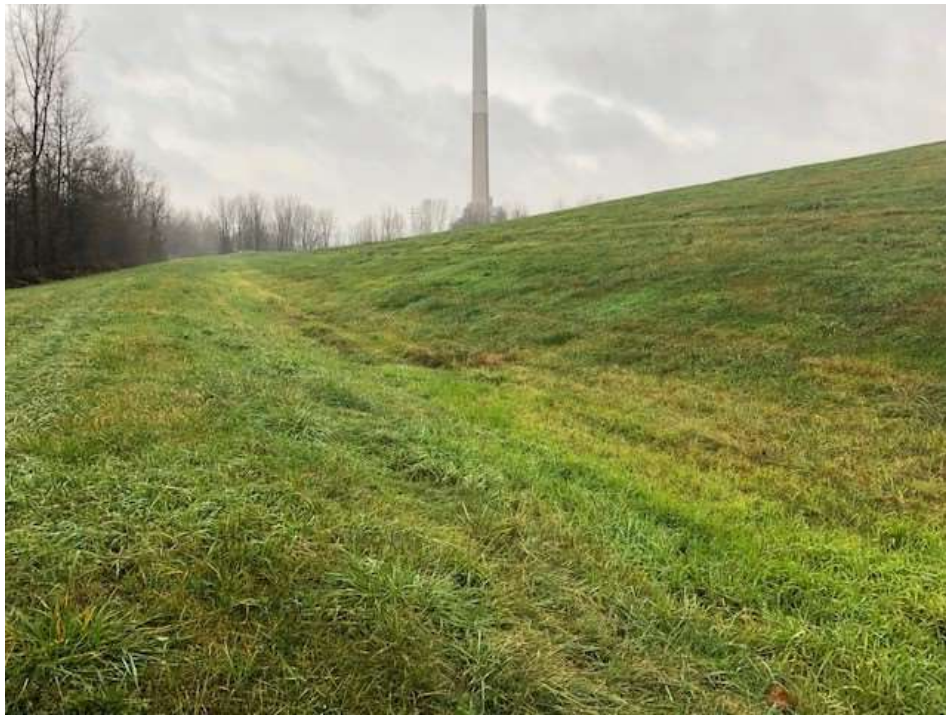
Photograph 19: East non-contact stormwater channel is clear of obstructions. East final cover lower slope is well vegetated and mowed annually. No evidence of animal burrows, erosion, or stability issues.

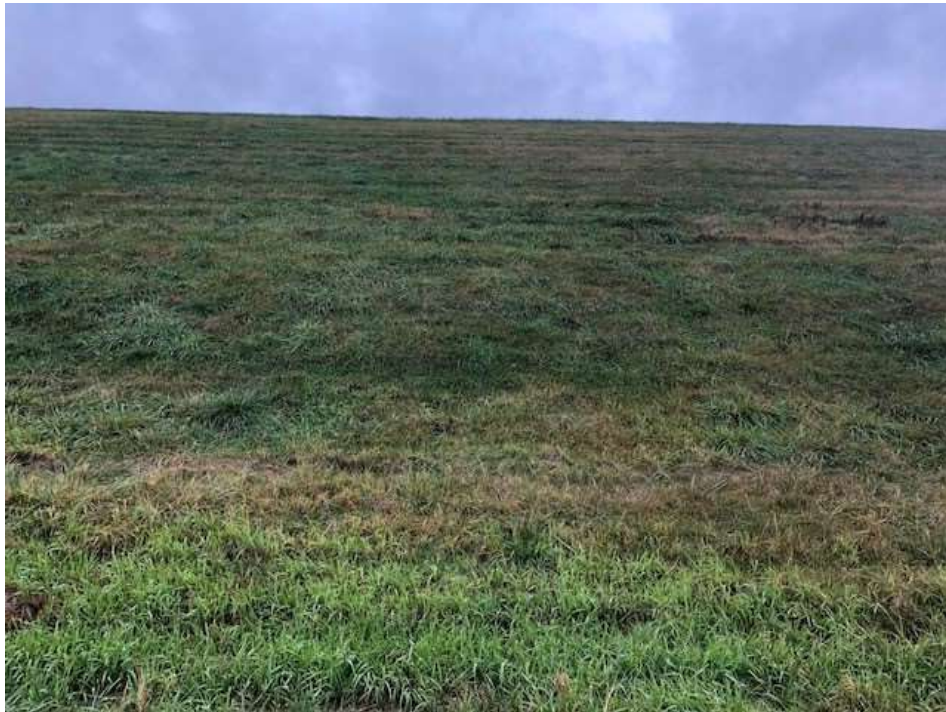
Photograph 20: East final cover lower slope is well vegetated and mowed annually. No evidence of animal burrows, erosion, or stability issues.

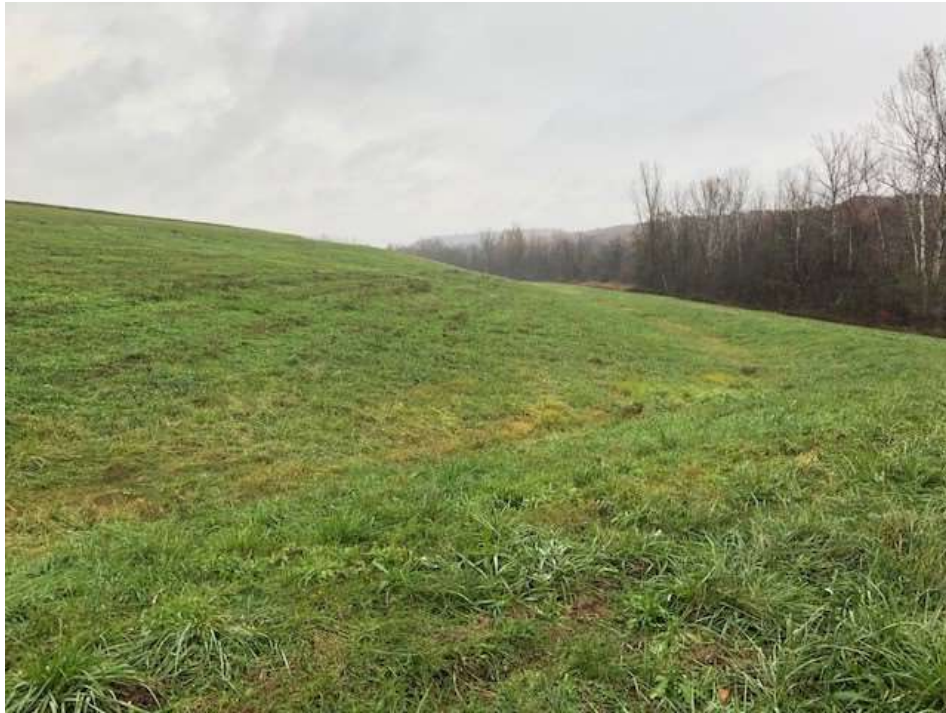
Photograph 21: East non-contact stormwater channel is clear of obstructions. East final cover lower slope is well vegetated and mowed annually. No evidence of animal burrows, erosion, or stability issues.

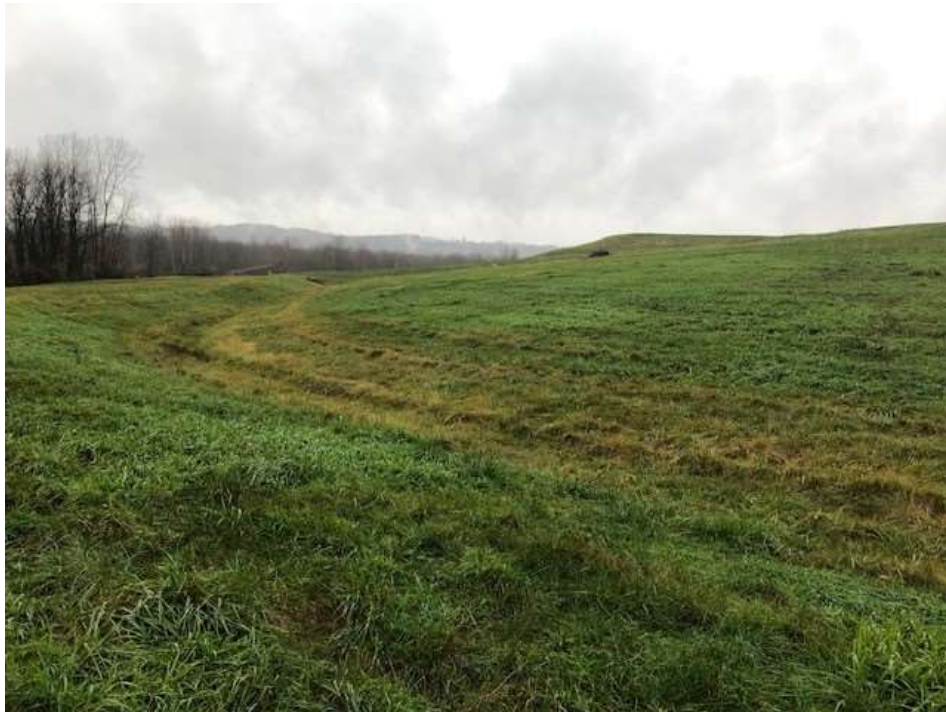
Photograph 22: South non-contact stormwater channel is clear of obstructions. South final cover lower slope is well vegetated and mowed annually. No evidence of animal burrows, erosion, or stability issues.

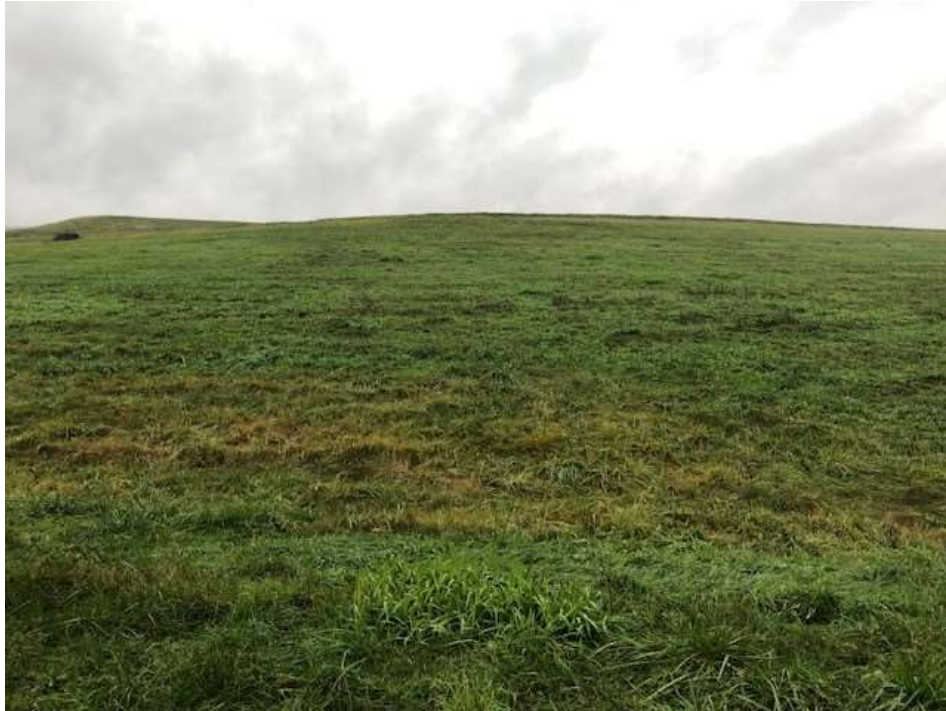
Photograph 23: Southeast corner final cover lower slope is well vegetated and mowed annually. No evidence of animal burrows, erosion, or stability issues.

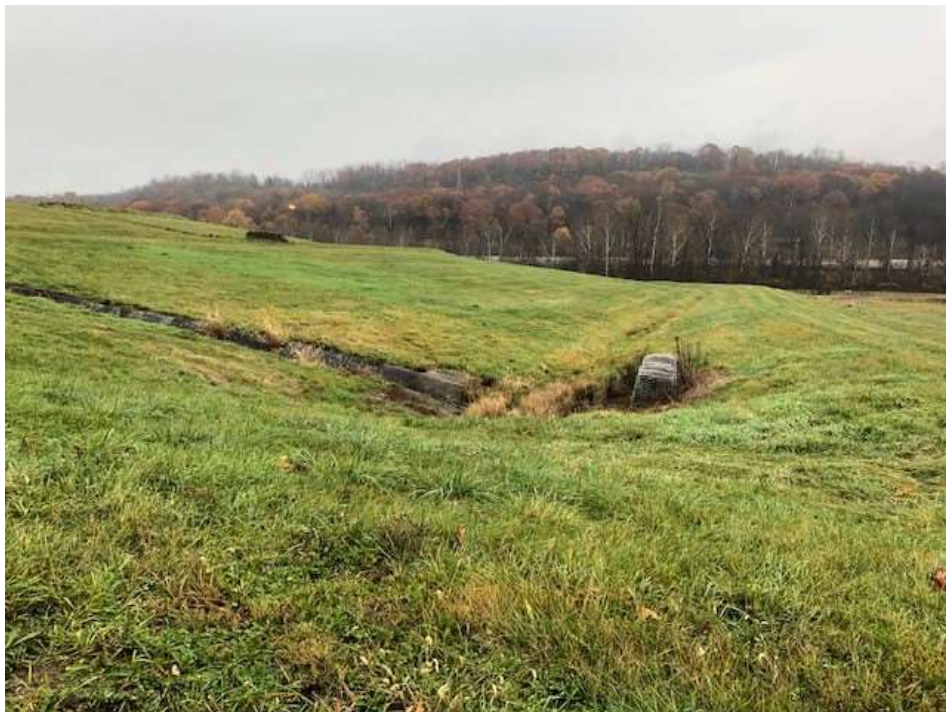
Photograph 24: South non-contact stormwater channel is clear of obstructions. South final cover lower slope is well vegetated and mowed annually. No evidence of animal burrows, erosion, or stability issues.

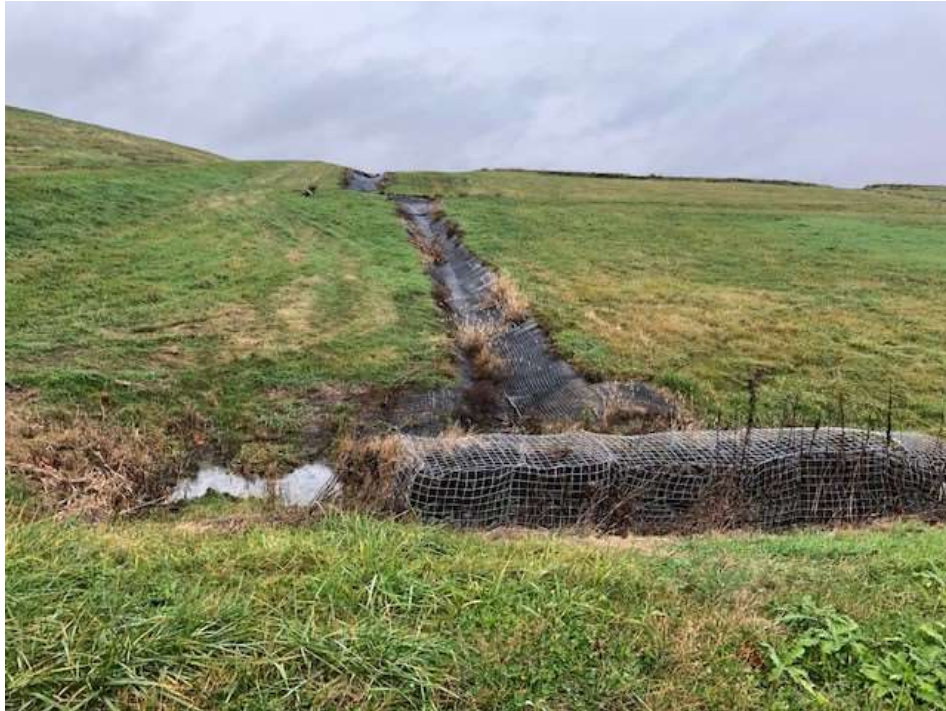
Photograph 25: Non-contact stormwater downchute is clear of obstructions. Gabion energy dissipator is installed at the junction with the stormwater (non- contact water) perimeter ditch.

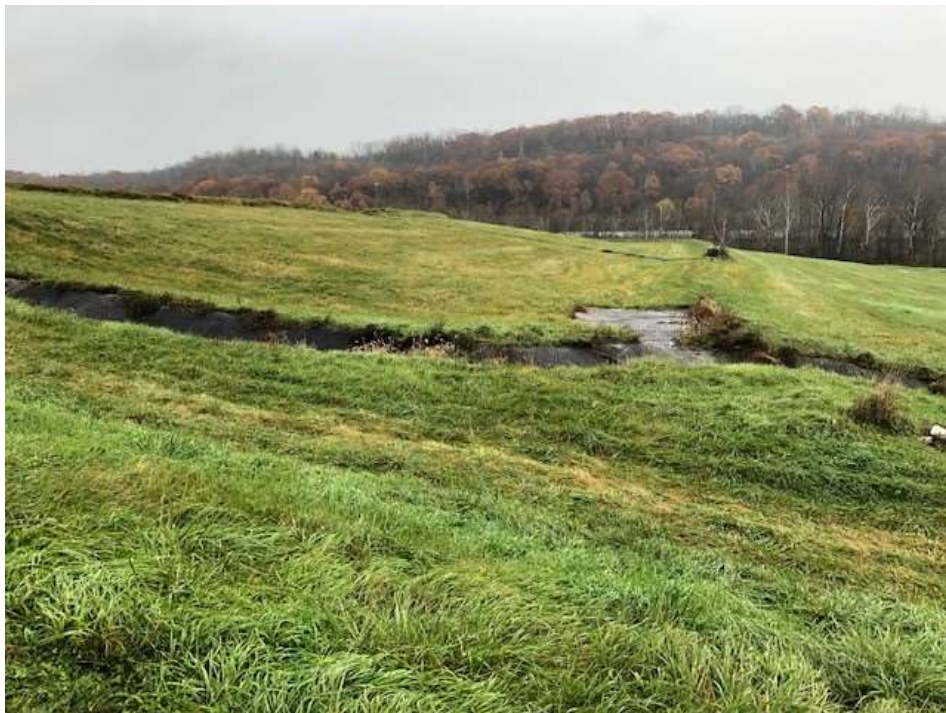
Photograph 26: South final cover upper slope is well vegetated and mowed annually. No evidence of animal burrows, erosion, or stability issues.

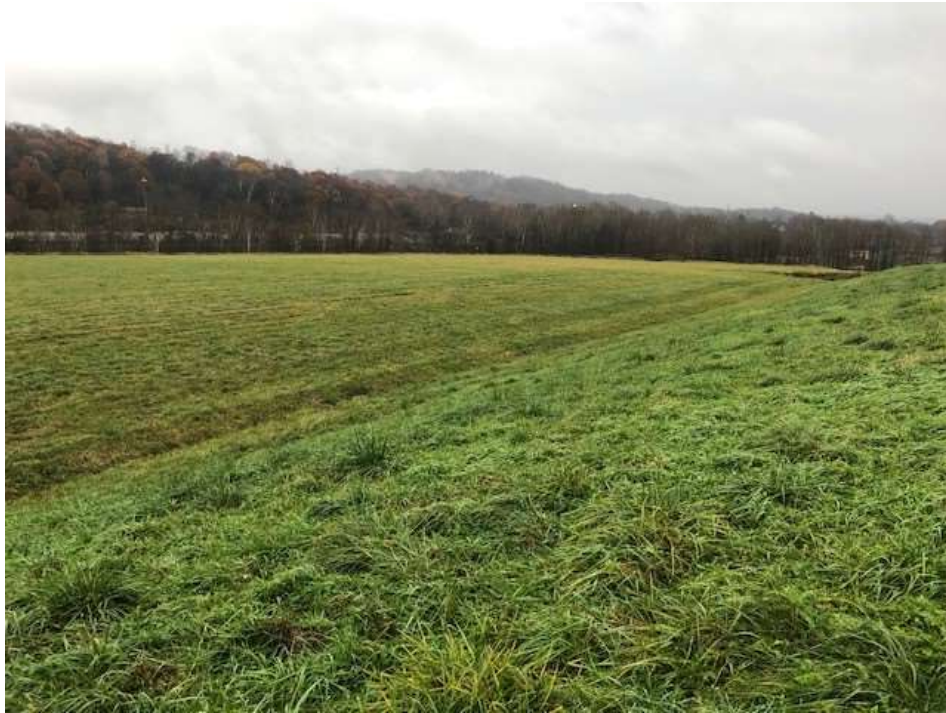
Photograph 27: Stage 6 final cover is well vegetated and mowed annually. No evidence of animal burrows, erosion, or stability issues.

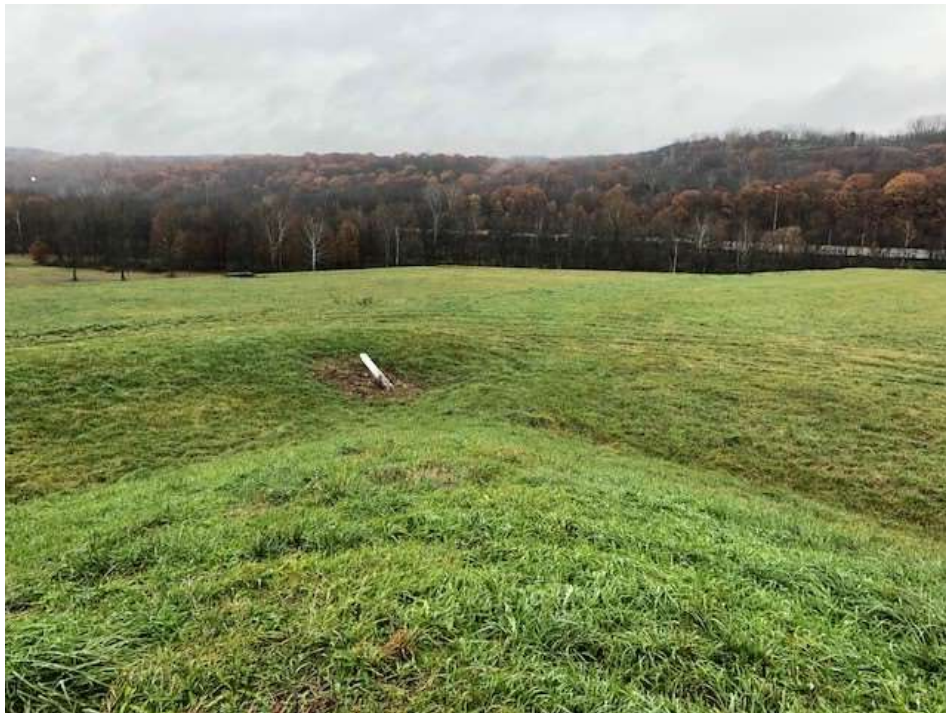
Photograph 28: Stage 5 final cover is well vegetated and mowed annually. No evidence of animal burrows, erosion, or stability issues.

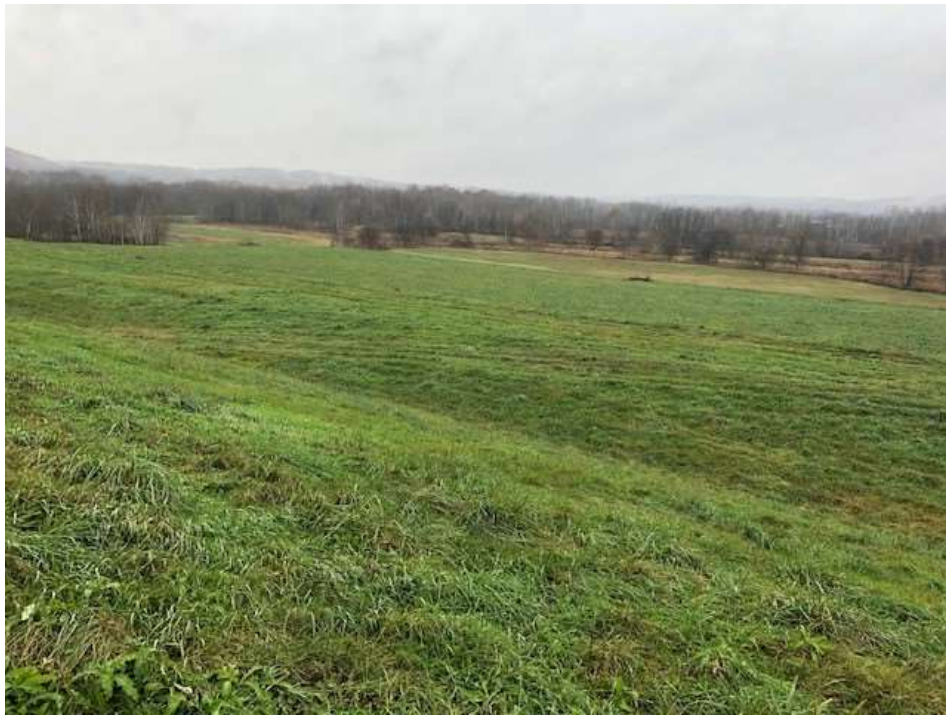
Photograph 29: Stage 5 final cover is well vegetated and mowed annually. No evidence of animal burrows, erosion, or stability issues.

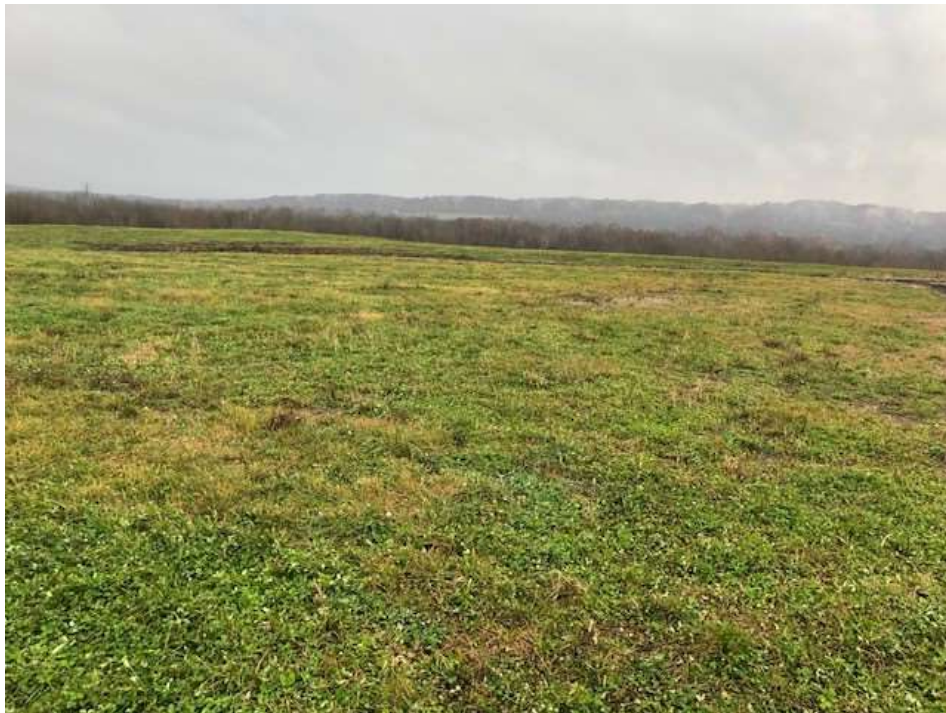
Photograph 30: Intermediate cover in active area is well vegetated and mowed annually.

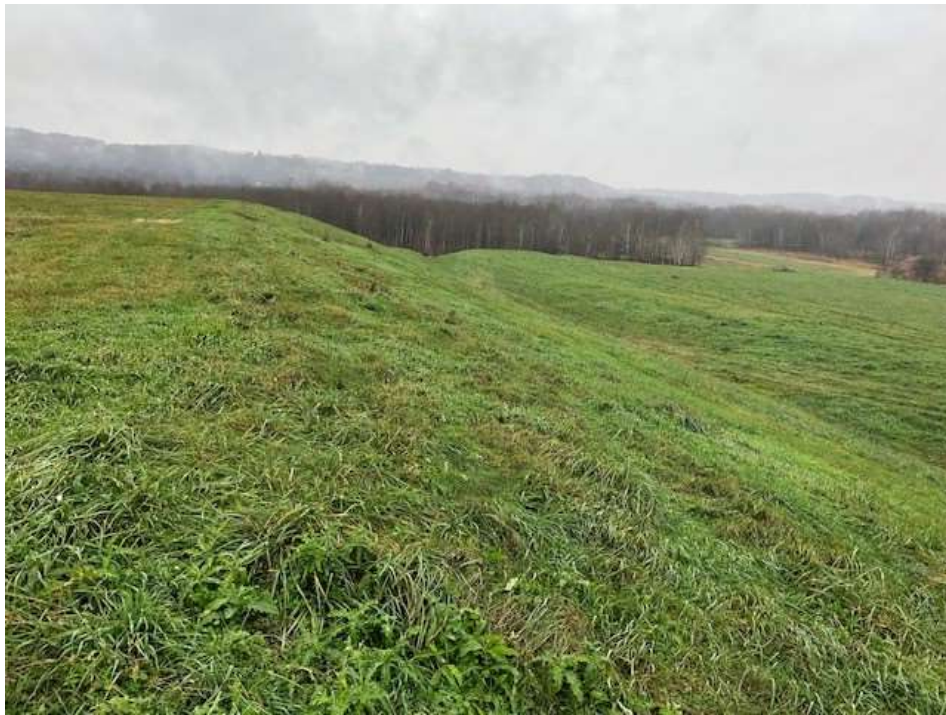
Photograph 31: Stage 4 north slope is well vegetated and mowed annually. No evidence of animal burrows, erosion, or stability issues.

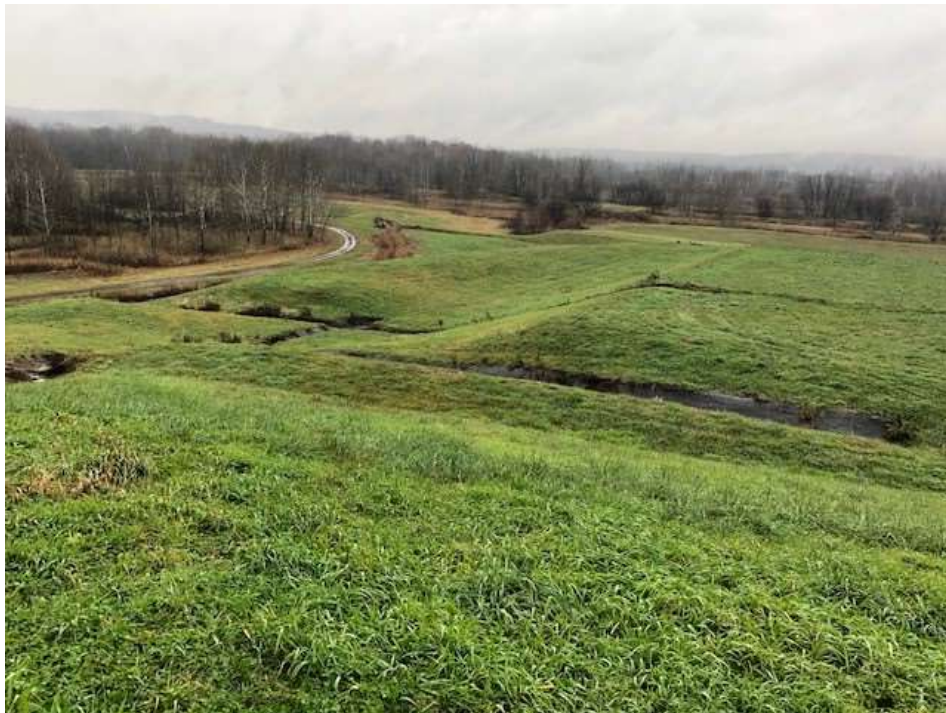
Photograph 32: Downchutes from west side of Stage 4 and Stage 5. No evidence of animal burrows, erosion, or stability issues on the vegetated slopes.
