**ANNUAL CCR UNIT INSPECTION REPORT
2021**

**NEW CASTLE STATION ASH LANDFILL
WEST PITTSBURGH, LAWRENCE COUNTY, PENNSYLVANIA**

**INSPECTION DATE: 11/18/2021
REPORT DATE: 1/14/2022**

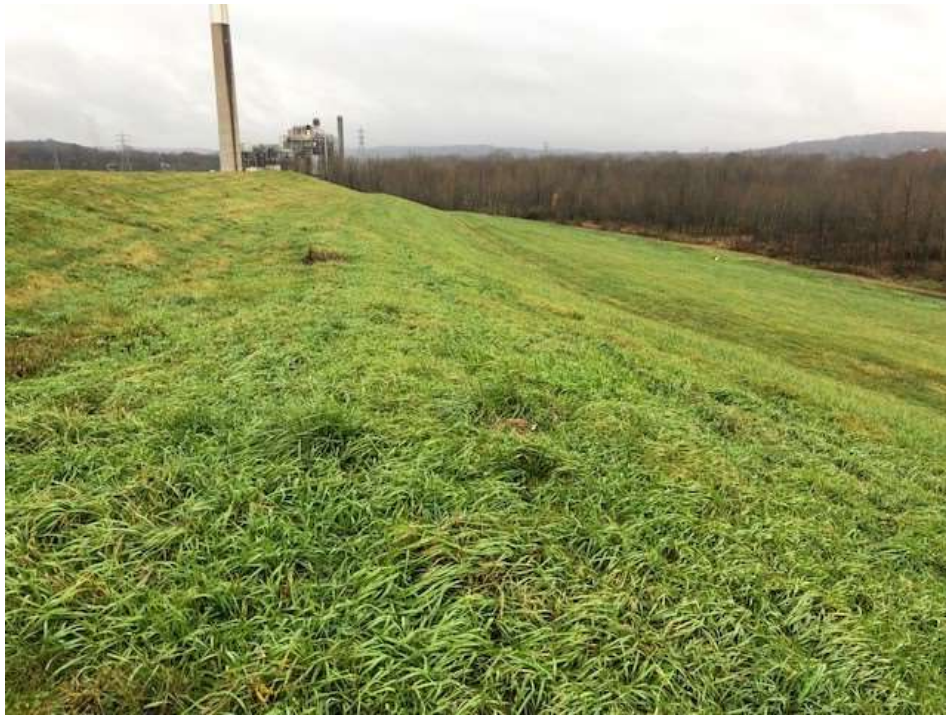
Photograph 33: Stage 4 west slope is well vegetated and mowed annually. No evidence of animal burrows, erosion, or stability issues.

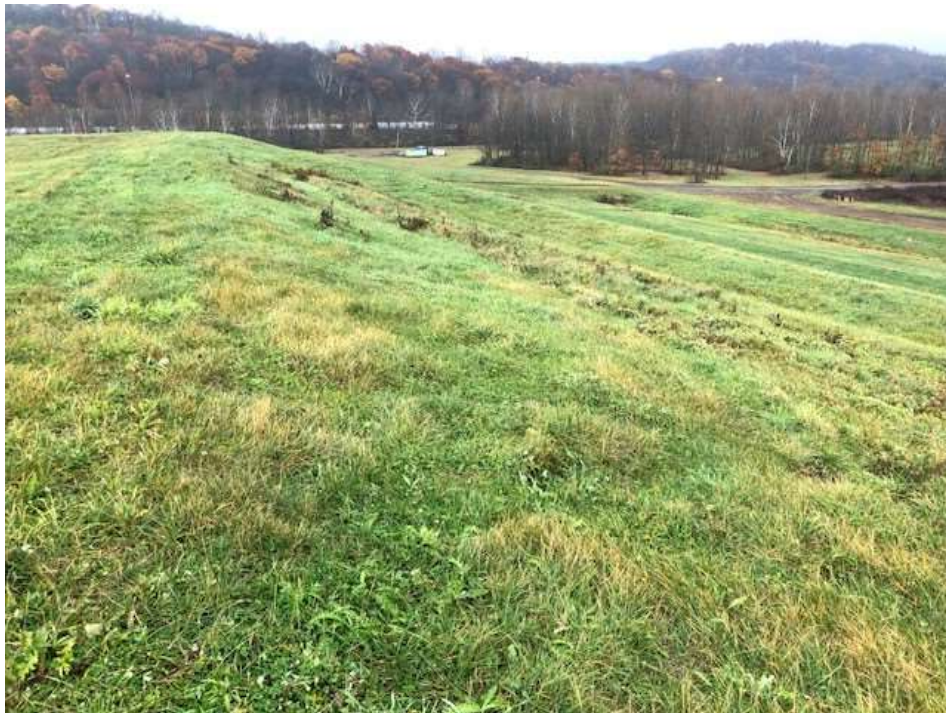
Photograph 34: Stage 4 south slope is well vegetated and mowed annually. No evidence of animal burrows, erosion, or stability issues.

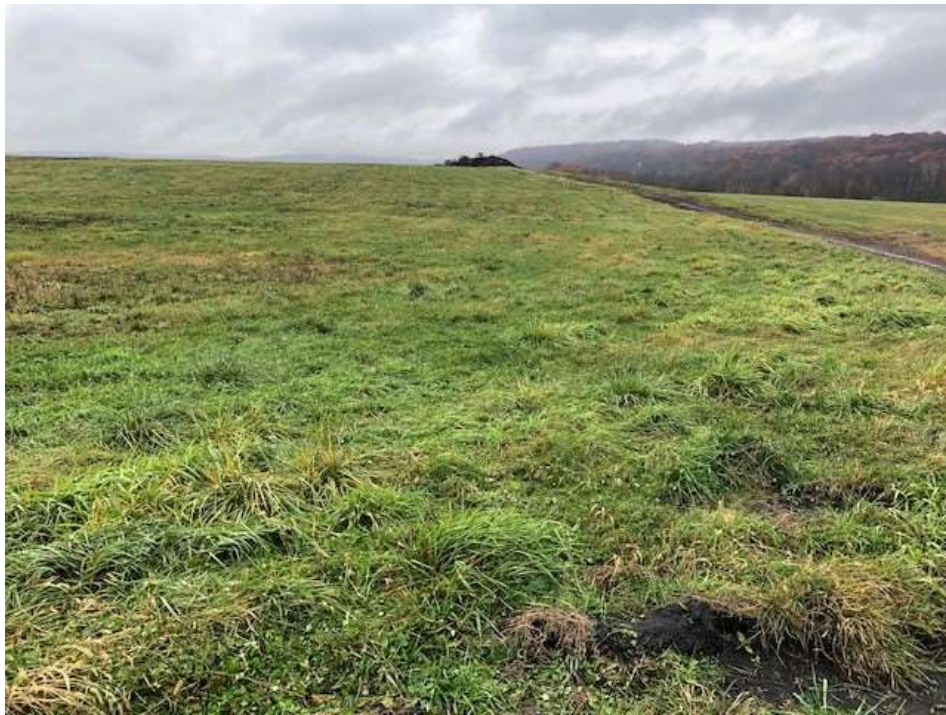
Photograph 35: Intermediate cover in active area is well vegetated and mowed annually.

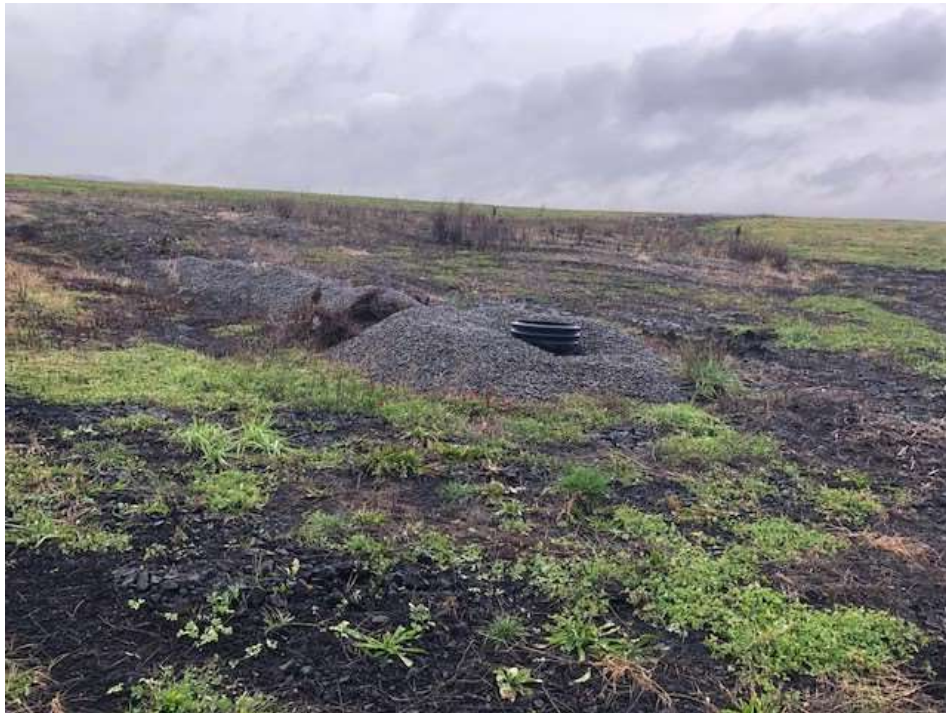
Photograph 36: Contact water collection riser in active area.
