**CCR COMPLIANCE
CLOSURE CERTIFICATION REPORT
CLOSURE BY REMOVAL
NEW CASTLE NORTH BOTTOM ASH POND**

GenOn Power Midwest LP
New Castle Generating Station
West Pittsburg, Pennsylvania

Aptim Environmental & Infrastructure, LLC
St. Charles, Illinois

June 2019

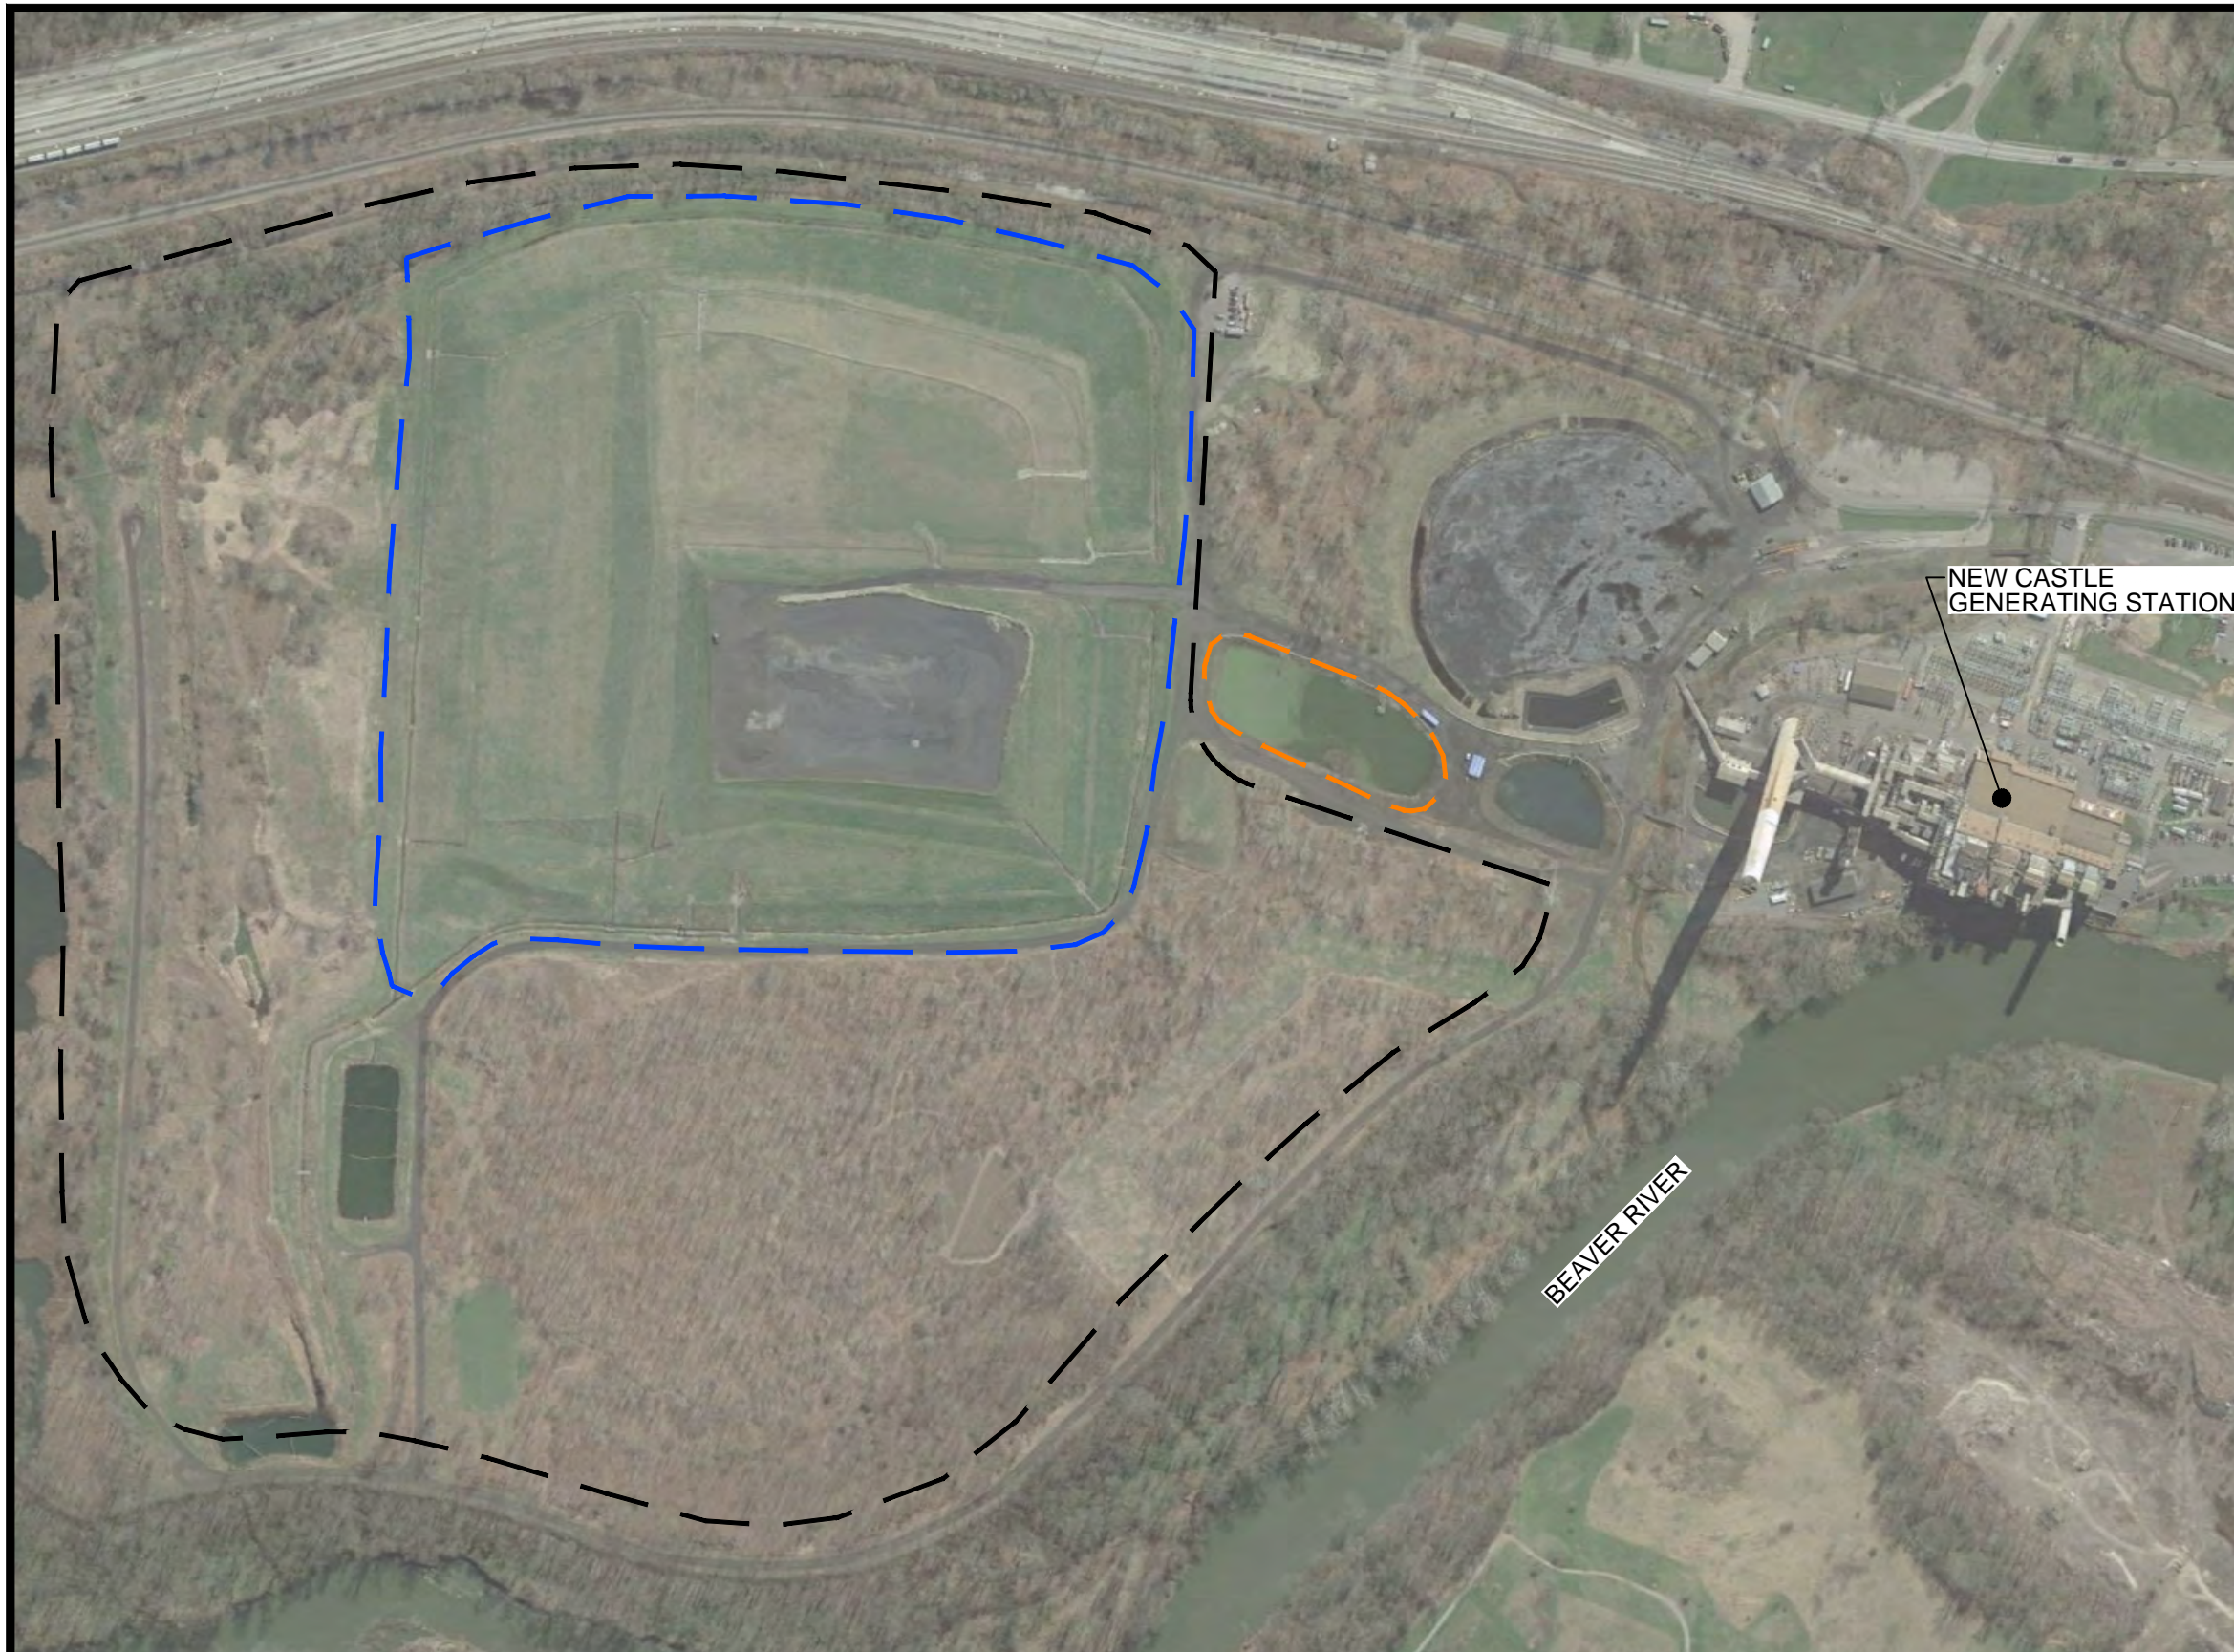
**FIGURE 1
SITE LOCATION MAP**

The North Bottom Ash Pond is reported to have been originally constructed in 1955. As shown on Figure 1, it is located immediately adjacent to an acknowledged unlined historic impoundment (approximately 120 acres in size) that was utilized for the management of coal ash. This impoundment accepted sluiced fly ash and bottom ash from approximately 1939 to 1978 and then “dry” fly ash from approximately 1978 to 1984. The impoundment continued to receive ash up until the time that the New Castle Plant Ash Landfill was constructed in the northern portion of the impoundment footprint.

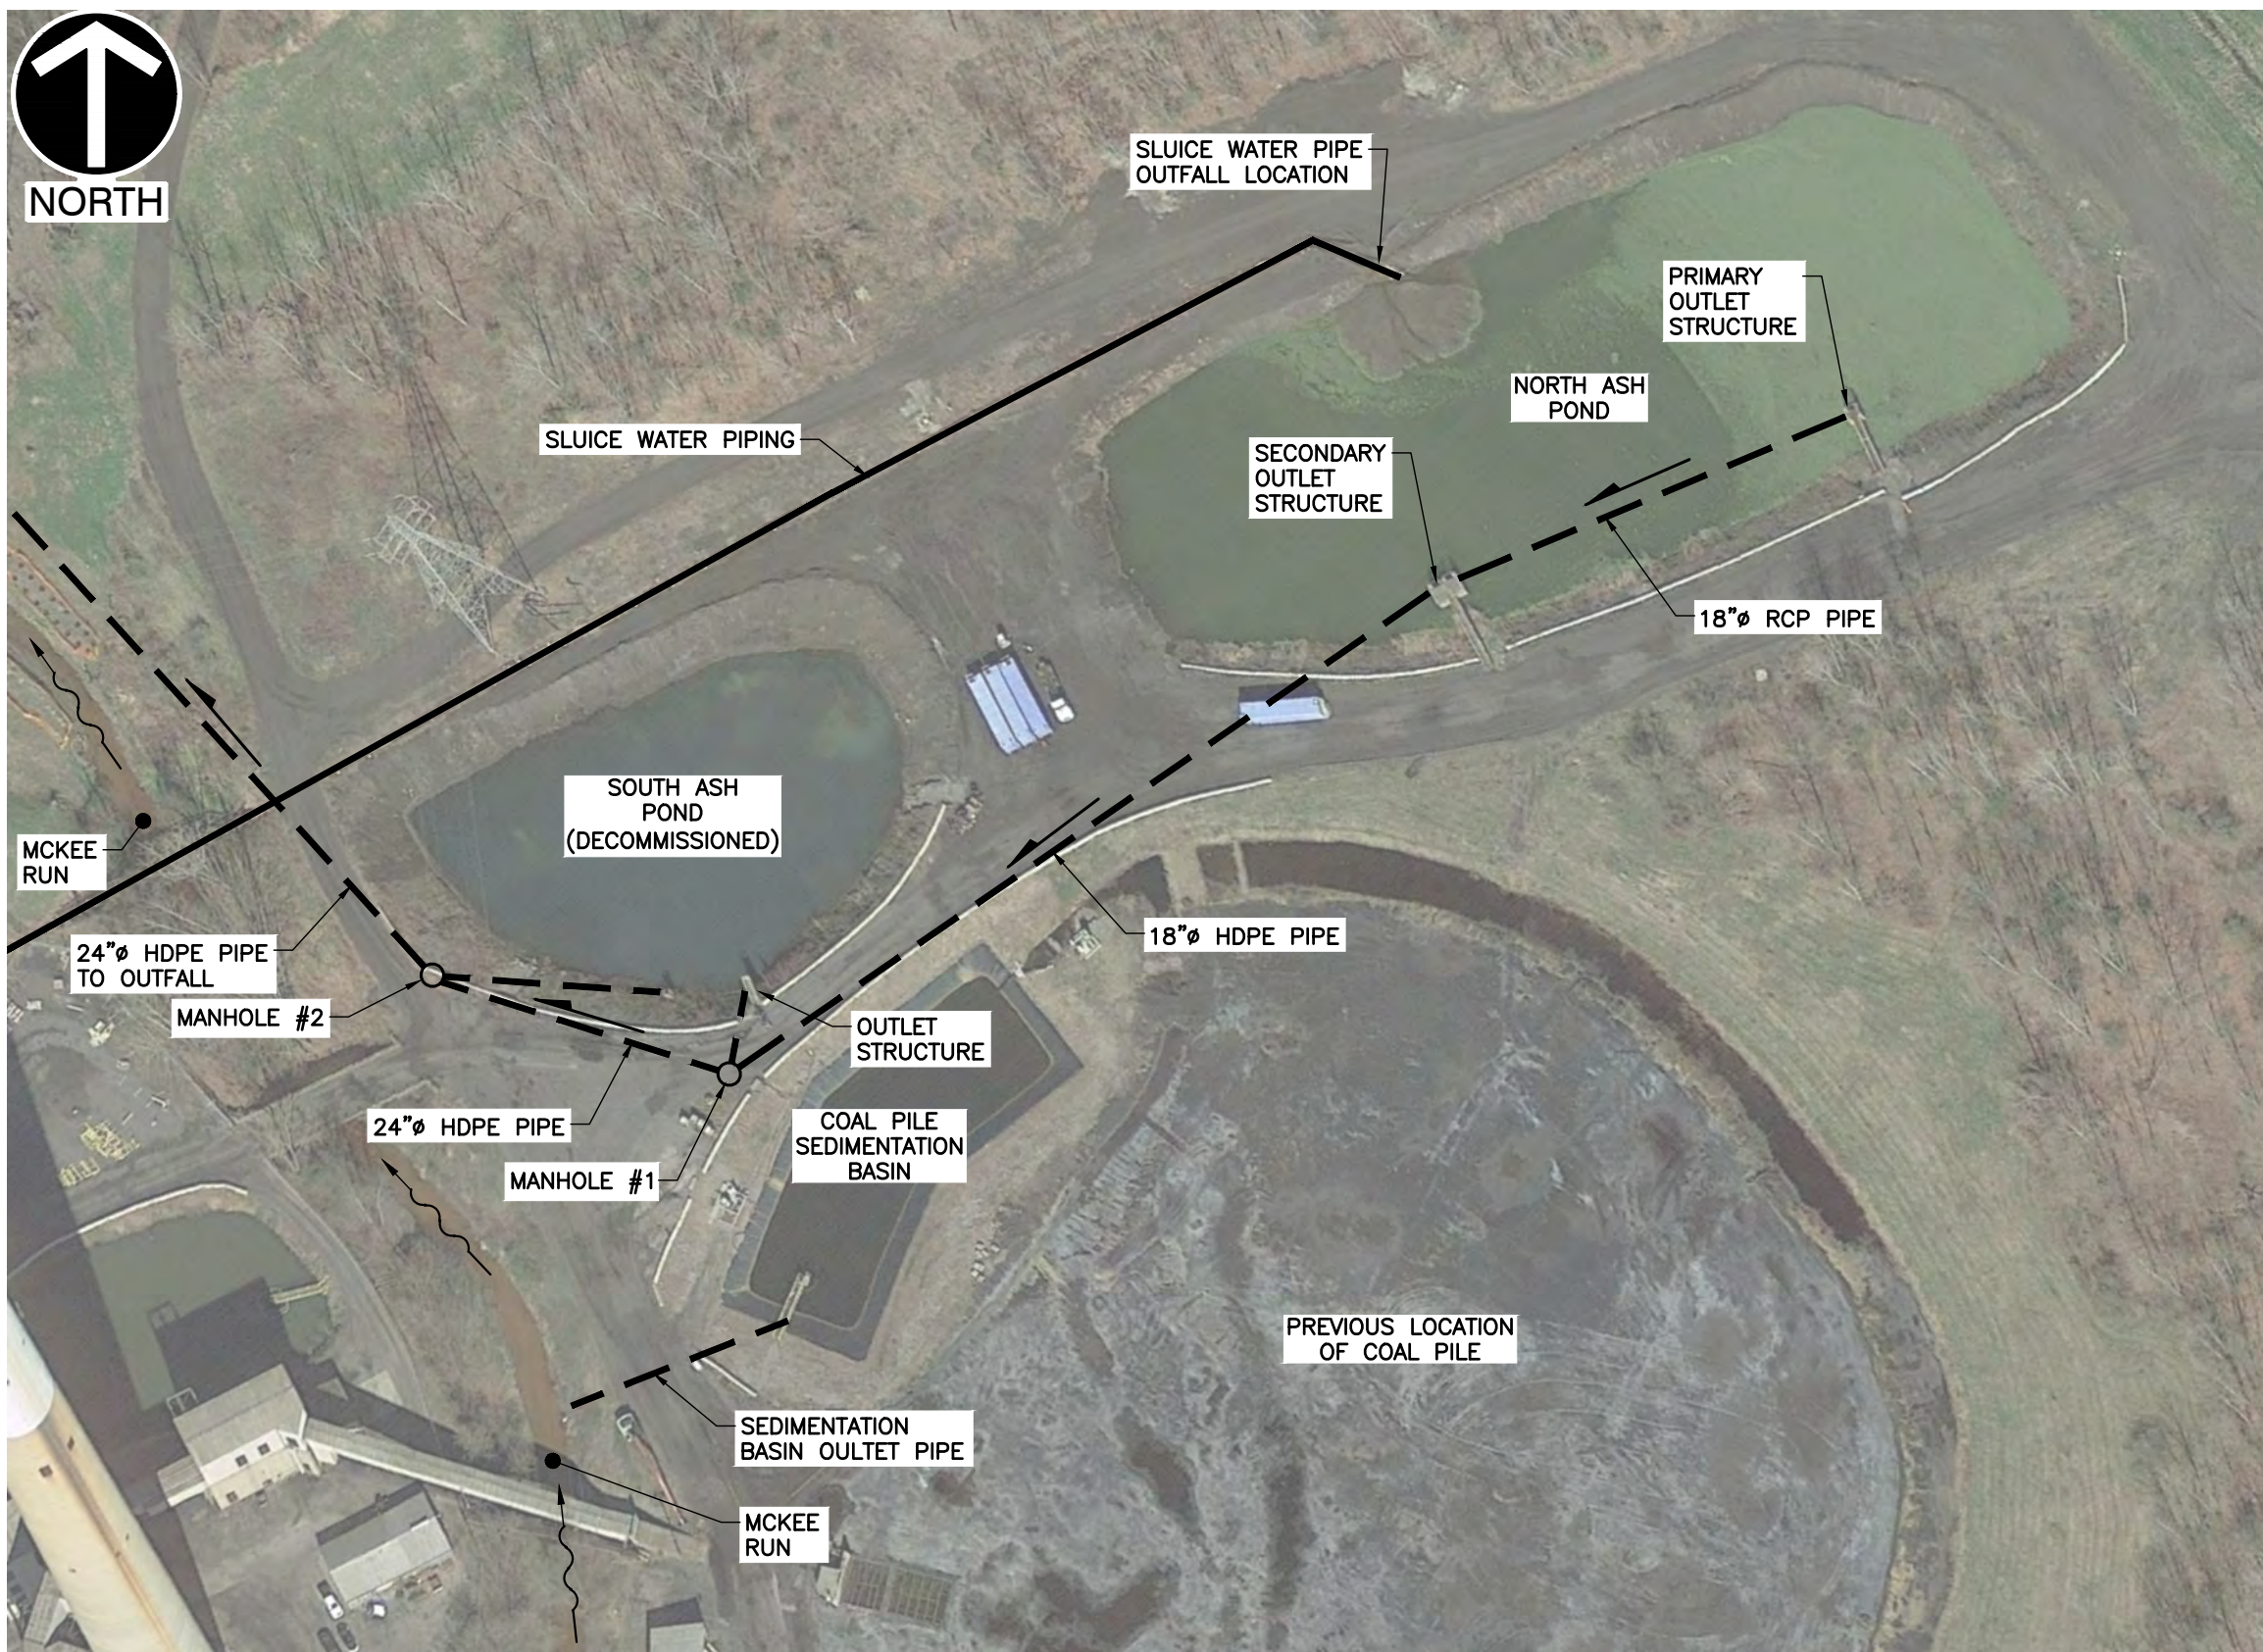
**NORTH ASH POND
 EXISTING CONDITIONS PLAN**

The New Castle Generating Station (Station) is located in West Pittsburg, Lawrence County, Pennsylvania. Refer to Figure 1 in Appendix B for the Site Location Map. The Station ceased operations using coal to generate power on March 23, 2016. The Station previously used the North Ash Pond and South Ash Pond for bottom ash management. The South Ash Pond was decommissioned and cleaned of CCR prior to the effective date of the CCR Rule, and is not considered in this Closure Plan. Refer to Figure 2 in Appendix B for the Existing Conditions Plan.

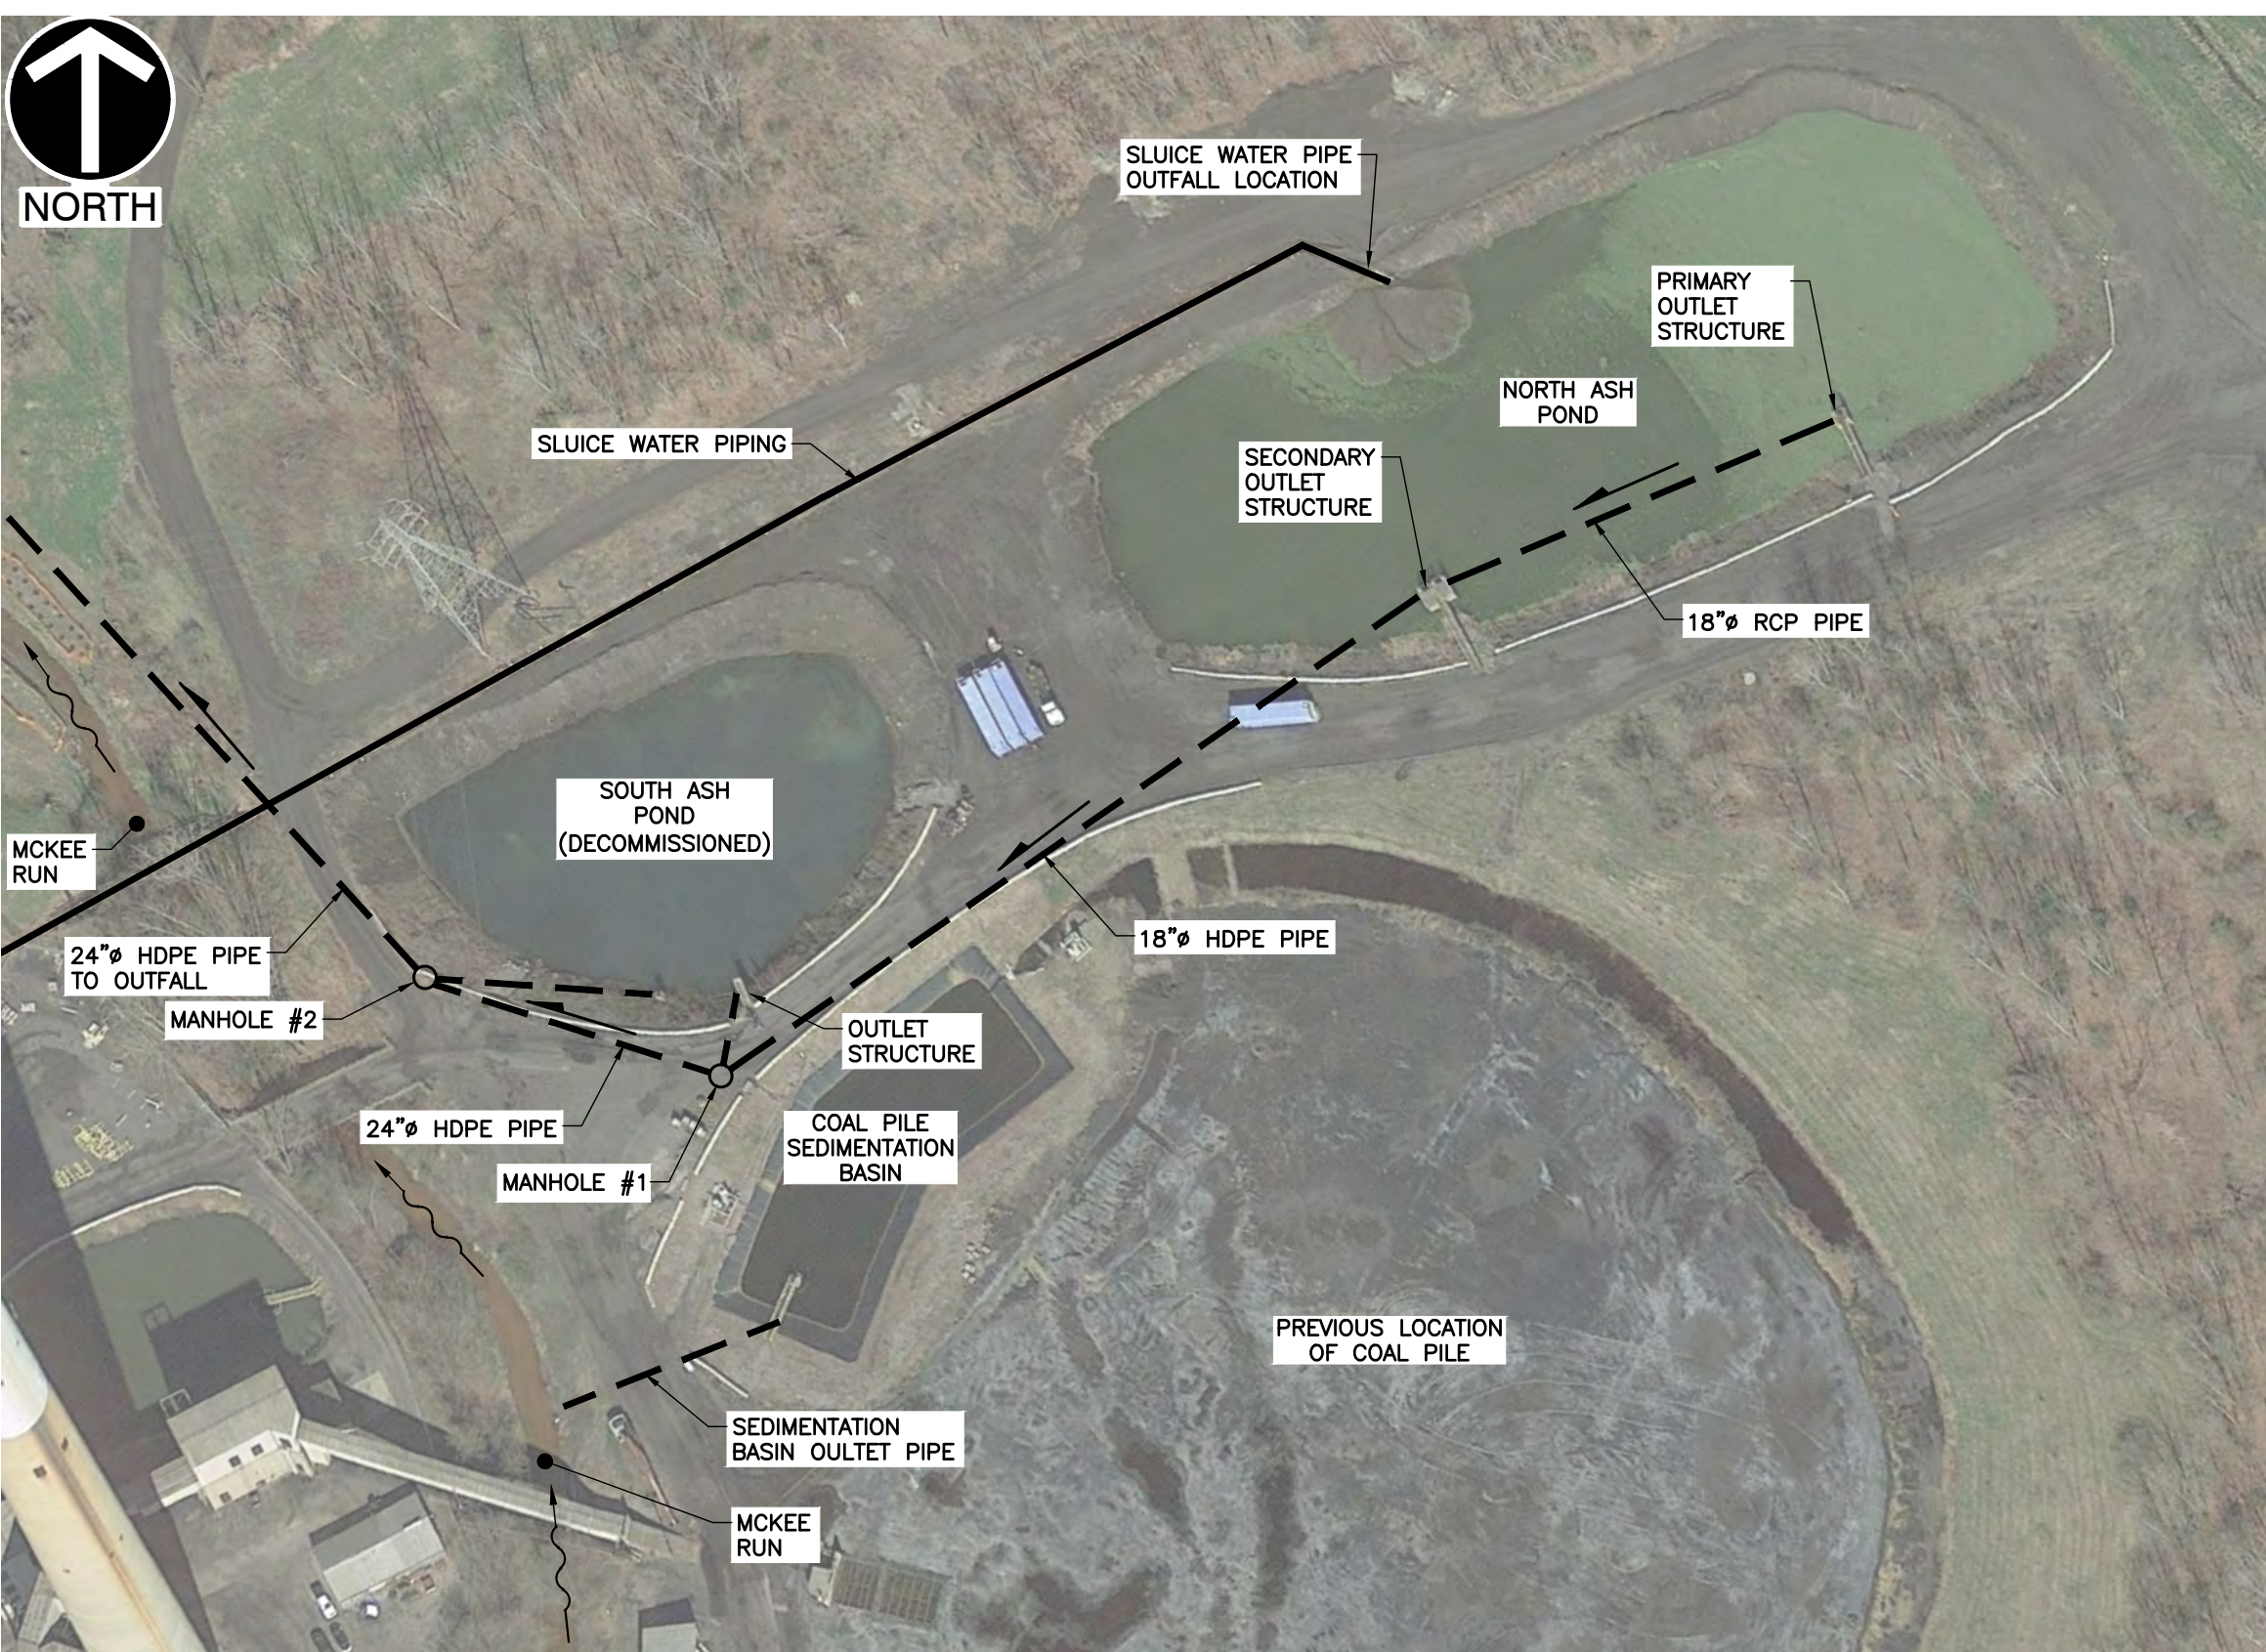
**NORTH ASH POND
 FINAL CONDITIONS PLAN**

Refer to Figure 3 in Appendix B for the Final Conditions Plan, which shows the general closure procedures for the Pond.

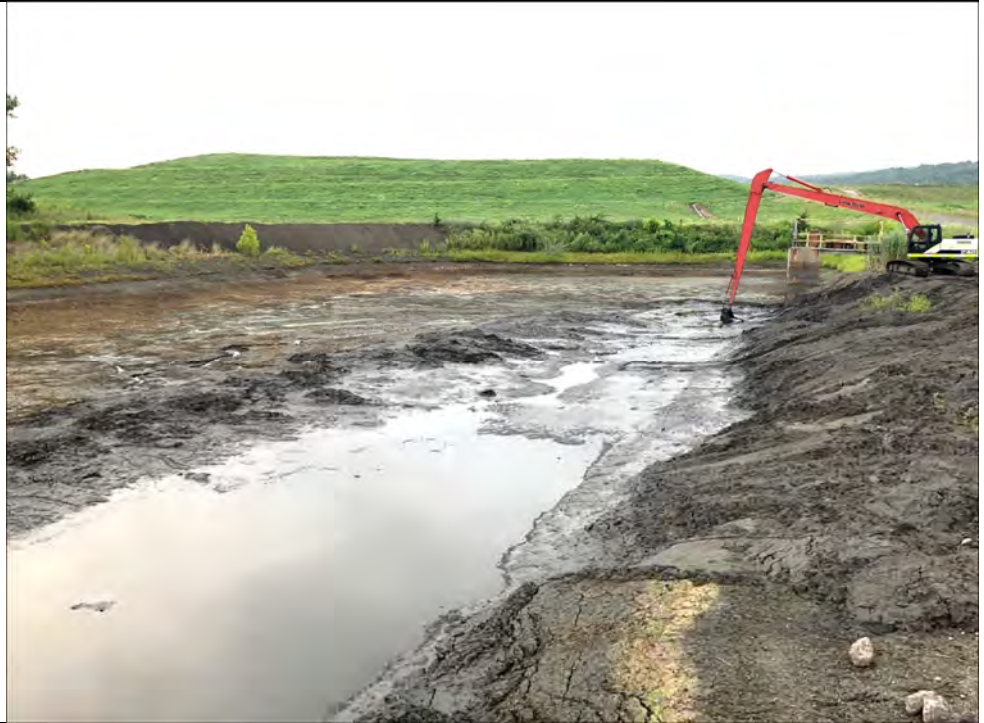
Photo No. 1:

Description: A long-stick track-hoe removes Coal Combustion Residuals (CCR) from the North Bottom Ash Pond (Pond). The CCR is loaded into an off-road haul truck and taken to the New Castle Plant Ash Landfill for disposal (landfill can be seen in background).

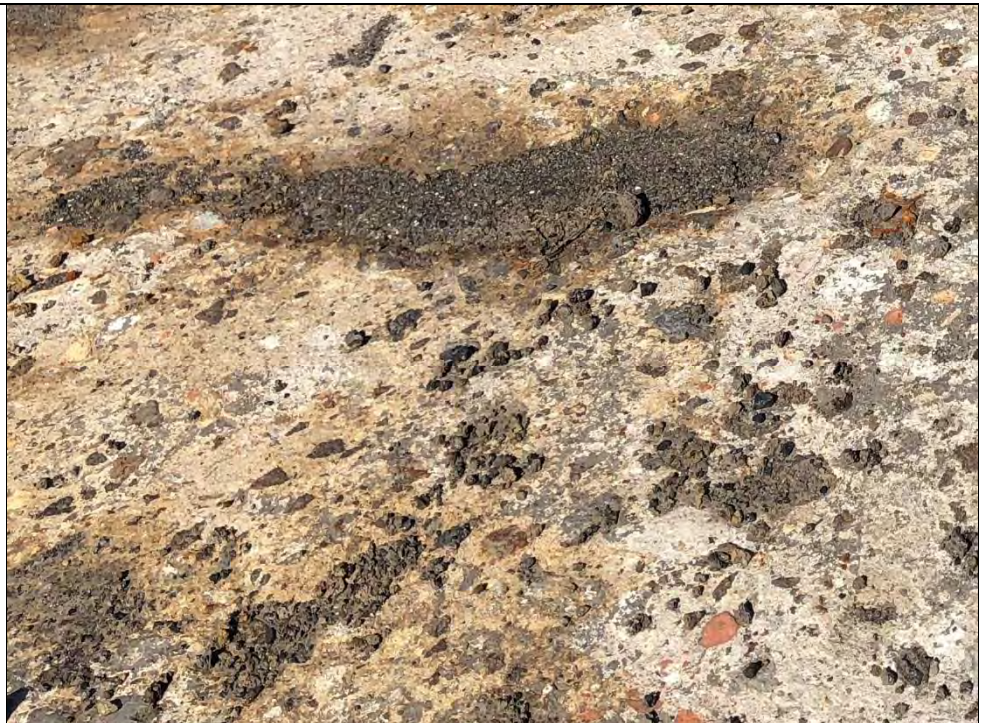
Photo No. 2:

Description: A concrete liner was encountered across the entire base and along the lower portion of the sideslopes of the Pond.

Excavation of CCR materials continued until a previously undocumented concrete liner was encountered at the base of the North Bottom Ash Pond. Concrete was found to be present across the entire base of the pond and the lower portion of the sideslopes (see Photograph Nos. 2 and 3 in Appendix B). Excavation on the sideslopes continued until CCR was no longer visible, which generally required over-excavation of the sideslopes in those areas not underlain by concrete. It is estimated that approximately 4,539 tons of CCR material were removed from the North Bottom Ash Pond. All excavated CCR material was placed in the New Castle Plant Ash Landfill, with cleaning/removal activities completed on September 25, 2018.

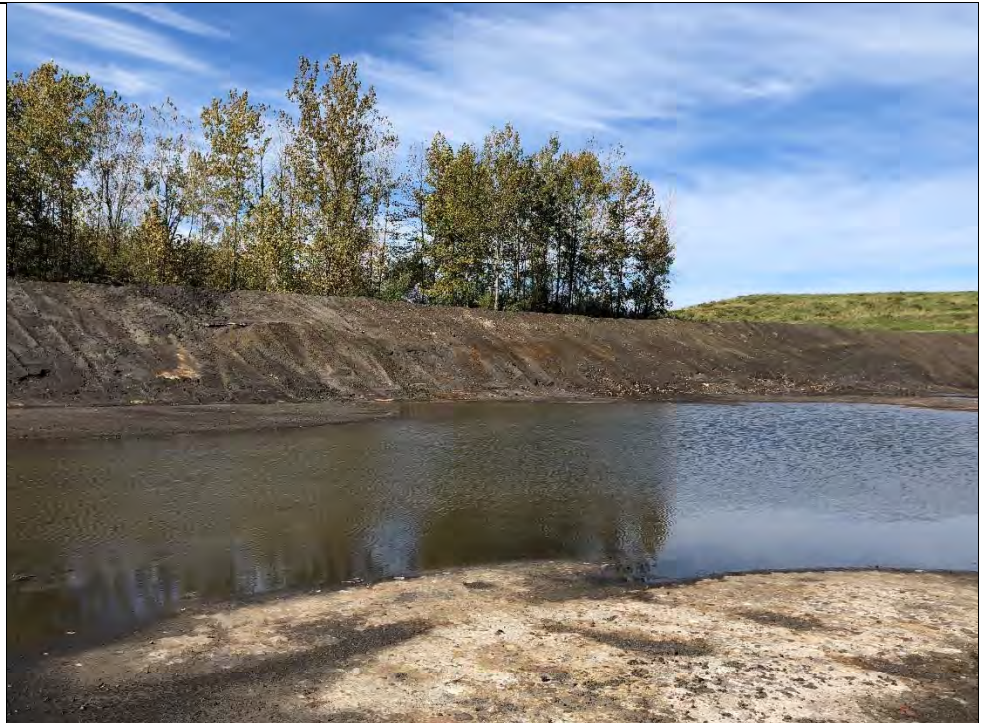
Photo No. 3:

Description: View of Pond after CCR removal. The concrete base can be seen in the foreground. The concrete extends across the entire base of the Pond, but had standing water over portions of it when photographed. The sideslopes were visually inspected, with no CCR observed at any location.

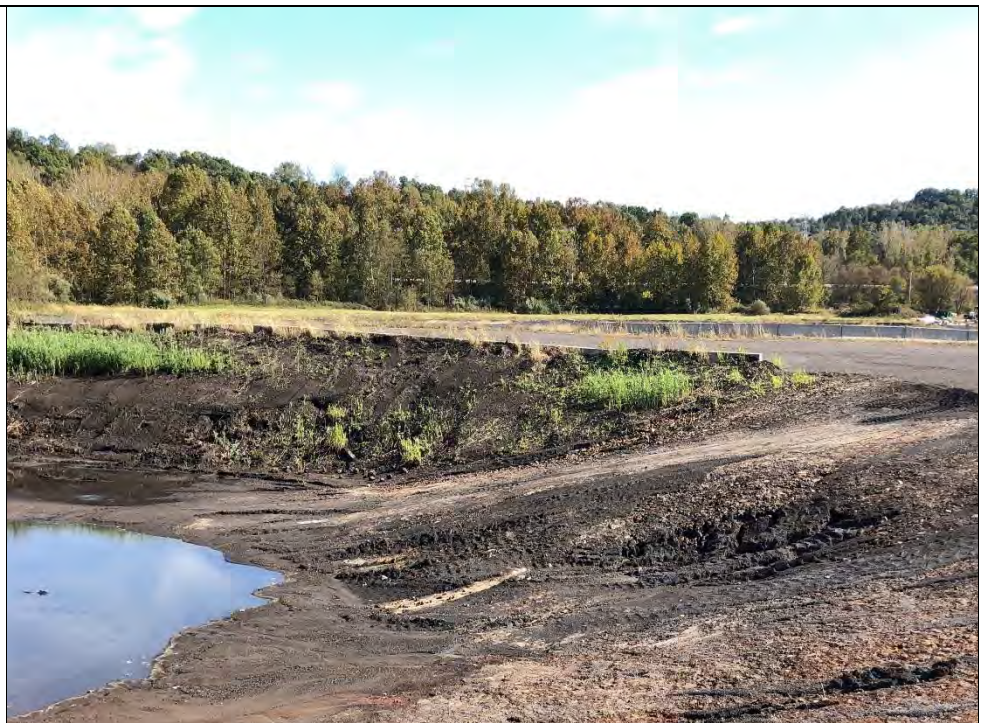
Photo No. 4:

Description: The concrete extended to the top of the Pond in two locations, suggesting that these locations may have been access ramps into the pond. Darker material is soil that was visually inspected and found to be absent of CCR.

In support of forthcoming closure, all inlet piping and associated structures were decommissioned and removed from the North Bottom Ash Pond. Two discharge weirs, identified as the primary and secondary outlet structures, and associated stoplogs were decontaminated and left in place (see Photograph Nos. 4 and 5 in Appendix B).

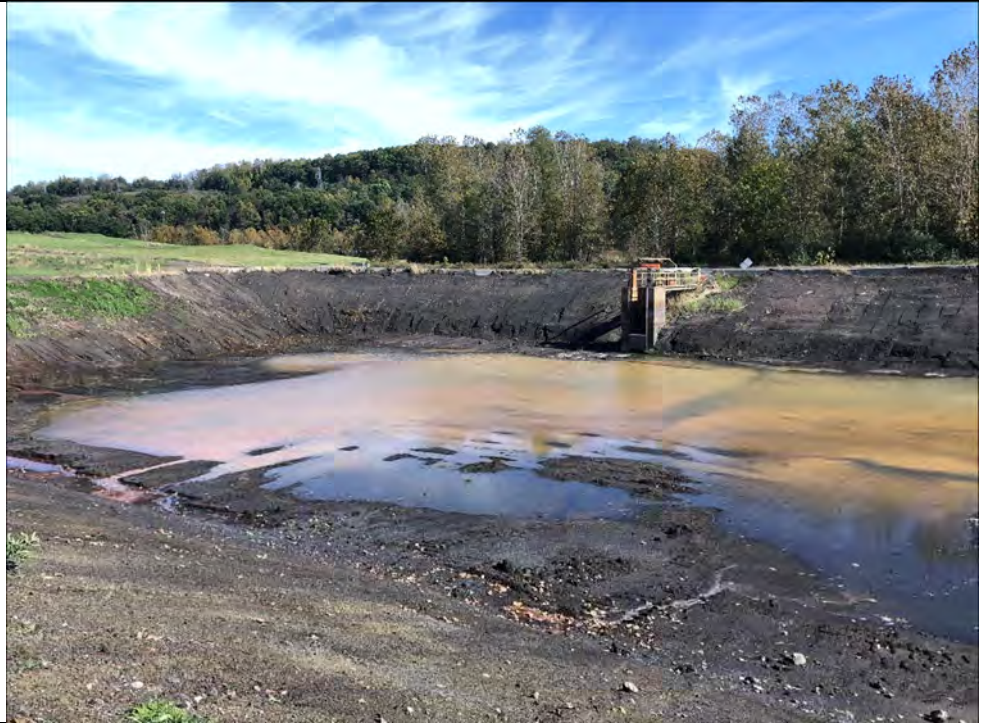
Photo No. 5:

Description: View of soil sideslopes that were visually inspected and found to be absent of CCR. The concrete base can be seen under the standing water. The primary (north) outlet structure is shown, and which will remain after pond closure.

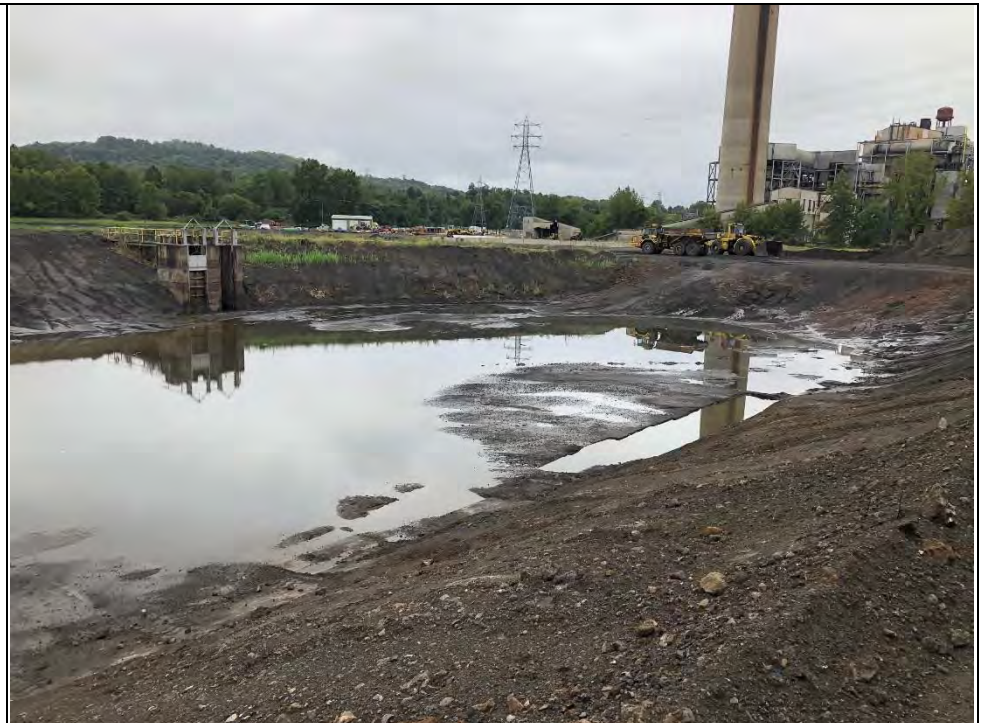
Photo No. 6:

Description: View of soil sideslopes that were visually inspected and found to be absent of CCR. The secondary (south) outlet structure is shown, and which will remain after pond closure.
